A FULL HOUSE INSPECTION CO. LLC – FORENSIC MOISTURE INVESTIGATION

This client has had a leak for **four years** with multiple unsuccessful repairs by their contractor. There is no evidence of active leakage at the time of the investigation in both photos.

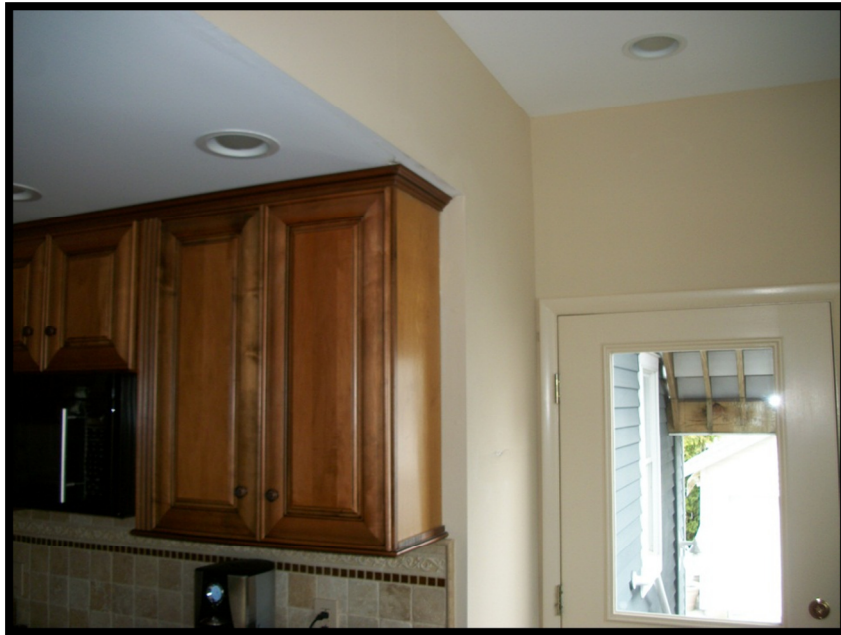
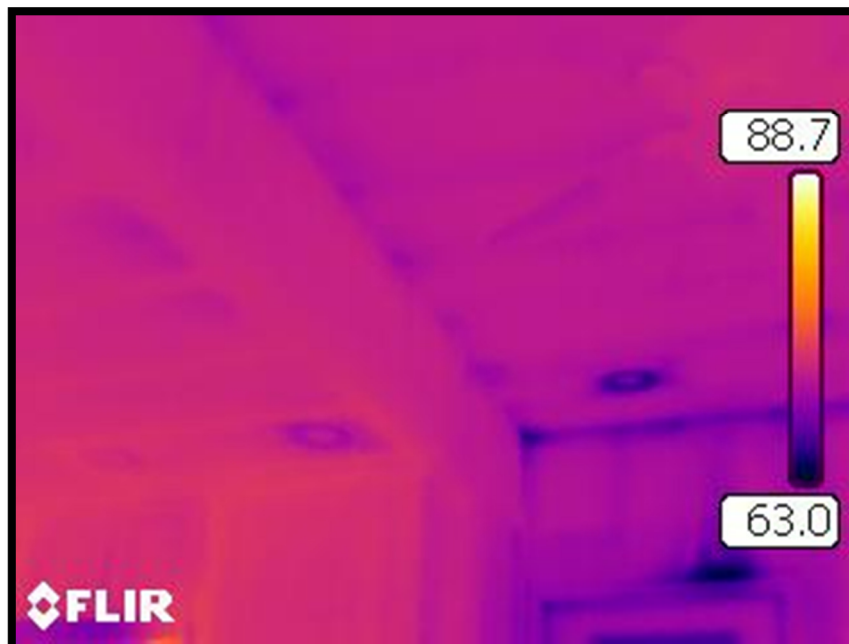
Thermograph taken before beginning applying moisture via the spray rack and engaging the blower door fan.

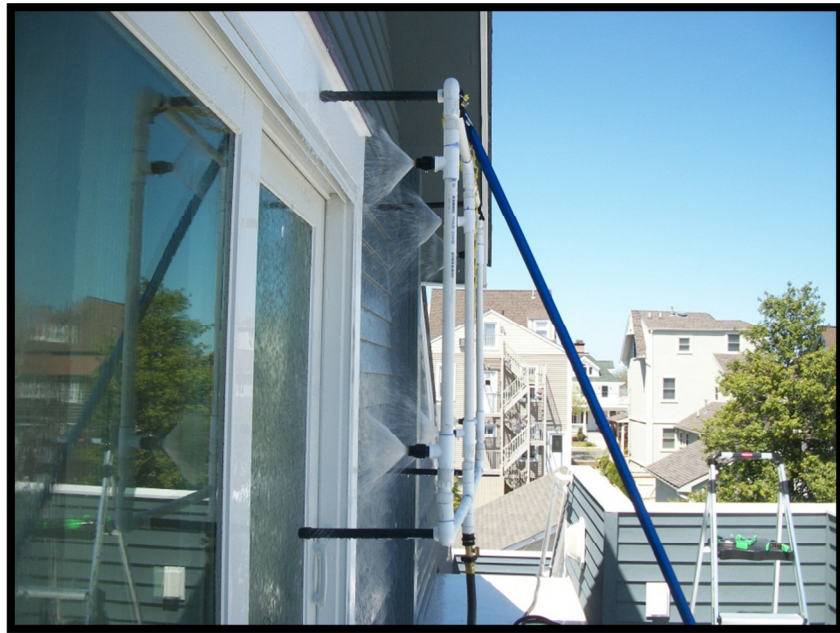
Water application via spray rack

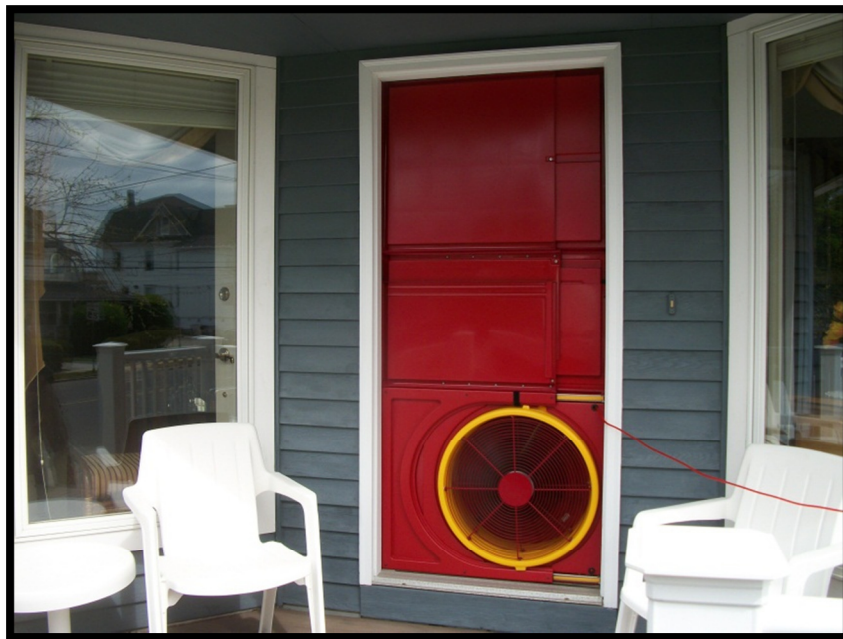
Blower door engaged to depressurize residence and simulate wind storm activity.

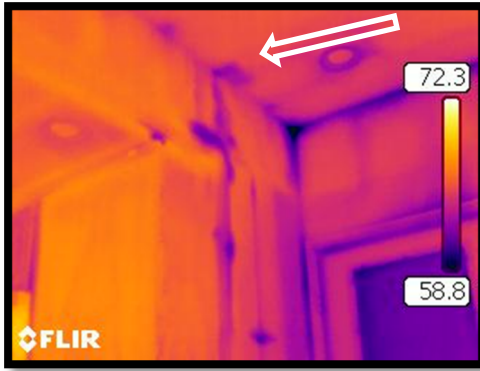
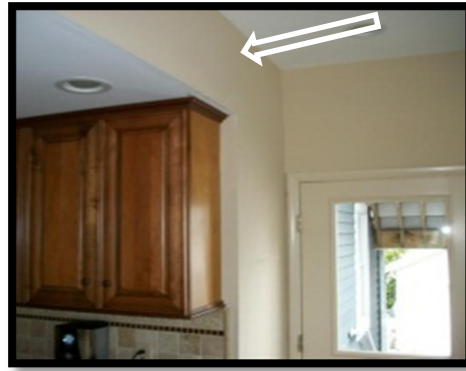
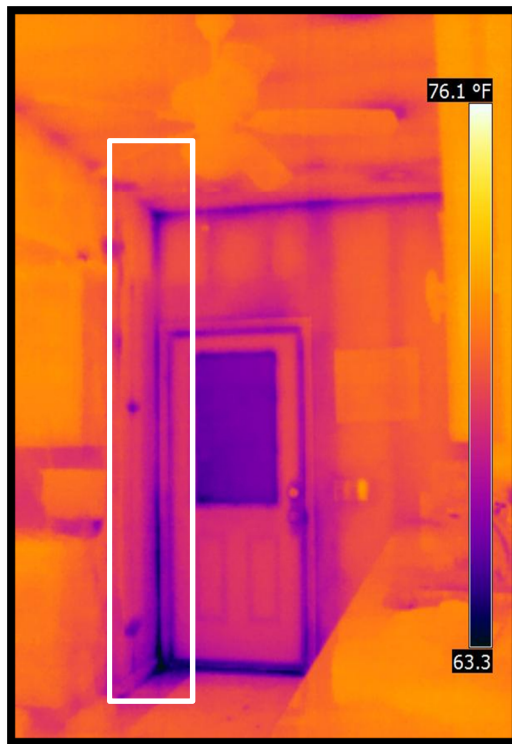
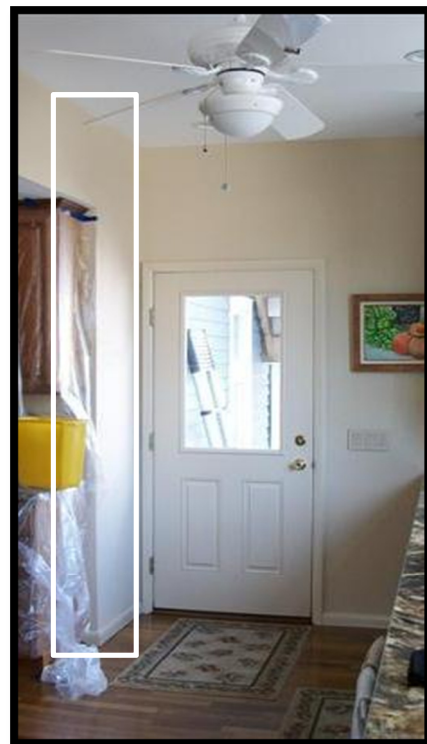
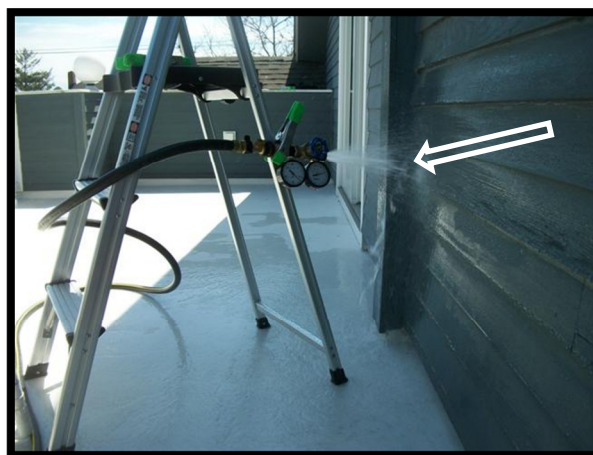
The boxes and arrows in the top four photos show the leak. After applying water to the deck, doors and siding, the leak was detected at the siding, as indicated in the last photo.

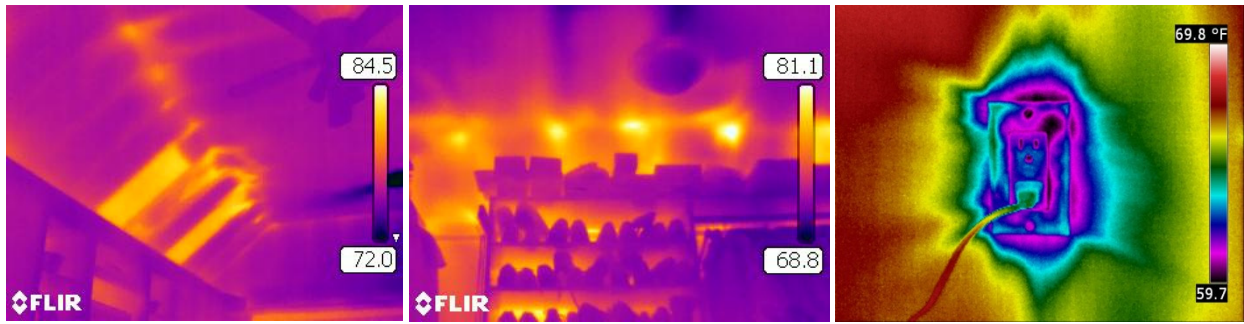
Insulation Faults: missing, gaps, voids and air infiltration

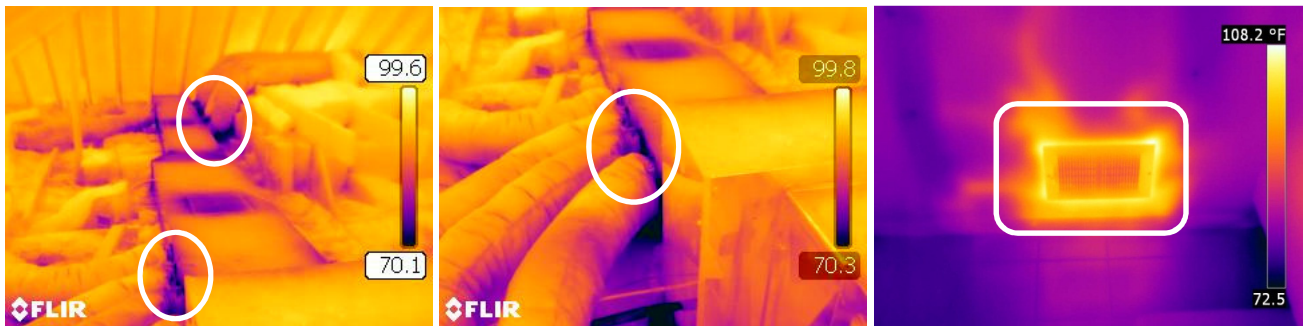
Leaking duct connections

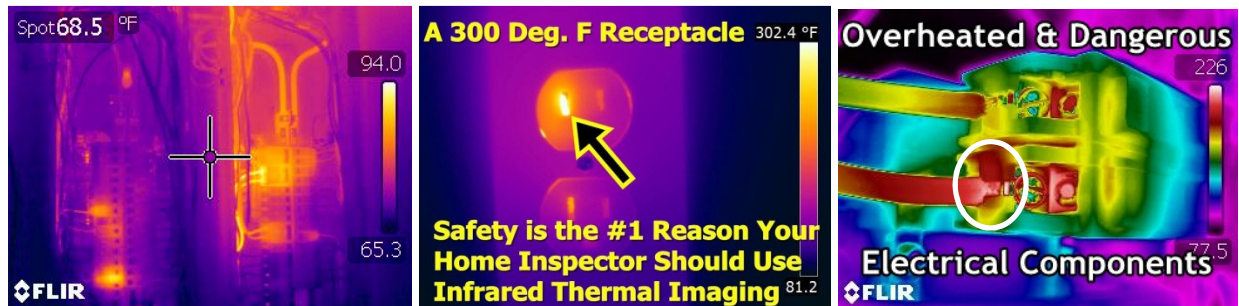
Dangerous electrical conditions

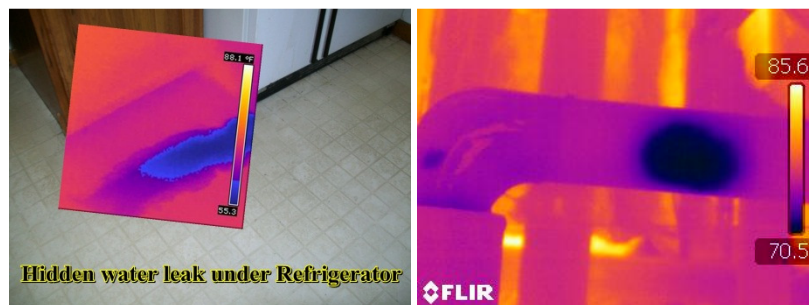
Plumbing leaks
