Qualitative Infrared Moisture Survey Report

The Sample Residence

QUALITATIVE INFRARED THERMOGRAPHIC REPORT

Subject Areas – Front exterior and exterior wall and window above front bedroom only.

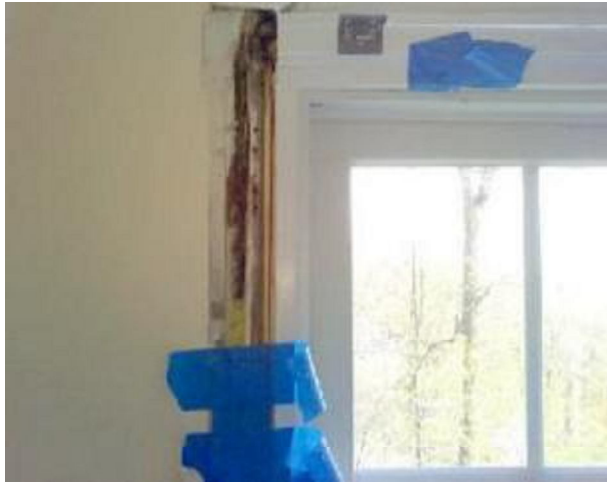
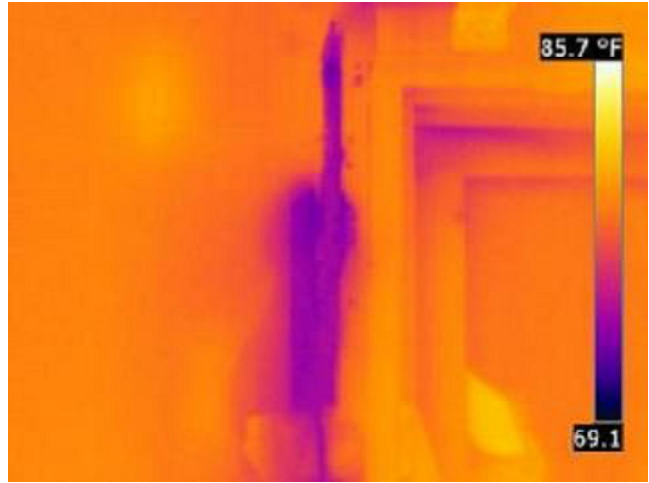
Location Floor: Second
Location Room: Bedroom
Location Direction: Right Front Corner of Window

Observations:
Images and photos taken before use of garden hose. No indication of leakage.

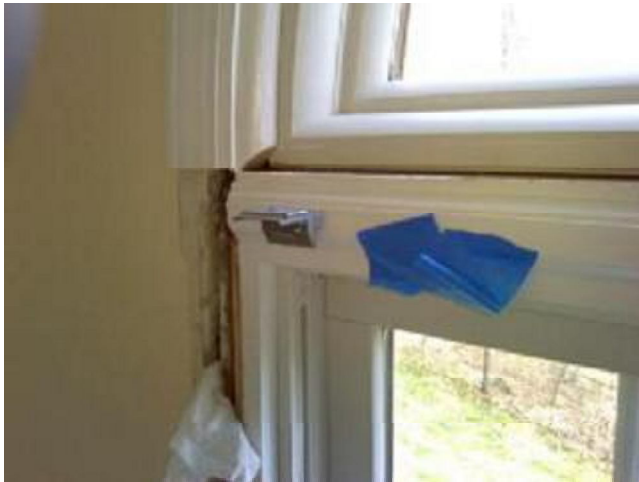
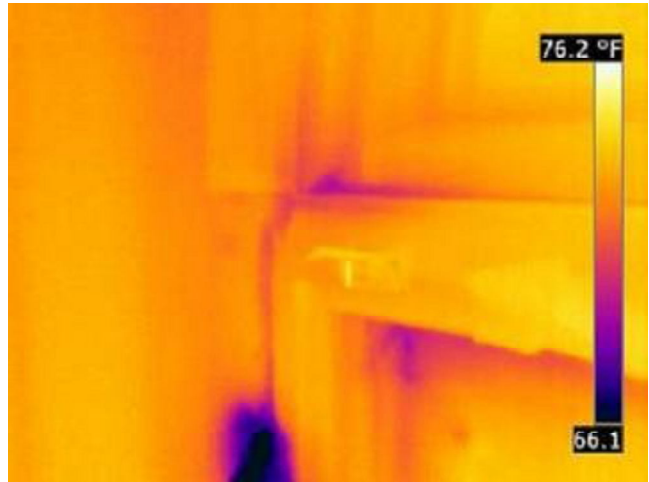
Observations:
Images and photos taken before use of garden hose. No indication of leakage.

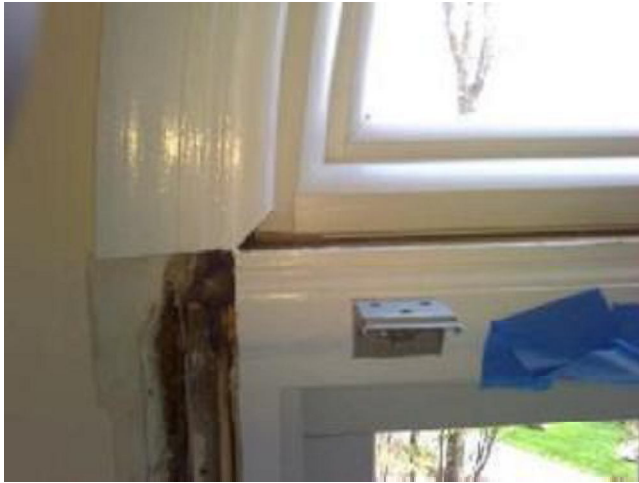
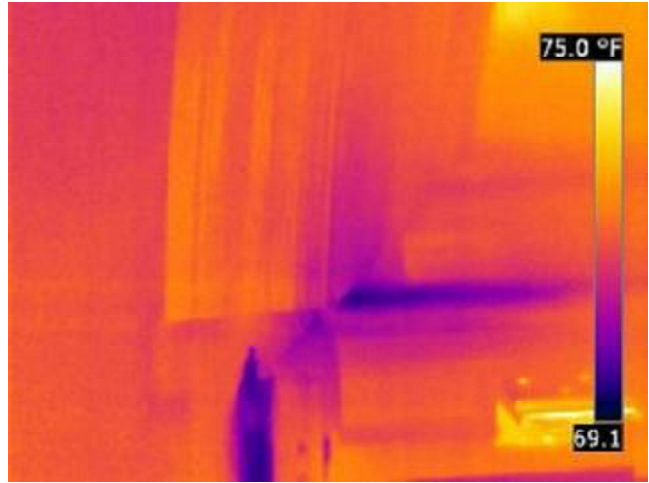
Observations:
Images and photos taken before use of garden hose. No indication of leakage.

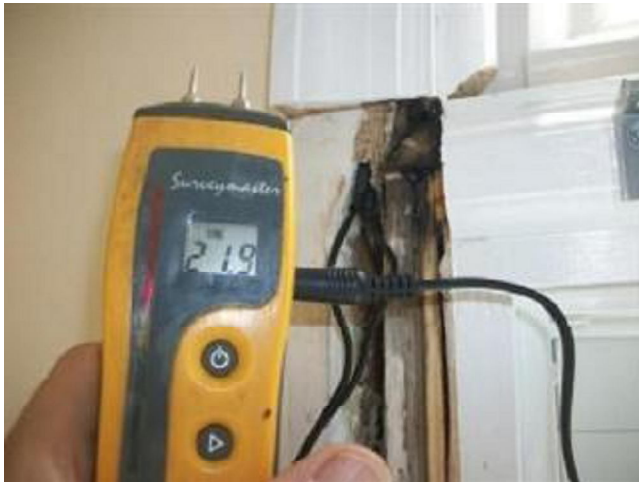
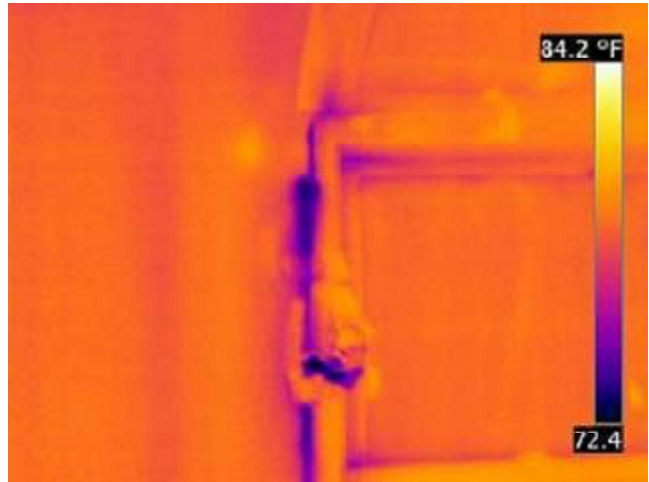
Observations:
Images and photos taken before use of garden hose. Moisture level of 21.9% noted.

A significant leak and moisture entry was noted at the right front corner where the half moon window joins the double hung window on top of, below and under the metal bracket which appears to fasten the half moon window to the lower double window. Moisture levels of approximately 21.5 % were noted above the metal bracket before the use of the garden hose. After soaking the exterior area, the moisture levels were the same, but the leak was only below the bracket area. Moisture levels of 90% were noted below and inside the bracket. This area strongly indicates leakage at the window and not the exterior wall assembly. The infrared thermal imaging scan did not detect cold patterns associated with leaks at any other location, except where the active leak was visibly noted. Note: the leaks occurred with and without the blower door fan in operation.

It is the inspector's opinion that the moisture entry is at the aforementioned area of the window. The window manufacturer should be retained for further evaluation and all necessary repairs to determine and eliminate all sources of moisture entry to provide a weathertight seal against leaks.

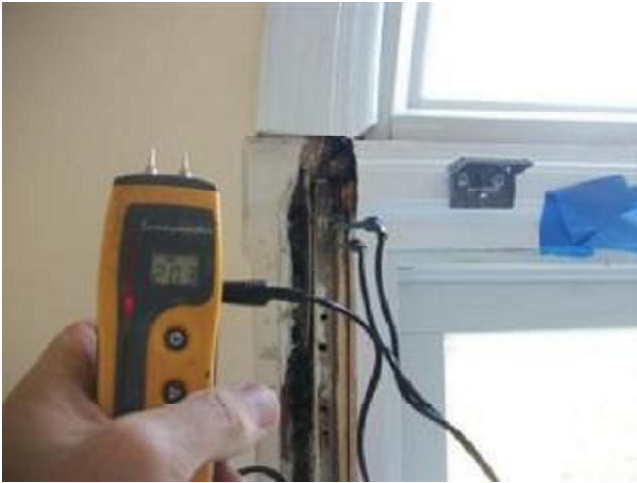
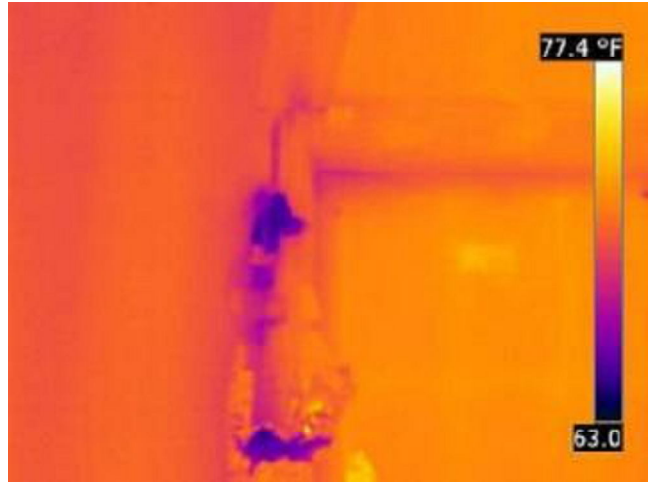
Observations:
Images and photos taken after use of garden hose. No indication of leakage.

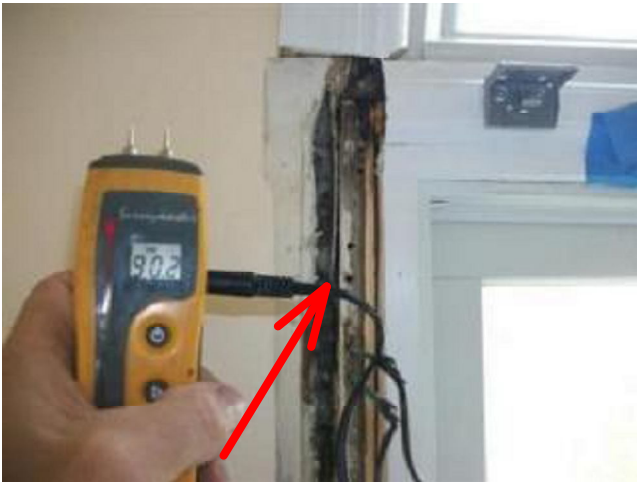
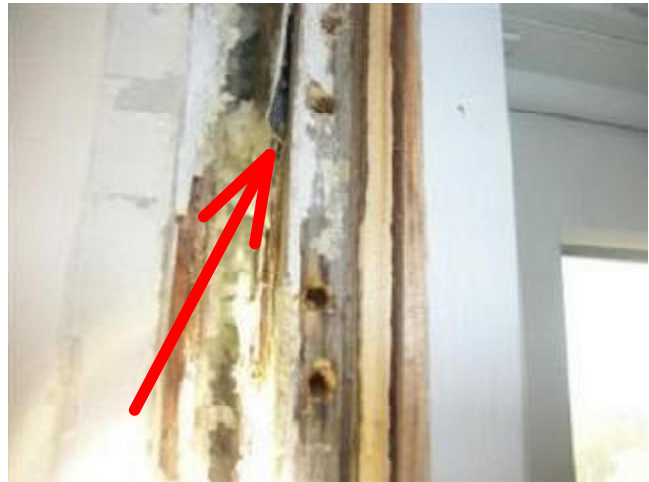
Observations:
Images and photos taken after use of garden hose. Moisture level of 90.2% noted. Arrow indicates water drips.
