Peter W. Bennett
 Certified Thermographer No. 7406
www.AFullHouseInspection.com
 Peter@AFullHouseInspectionCo.com
 732-758-9887

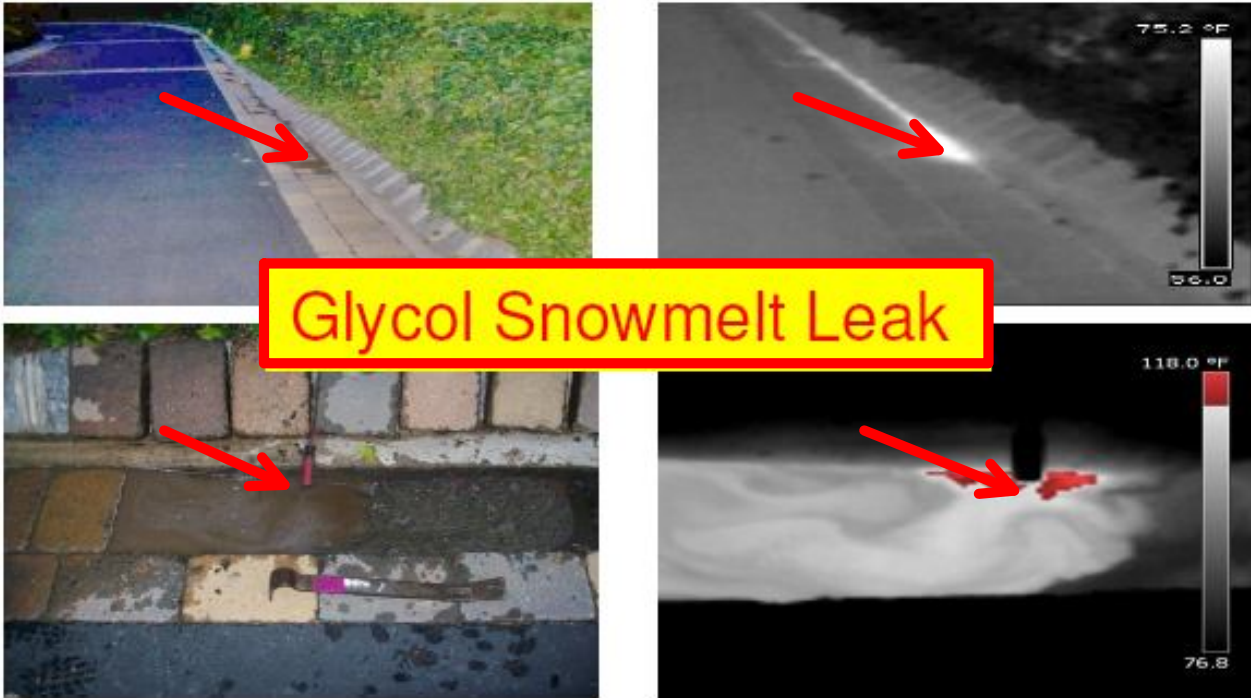
Infrared thermal imaging detected the hot leaking glycol which is visible in the photos and thermograms. The origin of the leak was detected at the hottest spot. The use of infrared saved the repair contractor approximately 2.5 hours of labor and needless destructive testing.

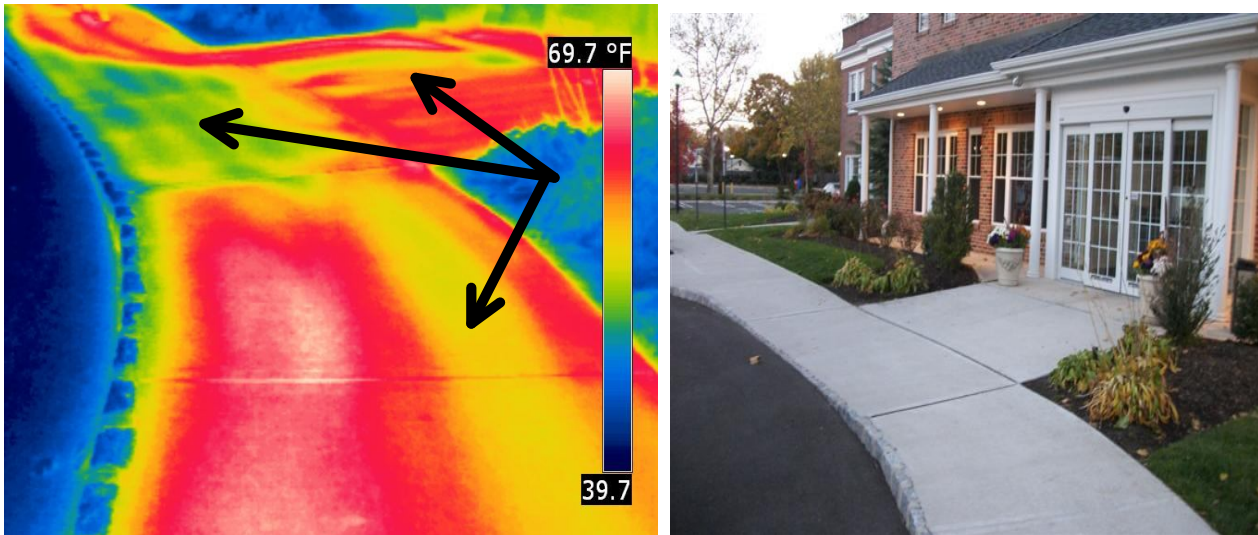
A local veterinarians office has a glycol snow melt system in their sidewalk which was not performing. Infrared imaging detected the cold areas instantly, as indicated by the arrows in the image. Needless, destructive testing was avoided as the pump for the system was defective.
