Thermal Imaging Report

123 High Utility Bill Street
Red Bank, NJ 07701

Prepared for: Mr. and Mrs. Homeowner

Prepared by: A Full House Inspection Co. LLC

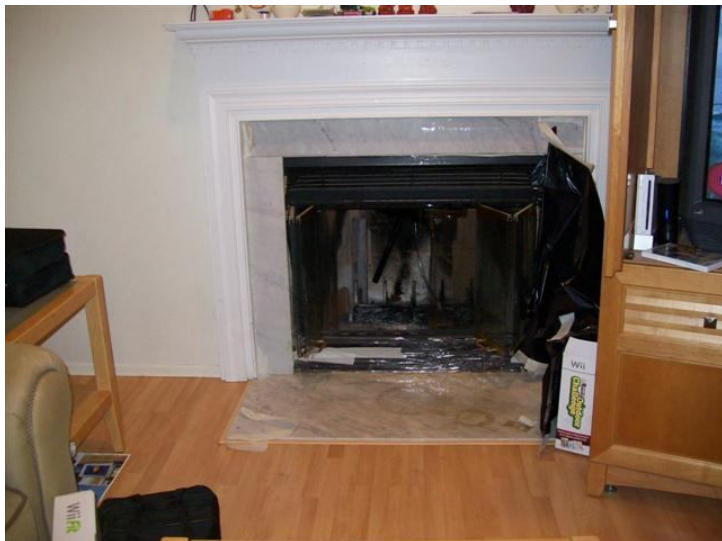
Location Room: Family

Observations:
 Cold air infiltration noted in blue. Retain a qualified contractor to check for missing insulation and correct condition. Priority 1.

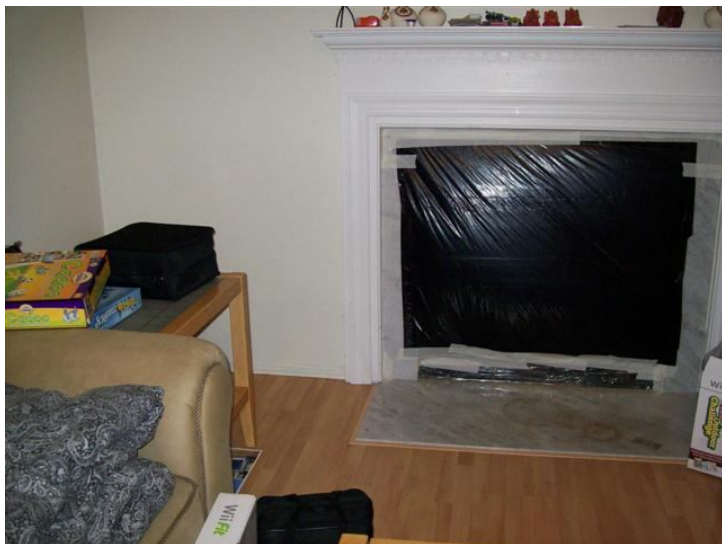
Location Room: Family

Observations:
 Cold air infiltration noted in blue around fireplace. Retain a qualified contractor to check for missing insulation and correct condition. Priority 1.

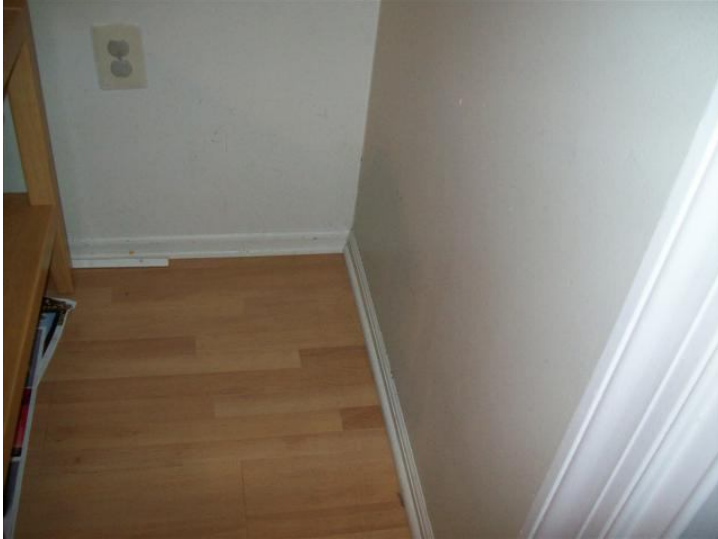
Location Room: Family

Observations:
Cold air infiltration noted in blue. Check for missing insulation at corresponding area in basement and correct condition. Priority 2.

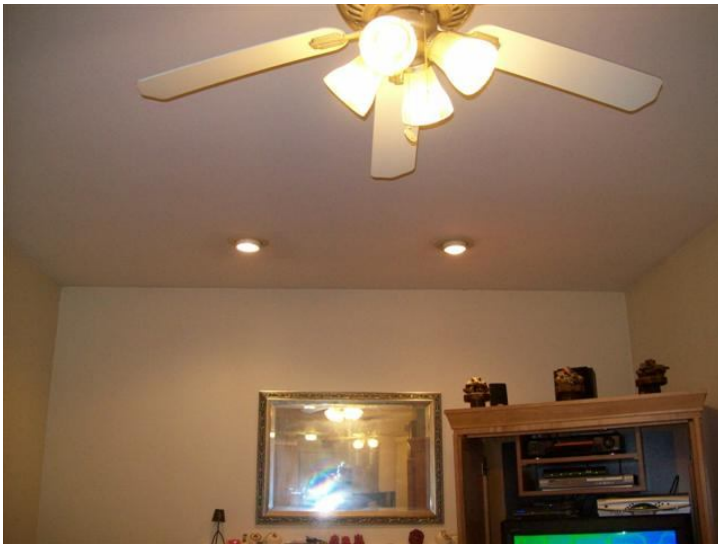
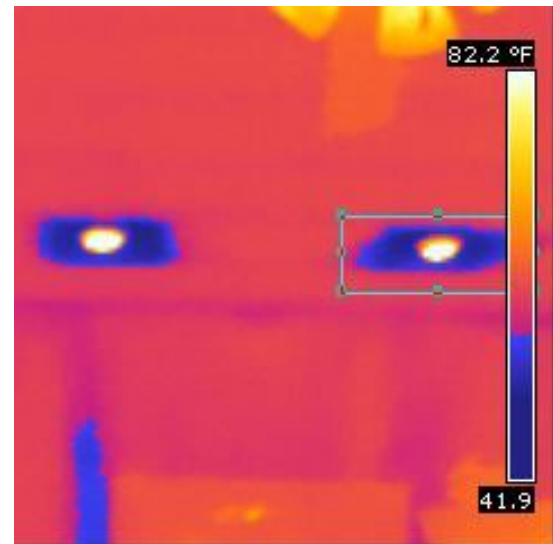
Observations:
Cold air infiltration noted in blue. Retain a qualified contactor to check for missing insulation and correct condition. Priority 1.

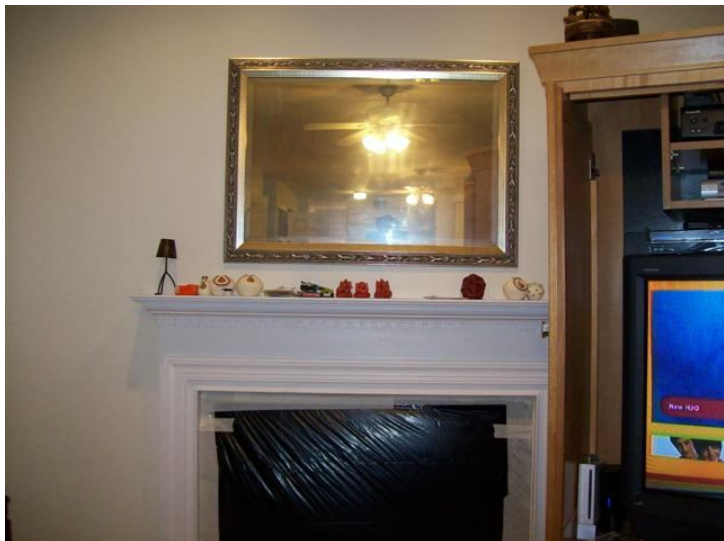
Location Room: Family

Observations:
 Cold air infiltration noted above fireplace. Retain a qualified contractor to correct condition. Priority 1.

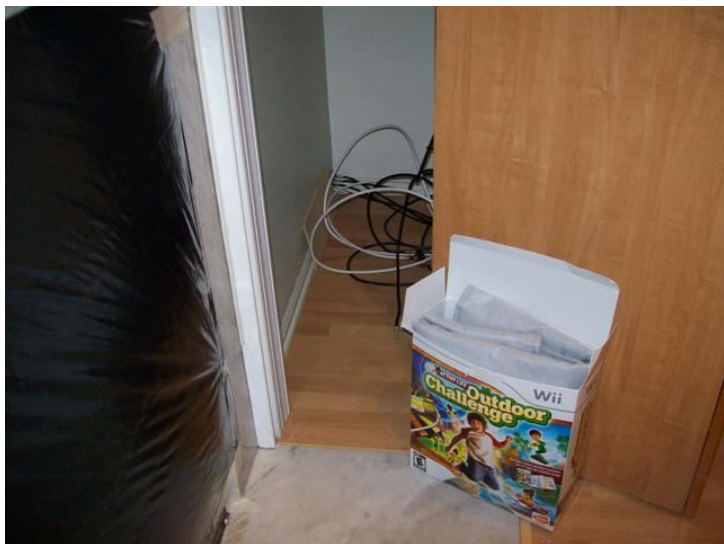
Location Room: Family

Observations:
 Cold air infiltration noted in blue around fireplace. Retain a qualified contractor to check for missing insulation and correct condition. Priority 1.

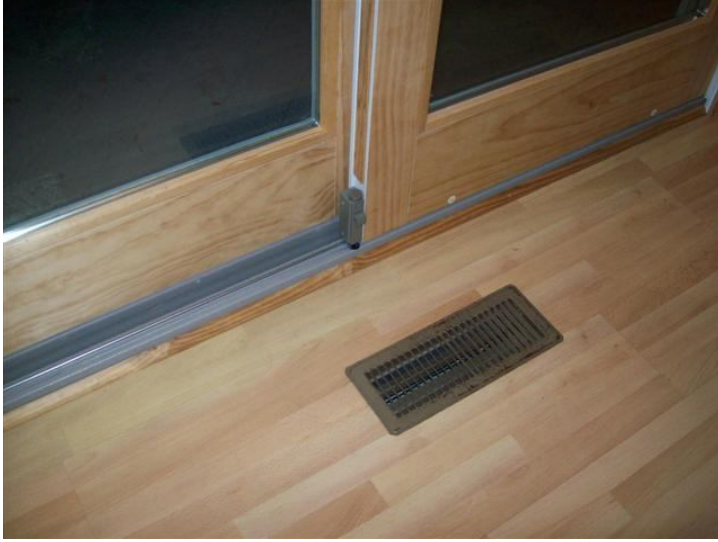
Location Room: Family

Observations:
Cold air infiltration noted in blue. Retain a qualified contractor to check for missing damaged/missing weather stripping and correct condition. Priority 2.

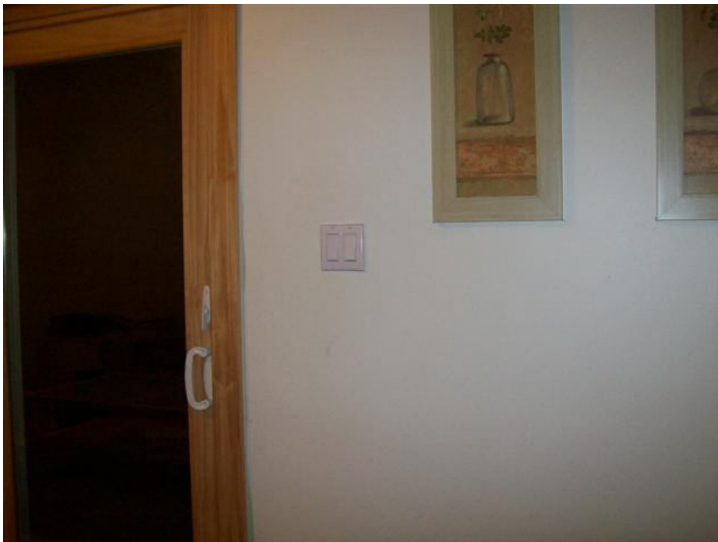
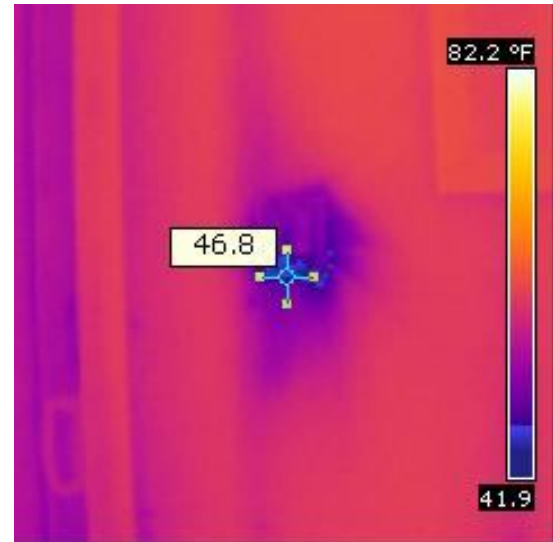
Location Room: Family

Observations:
Cold air infiltration at receptacle. Install foam gasket sealers. Priority 2.

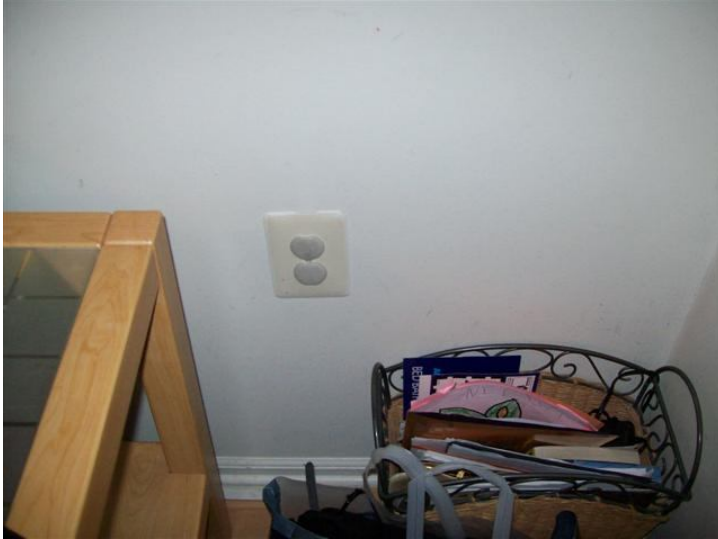
Location Room: Family

Observations:
Cold air infiltration at receptacle. Install foam gasket sealers. Priority 2.

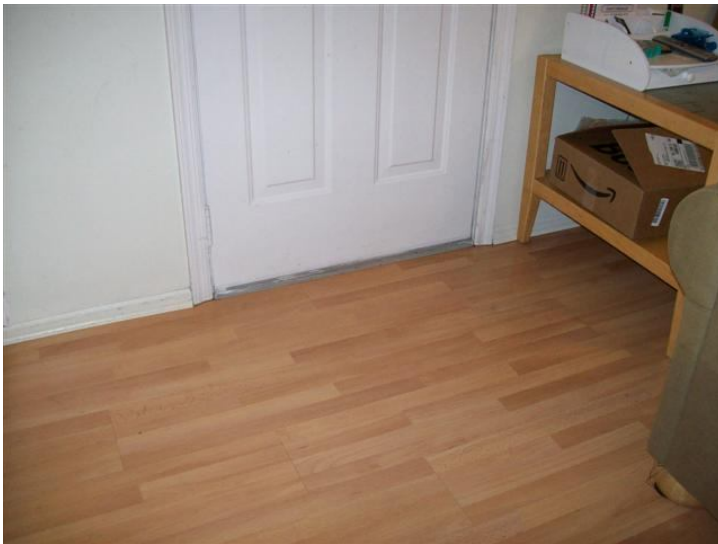
Location Room: Family

Observations:
Cold air infiltration at door. Replace weather stripping. Priority 1.

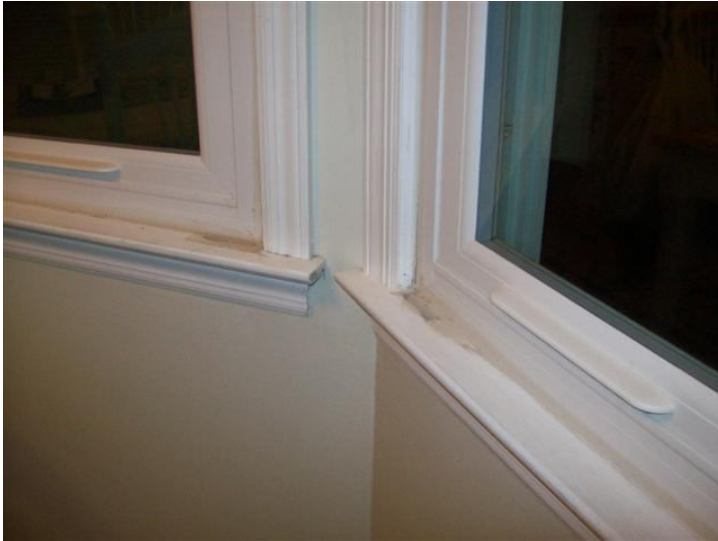
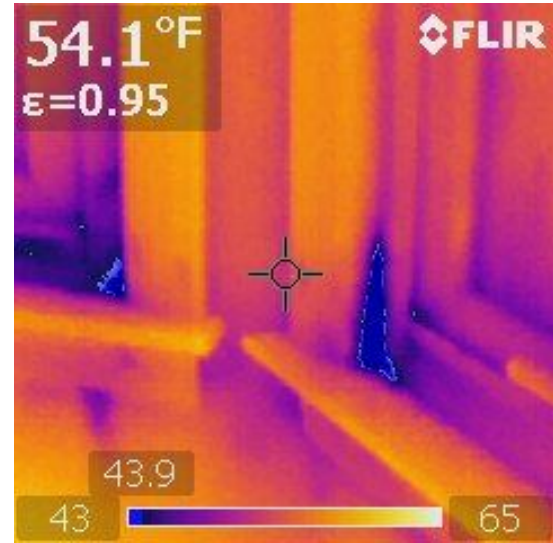
Location Room: Breakfast

Observations:
Cold air infiltration noted in blue. Caulk and seal at the interior and exterior. Priority 1.

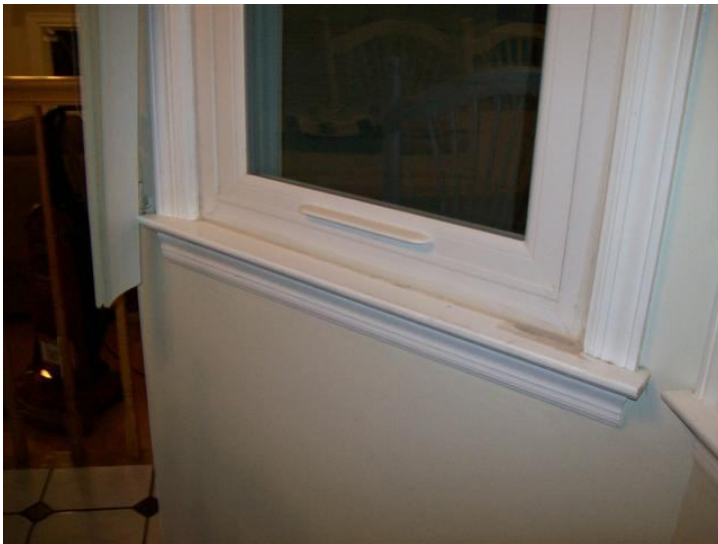
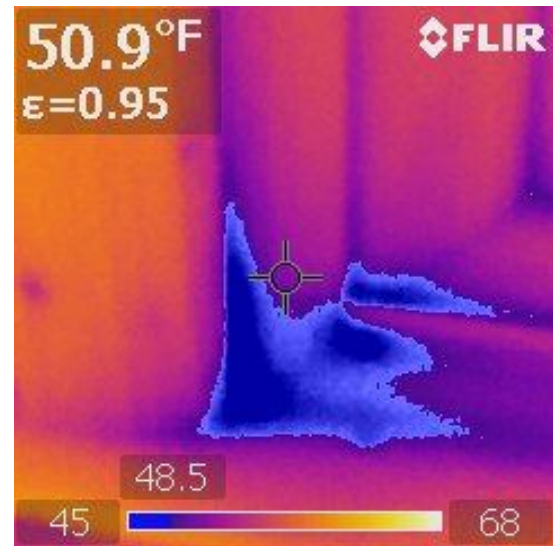
Location Room: Breakfast

Observations:
Cold air infiltration noted in blue. Caulk and seal at the interior and exterior. Priority 1.

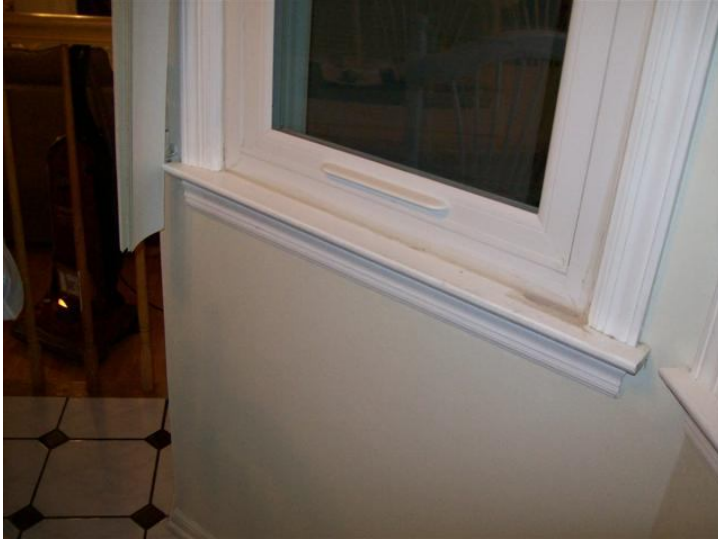
Location Room: Breakfast

Observations:
Cold air infiltration noted in blue. Caulk and seal at the interior and exterior. Priority 1.

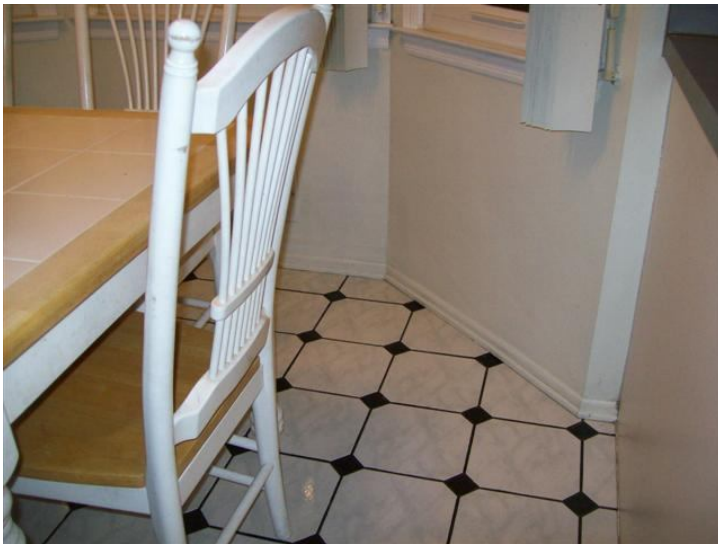
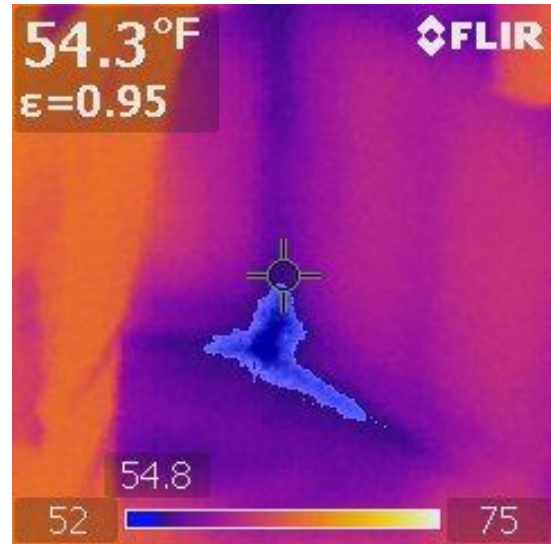
Location Room: Breakfast

Observations:
Cold air infiltration noted in blue. Install insulation were missing/void. Caulk and seal at the interior and exterior. Retain a qualified contactor for evaluation to correct condition. Priority 1.

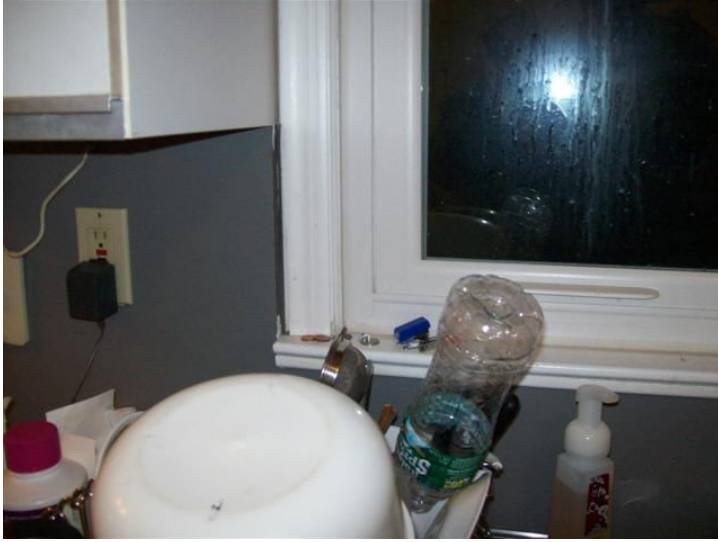
Location Room: Kitchen

Cold air infiltration noted in blue. Caulk and seal at the interior and exterior. Retain a qualified contactor for evaluation to correct condition. Priority 1.

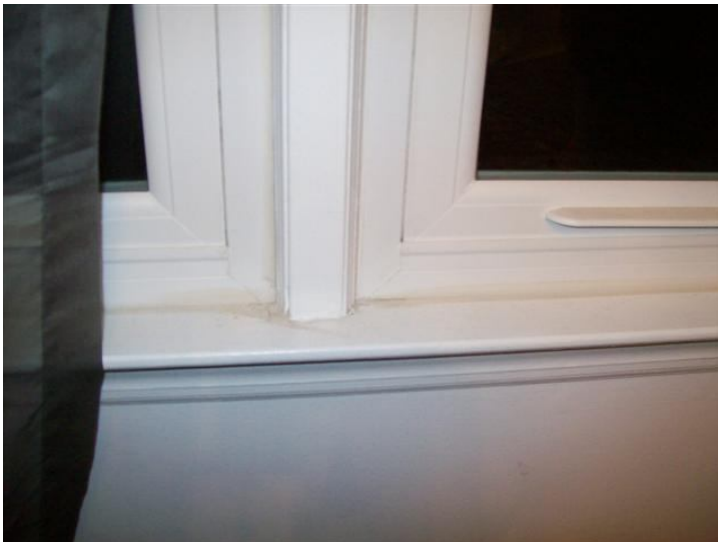
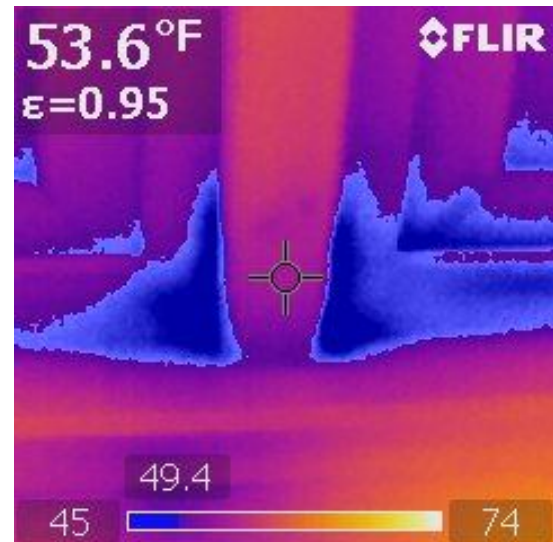
Location Room: Dining room

Cold air infiltration noted in blue. Caulk and seal at the interior and exterior. Retain a qualified contactor for evaluation to correct condition. Priority 1.

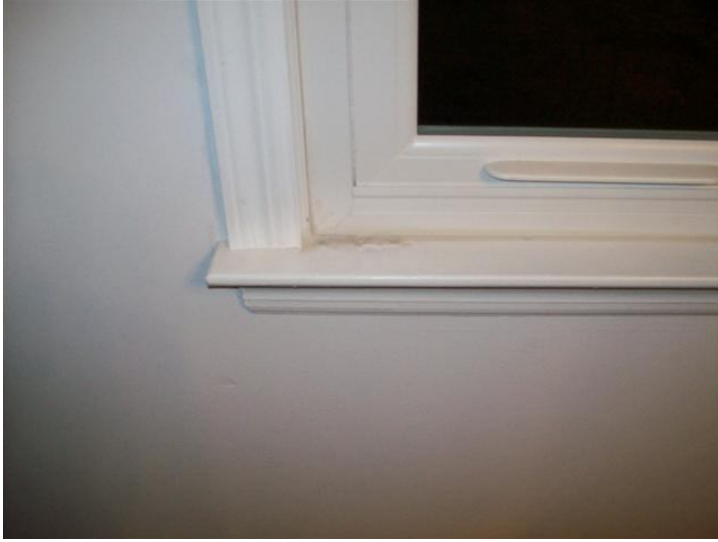
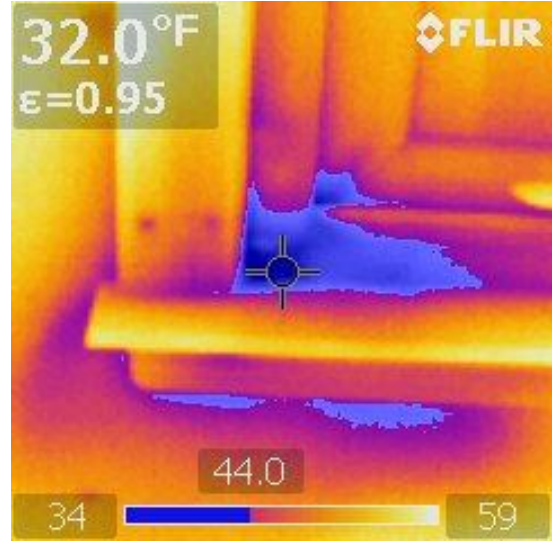
Location Room: Dining room

Observations:
Cold air infiltration noted in blue. Caulk and seal at the interior and exterior. Priority 1.

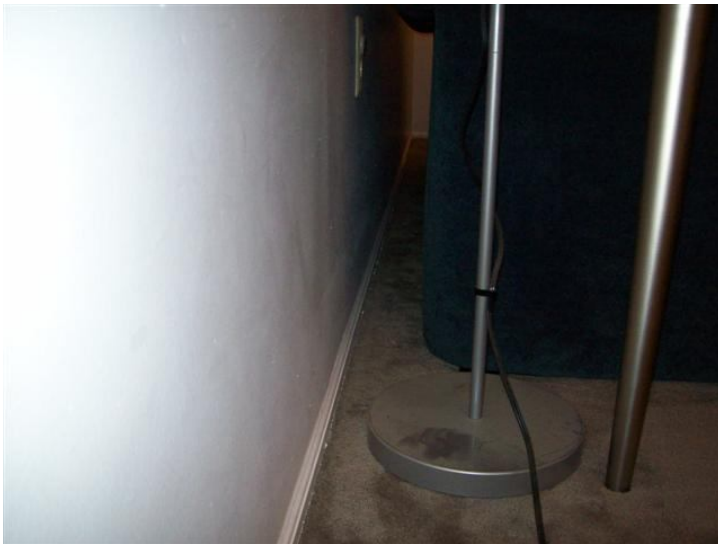
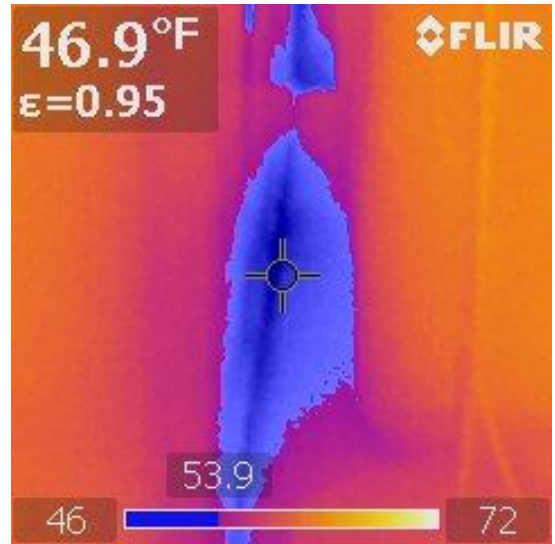
Location Room: Living Room

Observations:
Cold air infiltration noted in blue. Retain a qualified contractor further evaluation to correct this condition. Priority 1.

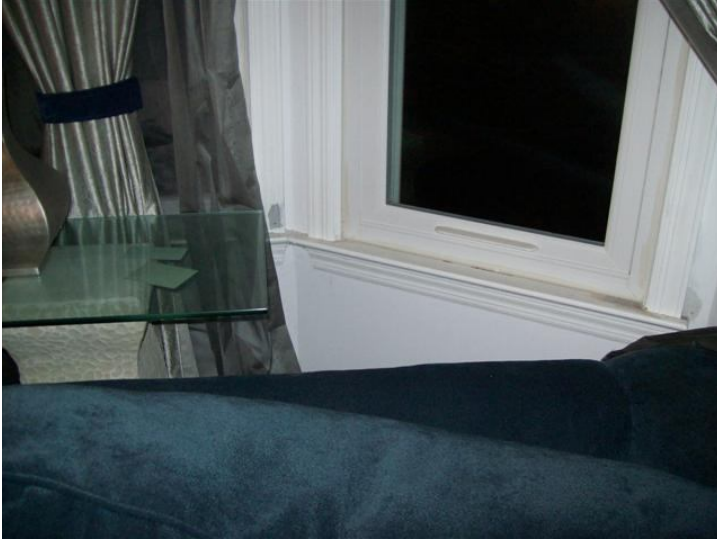
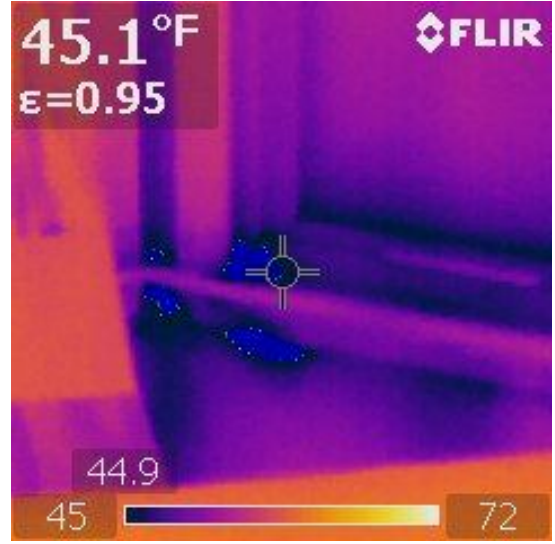
Location Room: Living Room

Cold air infiltration noted in blue. Caulk and seal at the interior and exterior. Retain a qualified contactor for evaluation to correct condition. Priority 1.

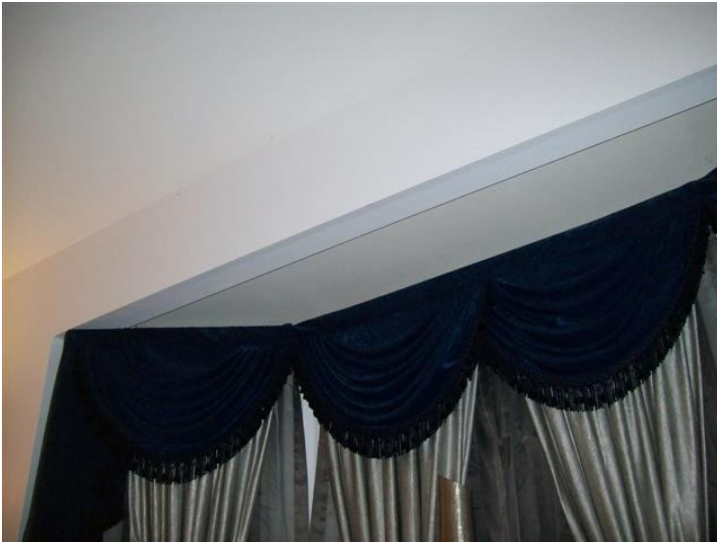
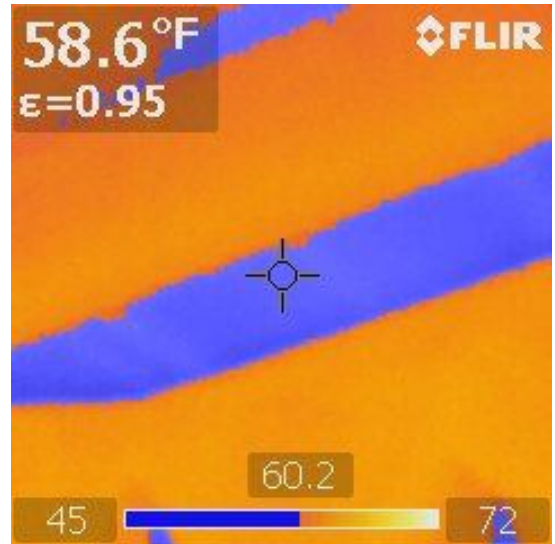
Location Room: Living Room

Cold air infiltration noted in blue. Retain a qualified contractor to correct this condition. Priority 2.

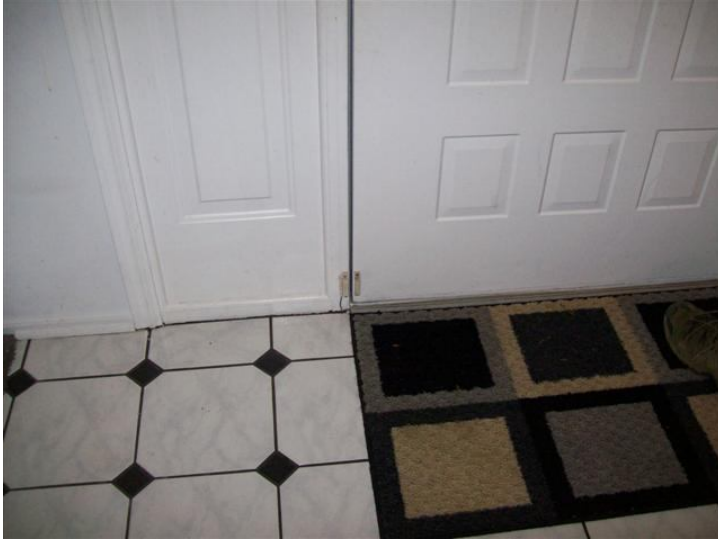
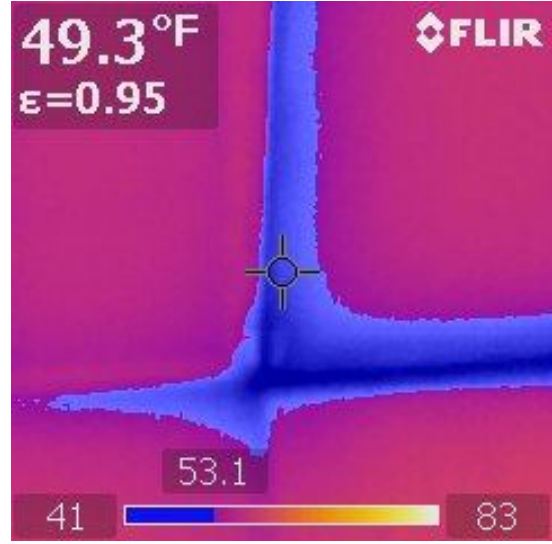
Cold air infiltration noted in blue. Retain a qualified contractor further evaluation to correct this condition. Priority 2.

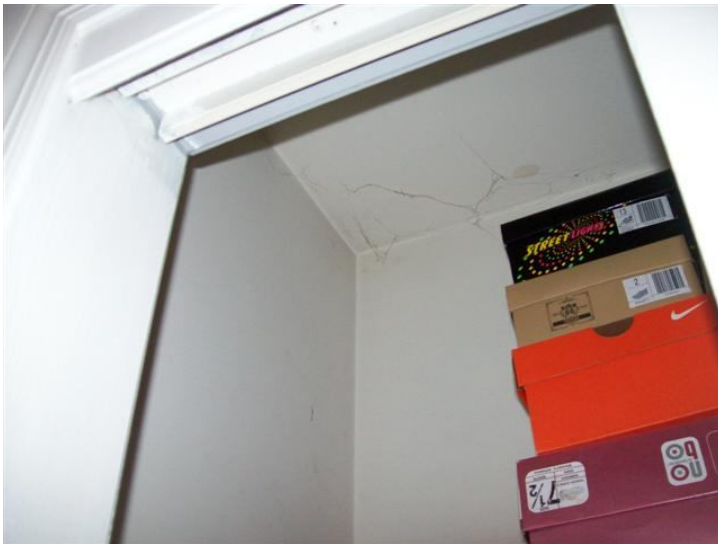
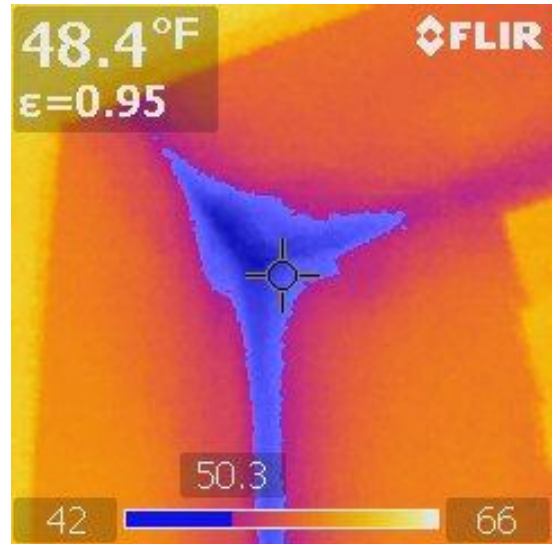
Location Room: Foyer

Cold air infiltration noted in blue. Retain a qualified contractor to correct condition. Priority 3.

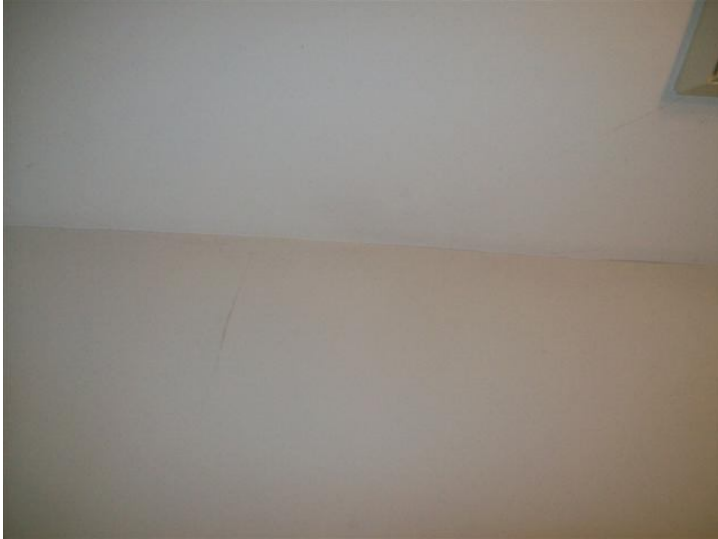
Observations:
Cold air infiltration noted in blue. Retain a qualified contractor to check for missing insulation and correct condition. Priority 1.

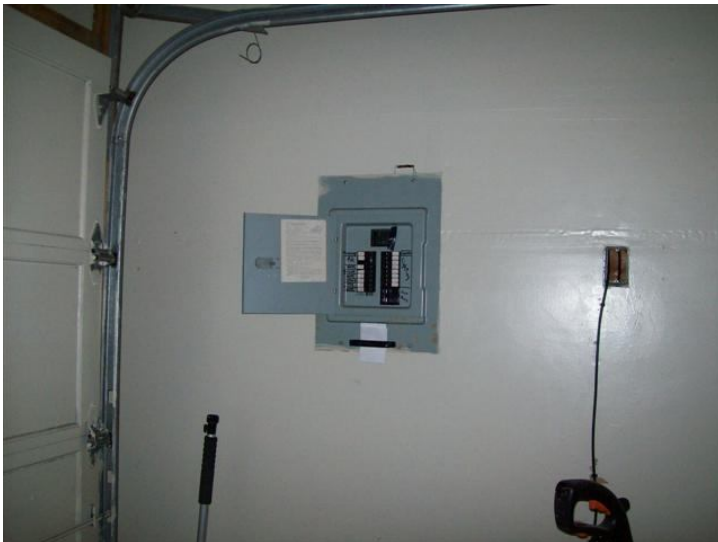
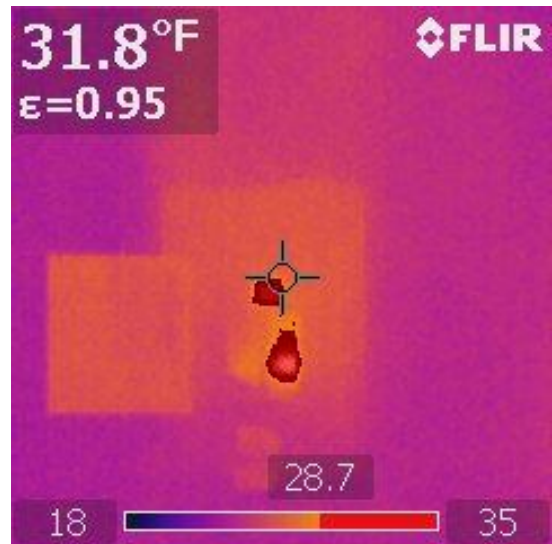
Location Room: Garage
Equipment: Main Panel

Observations:
Warm areas in red. No significant issues noted.

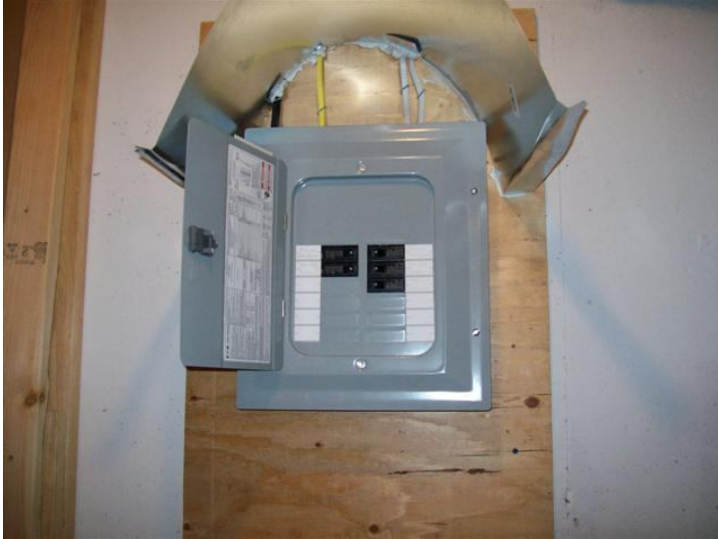
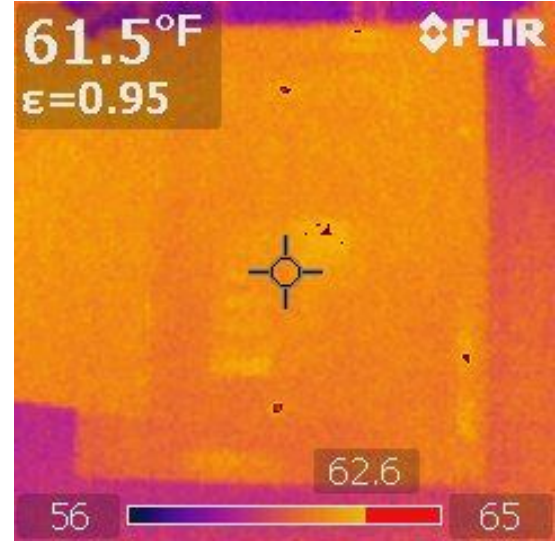
Location Room: Basement
Equipment: Service Panel

Observations:
No significant issues noted.

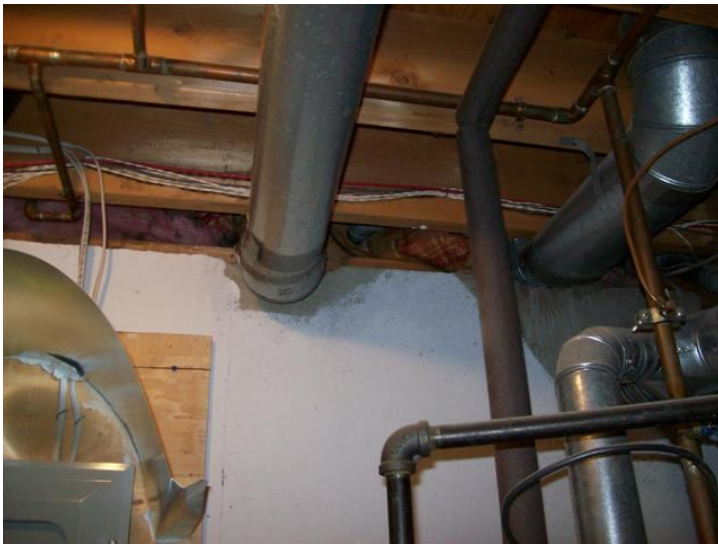
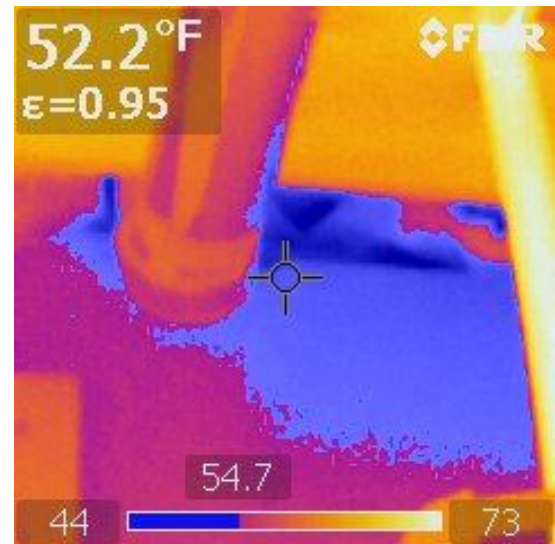
Location Room: Basement

Observations:
Cold air infiltration noted in blue. Correct insulation defect. Priority 1.

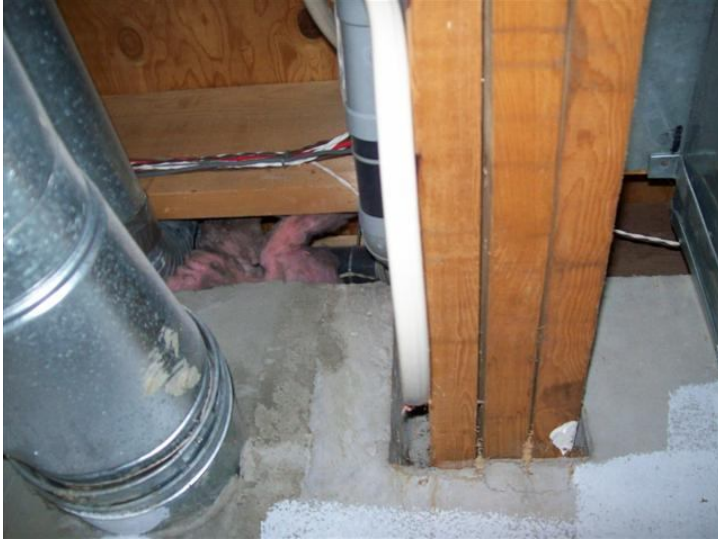
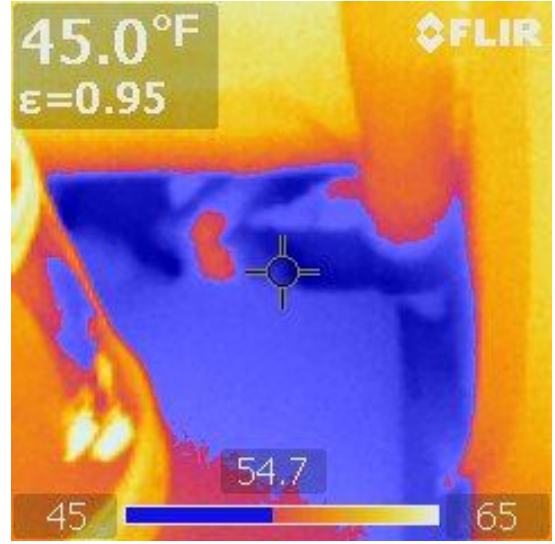
Location Room: Basement

Observations:
Cold air infiltration noted in blue. Correct insulation defect. Priority 1.

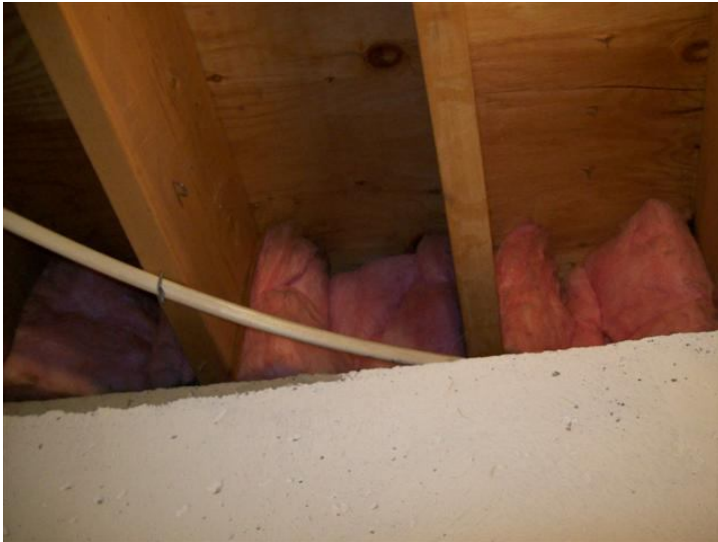
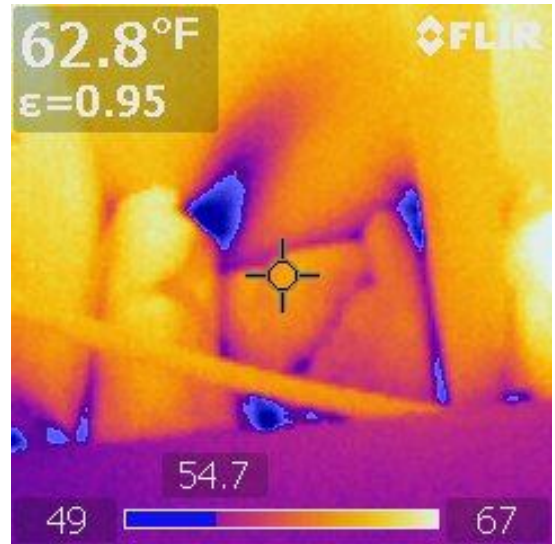
Location Room: Basement

Observations:
Cold air infiltration noted in blue. Correct insulation defect. Priority 1.

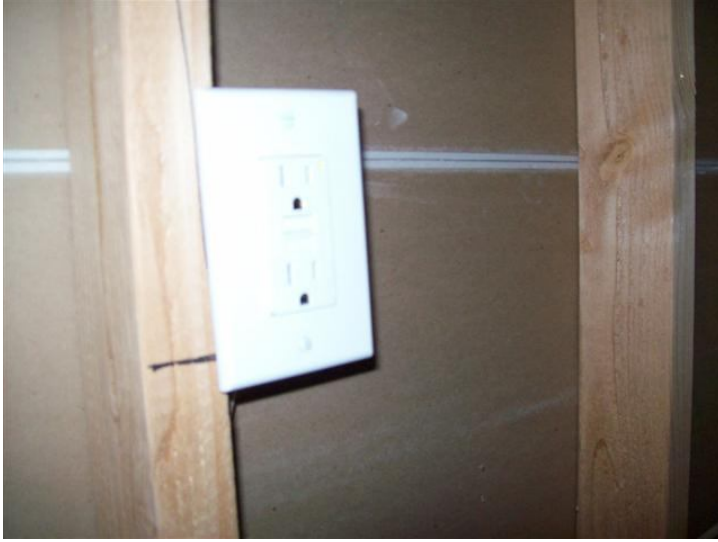
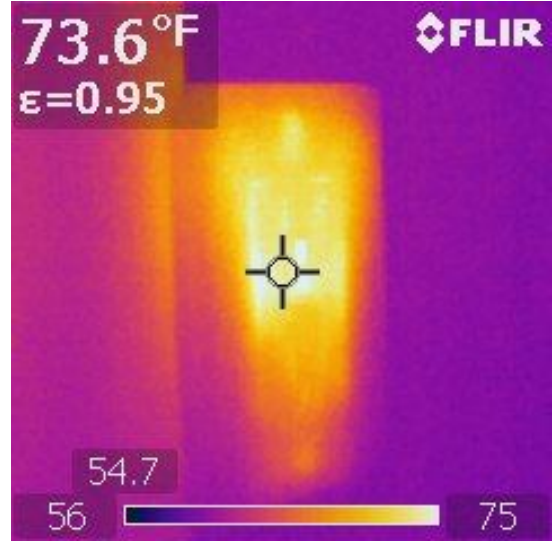
Location Room: Basement
Equipment: GFCI Outlet

Observations:
Typical and satisfactory condition.

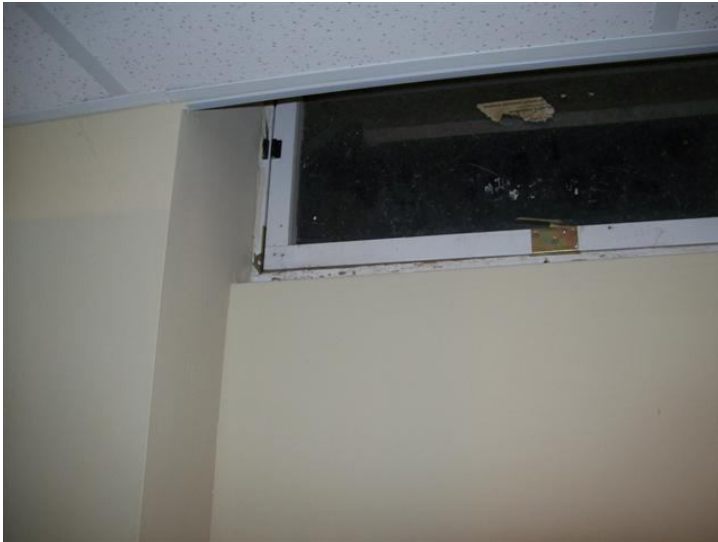
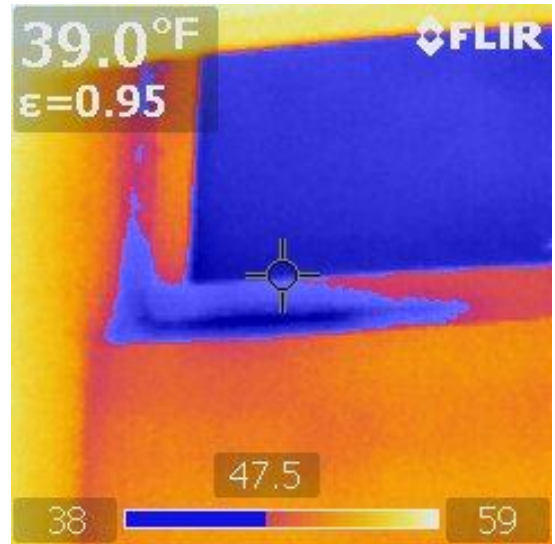
Location Room: Basement

Observations:
Cold air infiltration noted in blue. Correct defect. Priority 2.

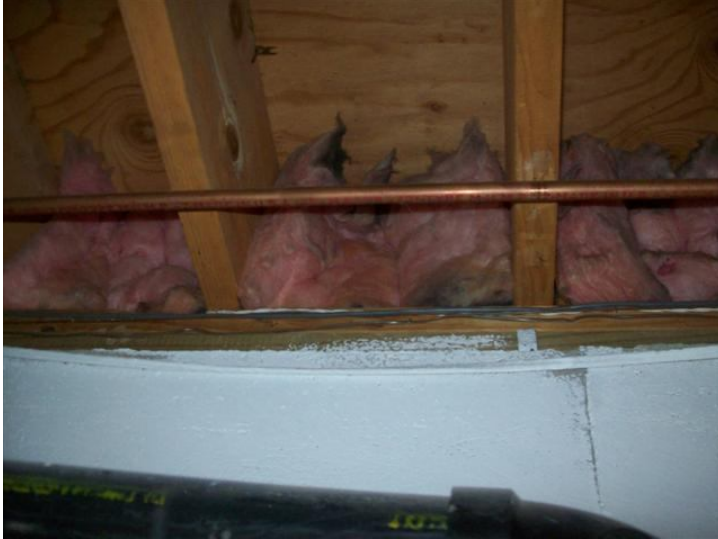
Location Room: Basement

Observations:
Cold air infiltration noted in blue. Correct insulation defect. Priority 1.

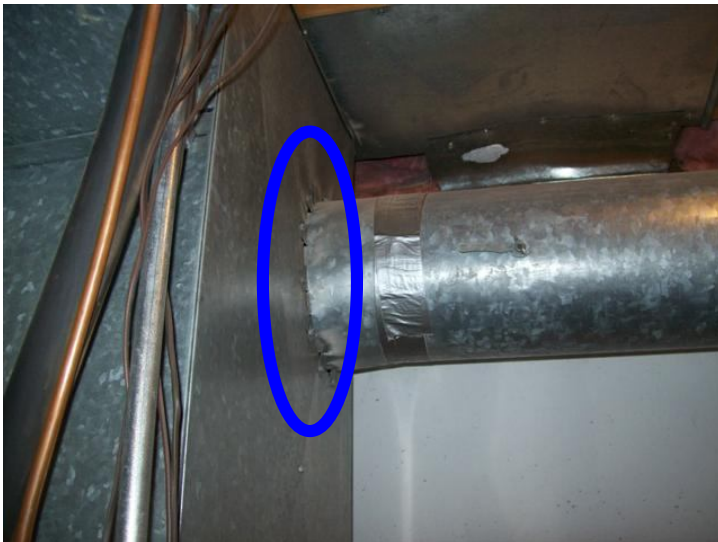
Observations:
Seal ductwork connection. Priority 1.

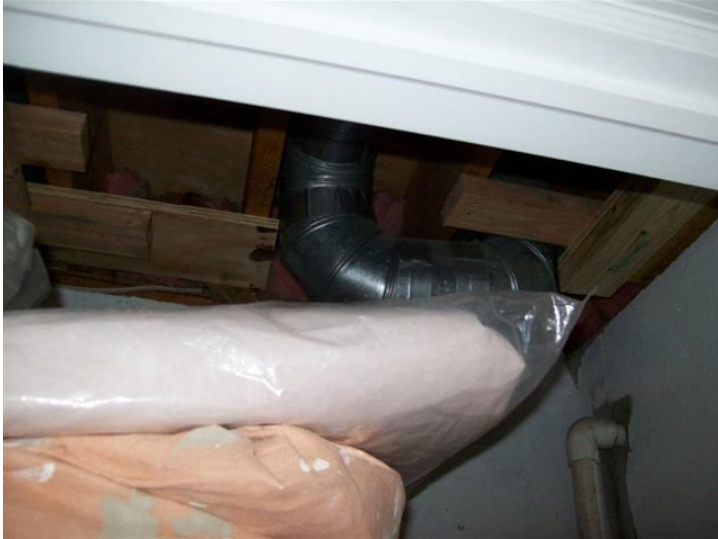
Location Room: Basement
Equipment: HVAC System

Observations:
Typical and acceptable condition

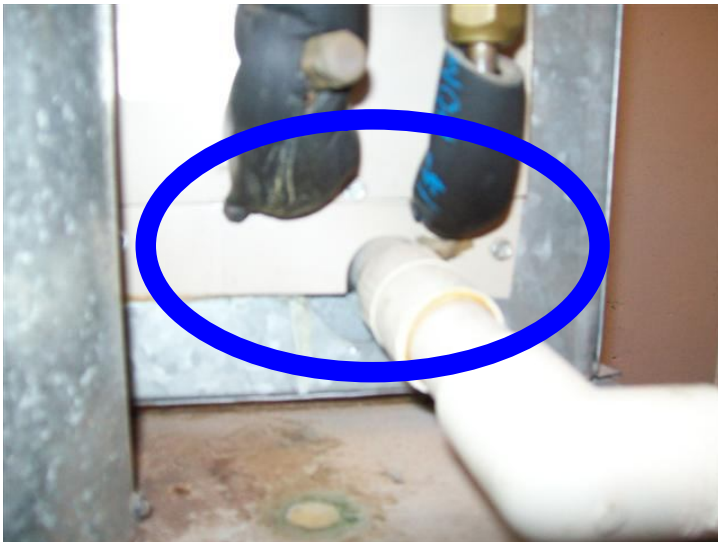
Equipment: HVAC System

Observations:
Seal area to prevent energy loss. Priority 2.

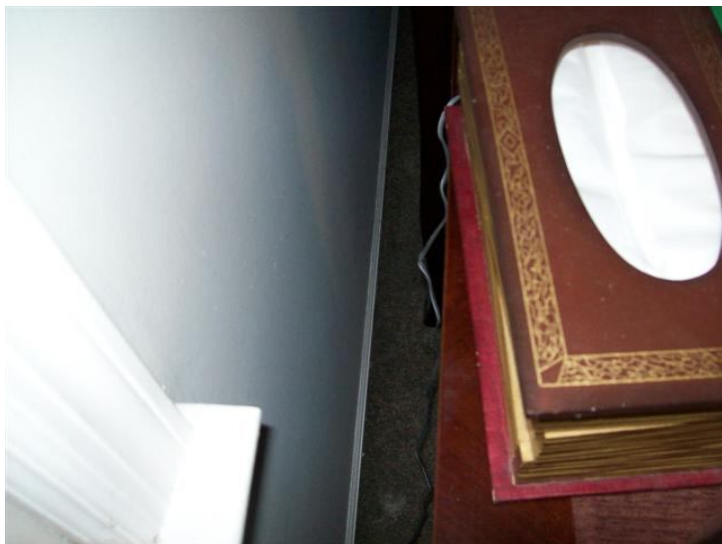
Location Room: Master Bedroom

Cold air infiltration noted in blue. Correct insulation defect. Retain qualified for further evaluation. Priority 2

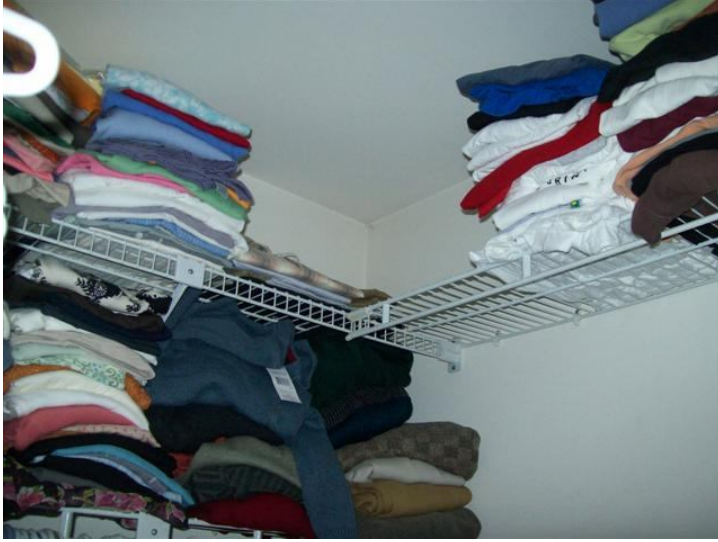
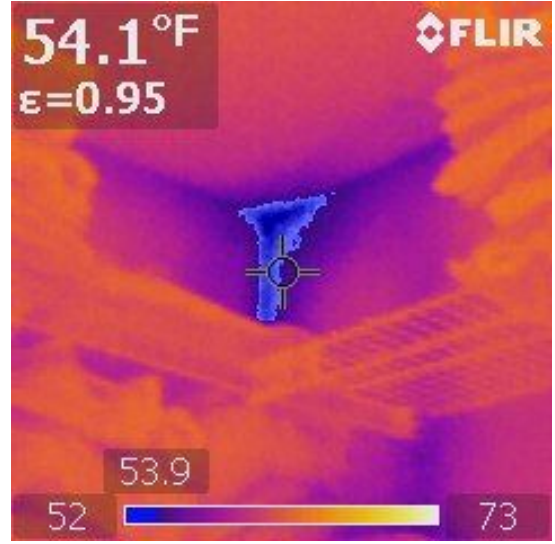
Observations:
Cold air infiltration noted in blue. Correct insulation defect. Retain qualified for further evaluation. Priority 3

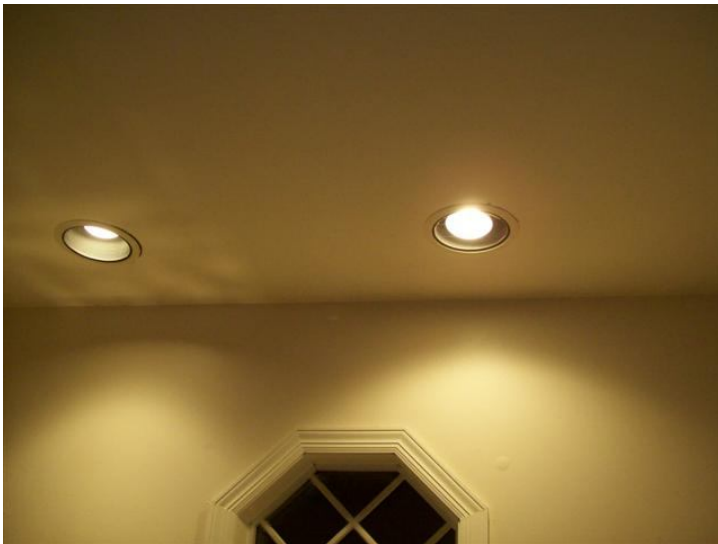
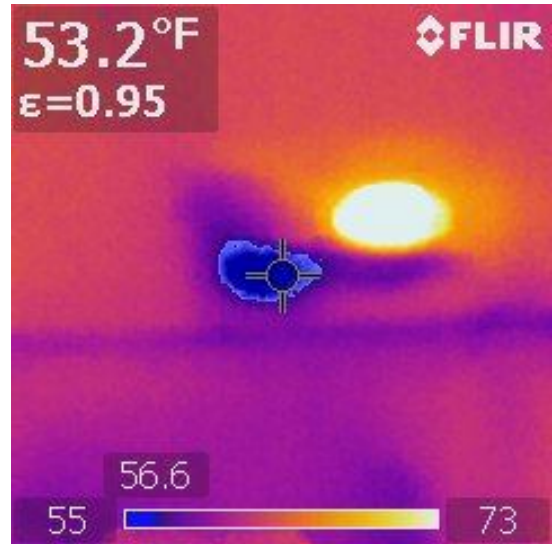
Location Room: Master Bathroom

Observations:
Cold air infiltration noted next to light which should be corrected. Priority 3

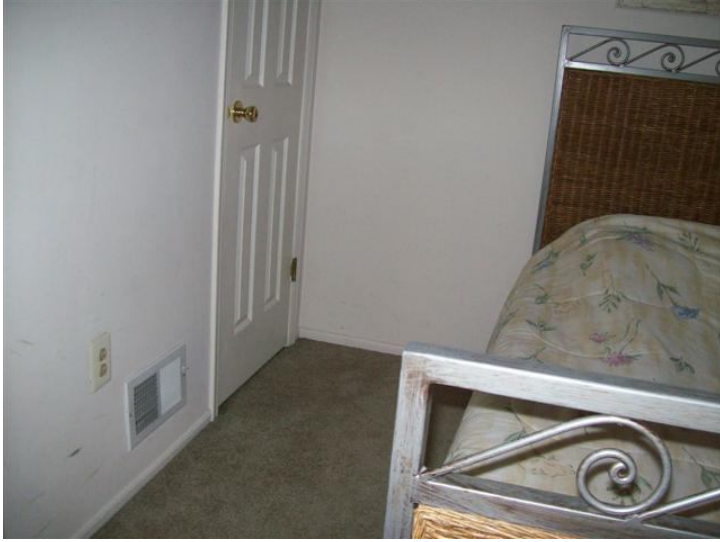
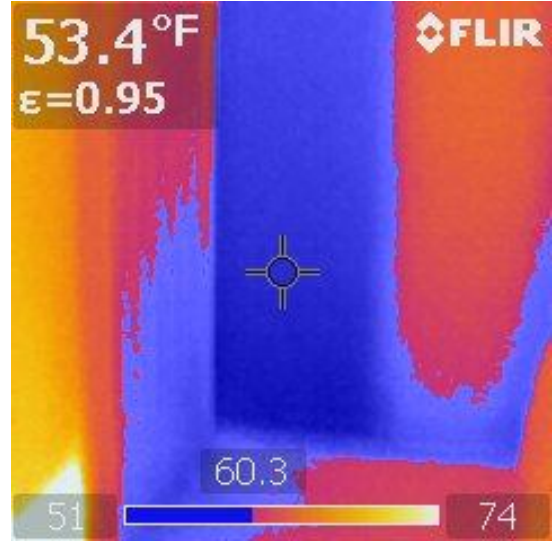
Observations:
Cold air infiltration noted in blue. Correct insulation defect. Retain qualified for further evaluation. Priority 1
