Thermal Imaging Report

123 High Utility Bill Street
Red Bank, NJ 07701

Prepared for: Mr. and Mrs. Homeowner

Prepared by: A Full House Inspection Co. LLC

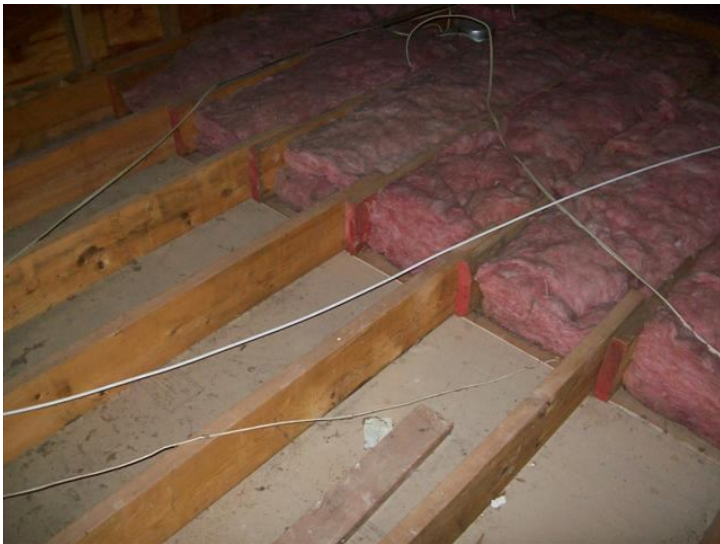
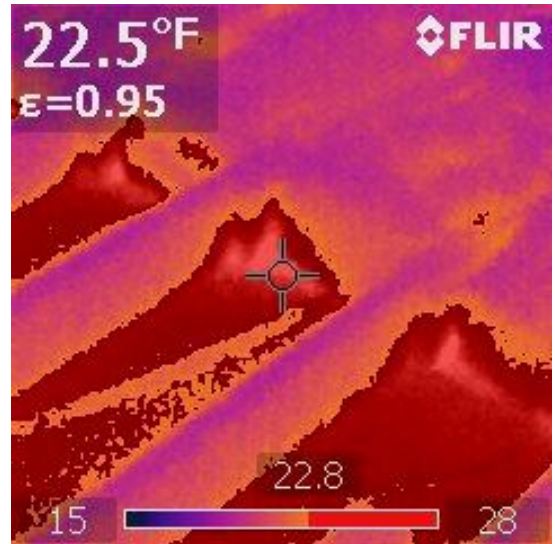
Observations:
Energy loss noted in red Correct insulation defect. Retain qualified for further evaluation. Priority 1

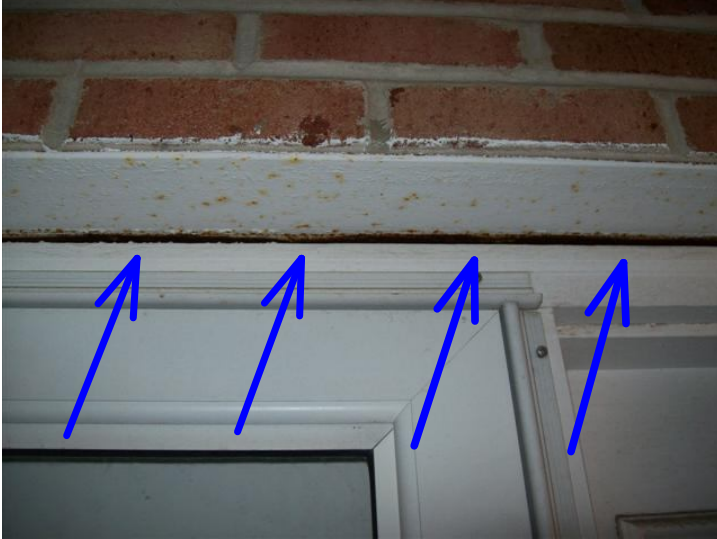
Observations:
Seal gap with backer rod and caulk. Priority 2.

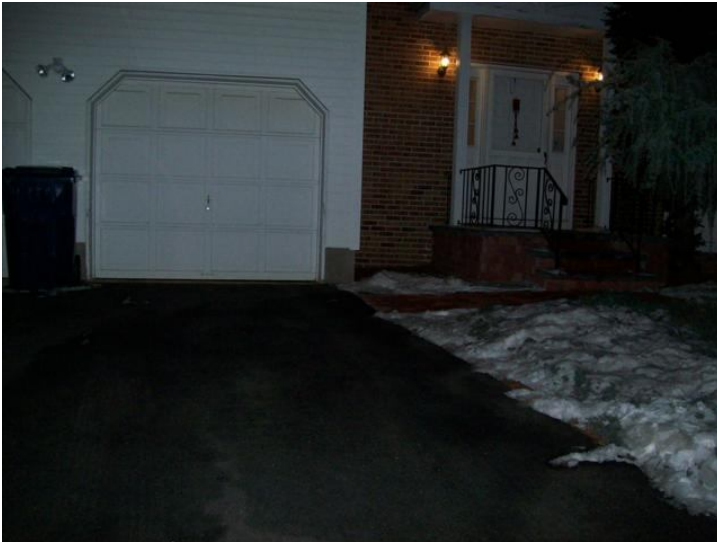
Location Direction: Front

Observations:
Hot area in red corresponds to cold air infiltration in basement.

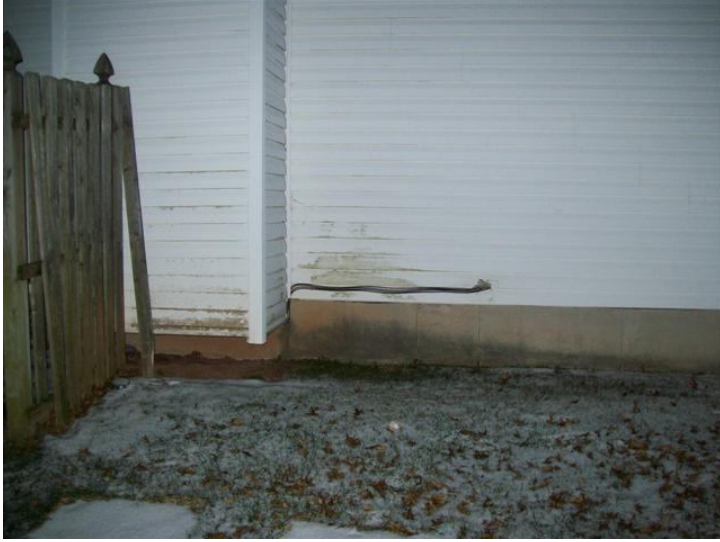
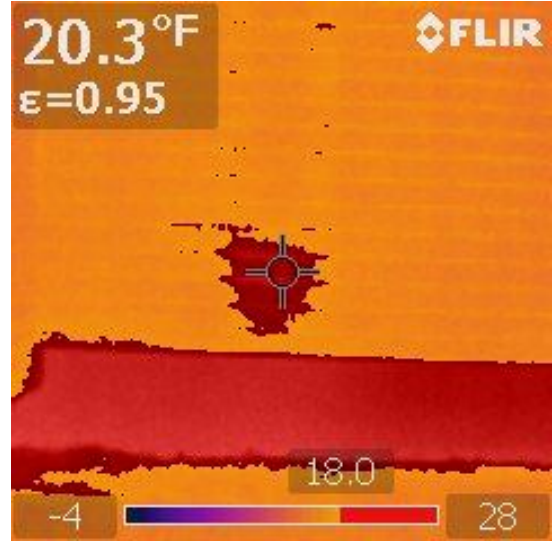
Observations:
Hot area in red corresponds to cold air infiltration in basement. Priority 1.

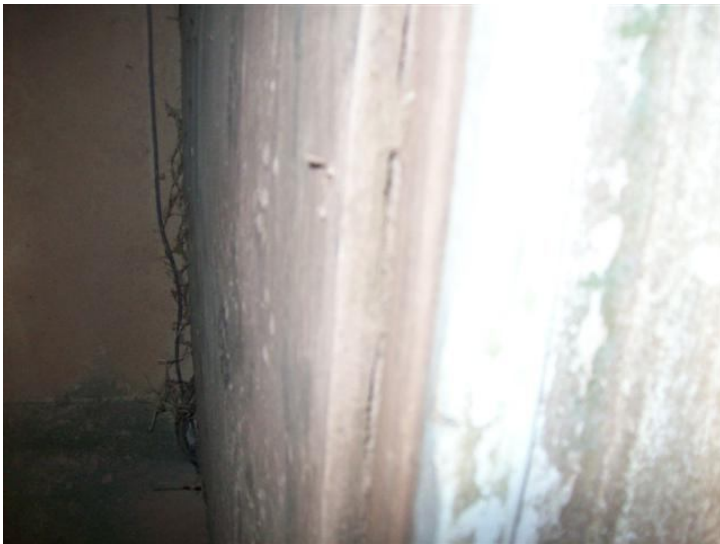
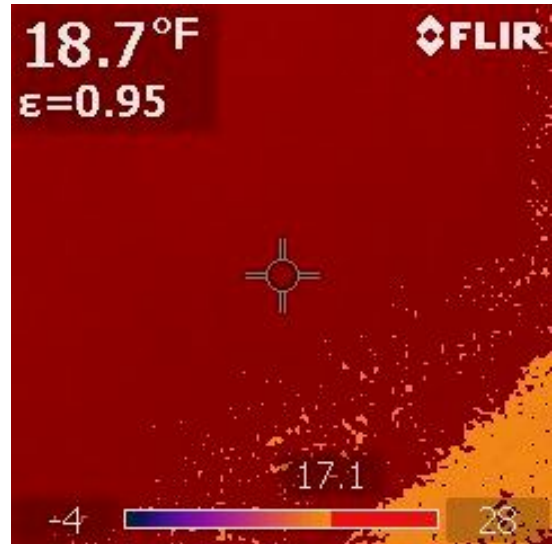
Location Direction: Exterior front wall
Equipment: Fireplace chase

Observations:
Hot area in red corresponds to cold air infiltration in fireplace. (photos taken at a right angle orientation) Retain qualified contactor for evaluation to correct condition. Priority 1

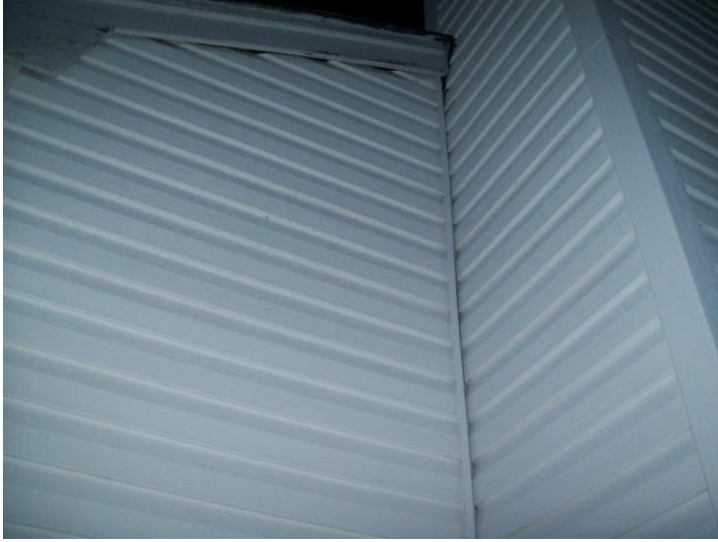
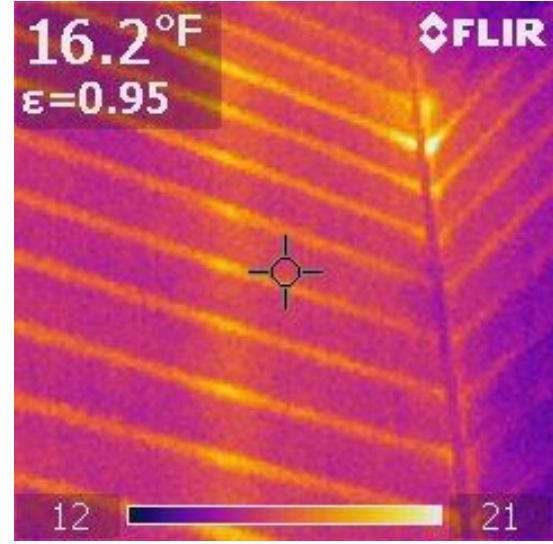
Observations:
 Hot area in red corresponds to energy loss around fireplace. Retain a contractor for evaluation.
 Priority 2.
