# A Full House Inspection Co. LLC

## EXECUTIVE SUMMARY OVERVIEW REPORT

**Client:** Mr. & Mrs. New Homeowner  
**Inspection Address:** 555 Warranty Road Road, Camelot, NJ 07739  
**Inspection Date:** 12/13/2008 Start: 2:00 pm End: 6:30 pm  
**Inspected by:** Peter W. Bennett

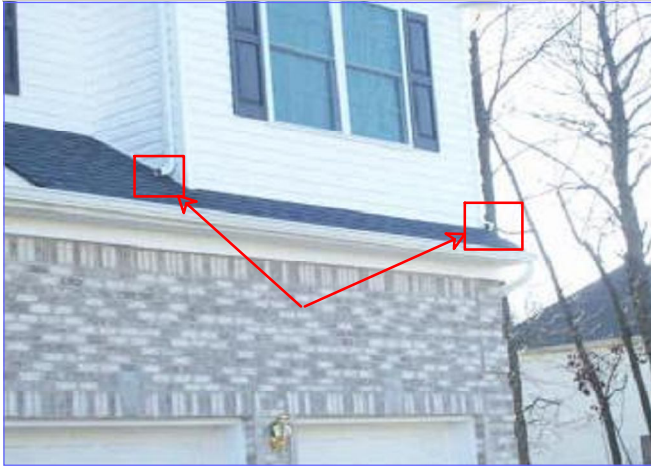
- One or more of the downspouts terminate adjacent the dwelling and should be extended to help prevent moisture and related issues from affecting the building.

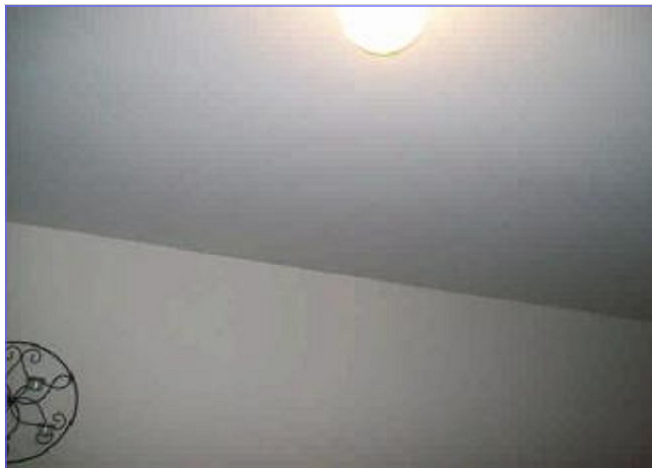
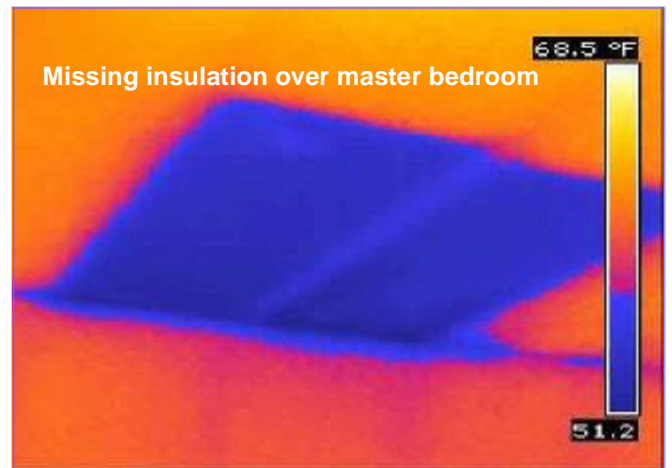
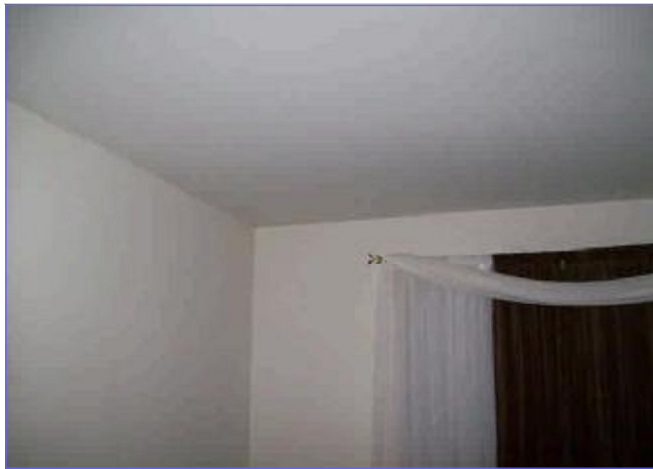
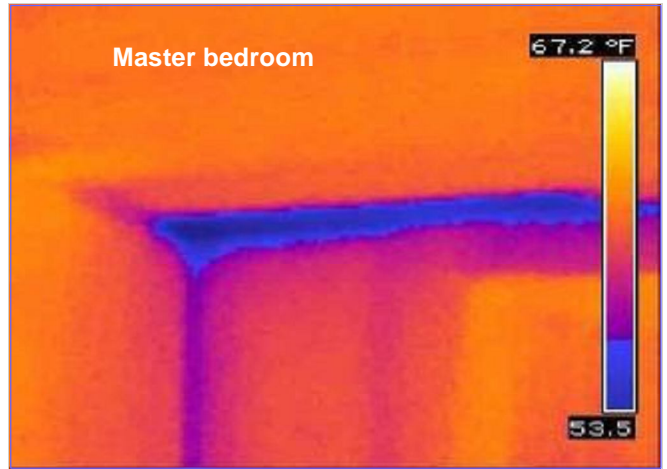
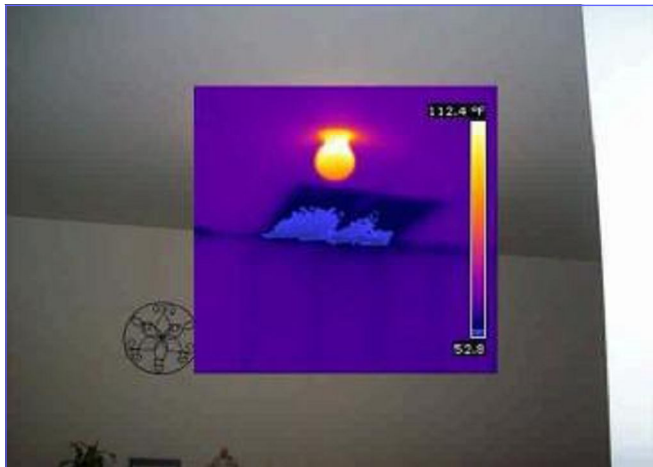
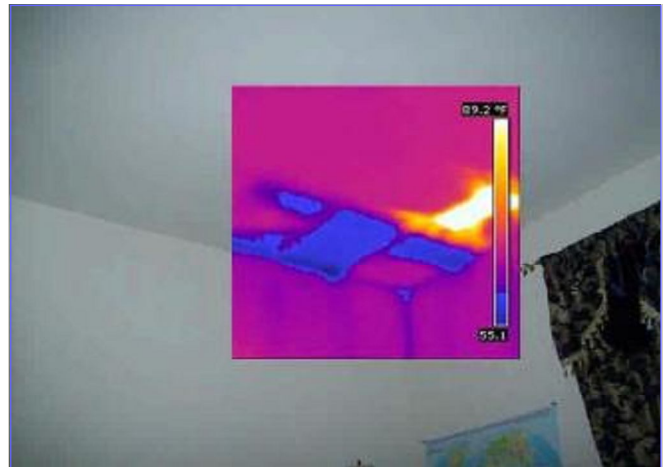
- 3.2 - ❖ The infrared images displayed thermal patterns (dark blue/purple) associated with cold air infiltration over the master bedroom, and the front bedroom areas. Insulation has been incorrectly installed ( voids, missing, compressed ) These conditions will allow significant energy loss and contribute to higher energy bills. A qualified contractor should inspect the areas and correct all insulation defects in accordance with industry standards.

- ❖ The infrared images displayed thermal patterns (dark blue/purple) associated with cold air infiltration over the master bedroom, and the front bedroom areas. Insulation has been incorrectly installed ( voids, missing, compressed ) These conditions will allow significant energy loss and contribute to higher energy bills. A qualified contractor should inspect the areas and correct all insulation defects in accordance with industry standards.

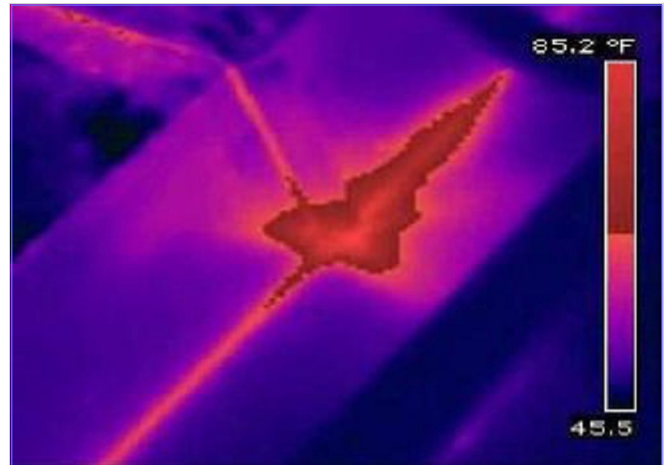
- 3.3 - ☐ The supply trunkline for the second floor HVAC system is leaking conditioned air at several locations. Evaluation and repairs by a qualified HVAC contractor are recommended.

- The supply trunkline for the second floor HVAC system is leaking conditioned air at several locations. Evaluation and repairs by a qualified HVAC contractor are recommended.

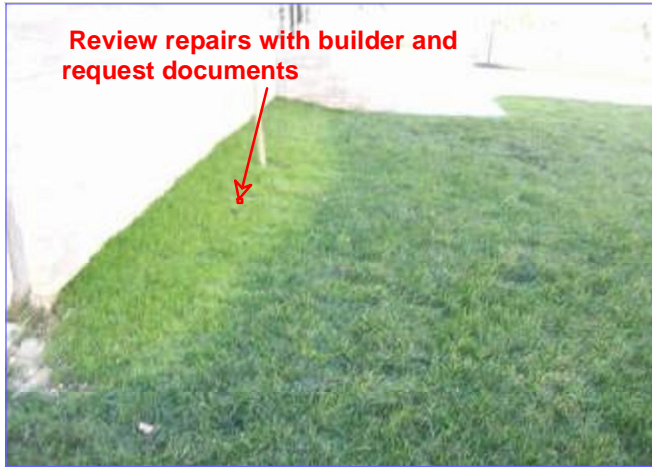
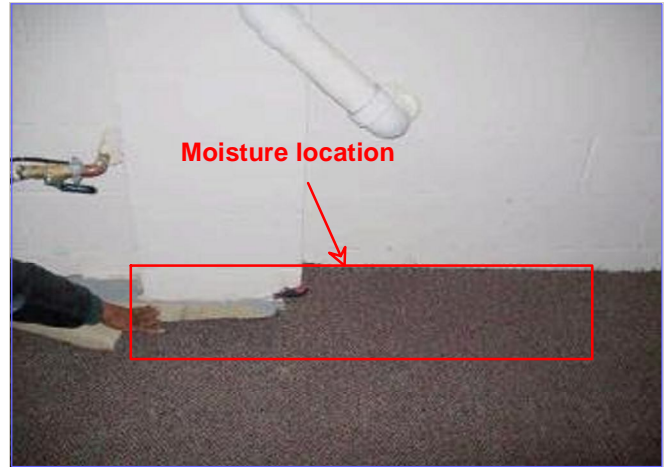
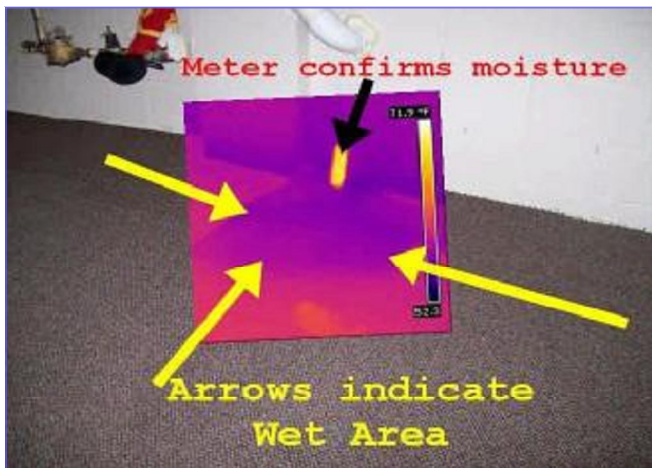
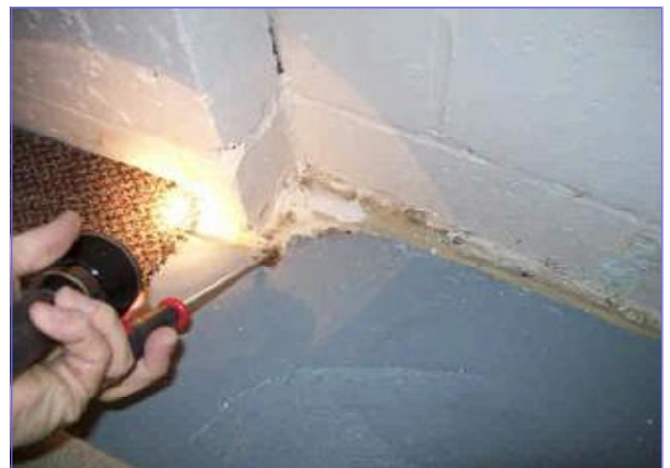
- 4.1 - ❖ Accumulation of water was present at the front wall of the basement. The exterior soil grading adjacent the foundation should be improved in conjunction with drainage (gutters/downspouts, extensions) Area drains if present, should be free and clear. A qualified and competent drainage contractor in collaboration with a basement waterproofing specialist should evaluate these conditions, and implement remedial measures to control/eliminate moisture entry to help manage water intrusion.

- ❖ Accumulation of water was present at the front wall of the basement. The exterior soil grading adjacent the foundation should be improved in conjunction with drainage (gutters/downspouts, extensions) Area drains if present, should be free and clear. A qualified and competent drainage contractor in collaboration with a basement waterproofing specialist should evaluate these conditions, and implement remedial measures to control/eliminate moisture entry to help manage water intrusion.

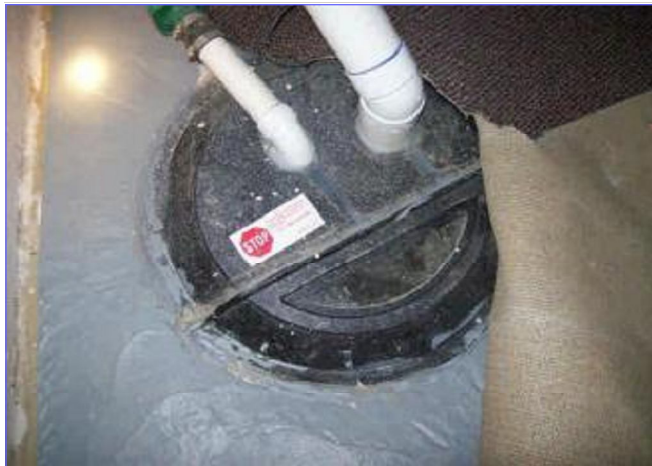
- ❑ The sump pump cover was sealed so the sump pump could not be tested. Suggestion: installation of a backup battery and warning alarm, along with possessing a spare sump are recommended. There is a water based pump system which you should consider: <http://www.basepump.com/Basepump.htm>  
( Check with your homeowner's insurance company about coverage due to water damage from a failed sump pump. )

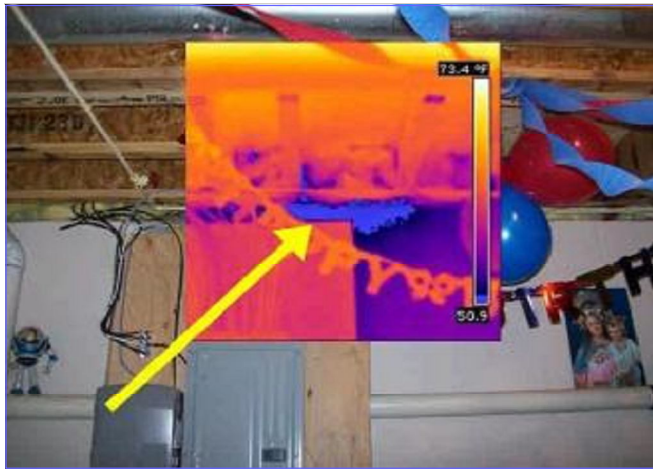
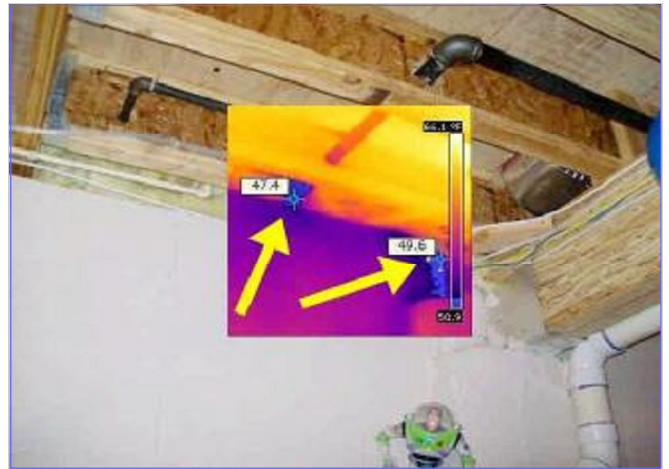
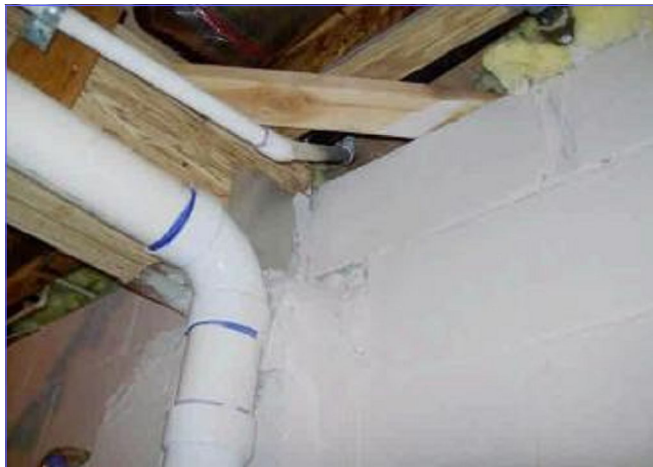
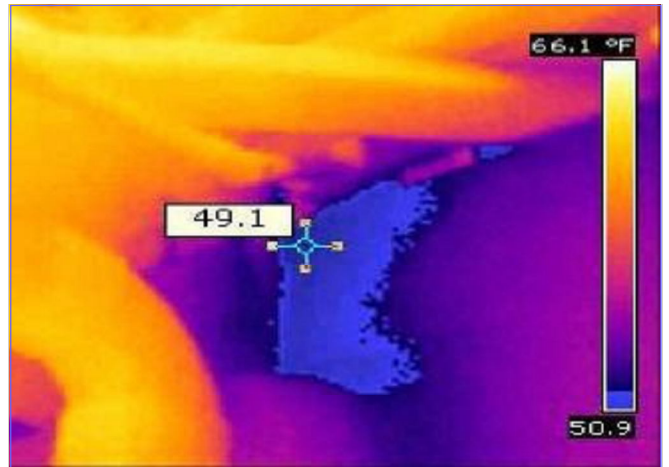
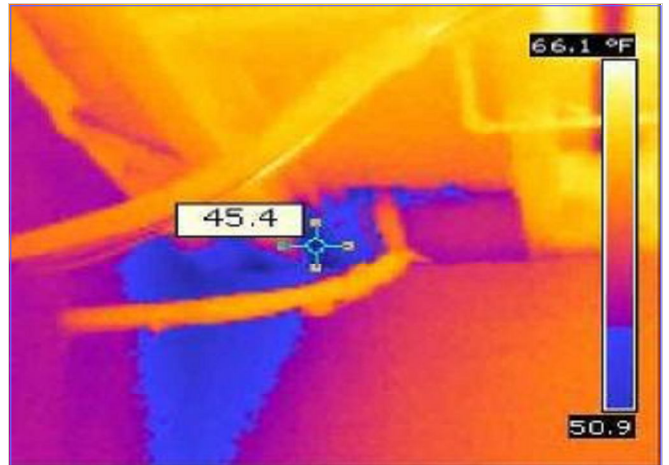
- 4.2 - ❖ The infrared images displayed thermal patterns (dark blue/purple) associated with cold air infiltration at the front, side and rear rim/band joist areas. Insulation has been incorrectly installed ( voids, missing, compressed ) These conditions will allow significant energy loss and contribute to higher energy bills. A qualified contractor should inspect the rim/band joist areas and correct all insulation defects in accordance with industry standards.

- ❖ The infrared images displayed thermal patterns (dark blue/purple) associated with cold air infiltration at the front, side and rear rim/band joist areas. Insulation has been incorrectly installed ( voids, missing, compressed ) These conditions will allow significant energy loss and contribute to higher energy bills. A qualified contractor should inspect the rim/band joist areas and correct all insulation defects in accordance with industry standards.

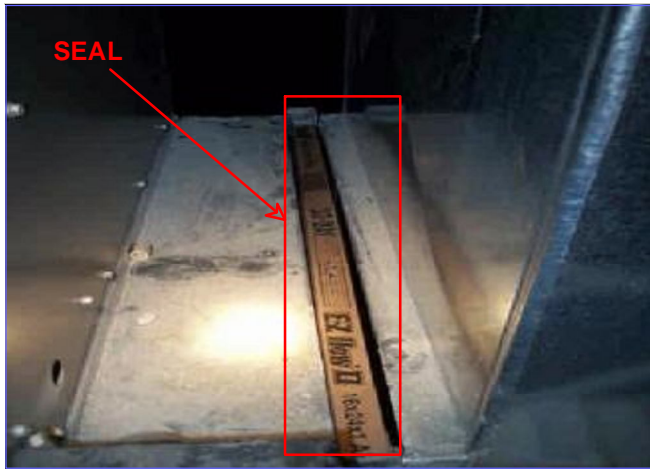
- The opening for the air filter is unsealed. This may allow unfiltered air to enter the system. Under certain circumstances this may also present issues with combustion air. We recommend the opening be properly sealed.

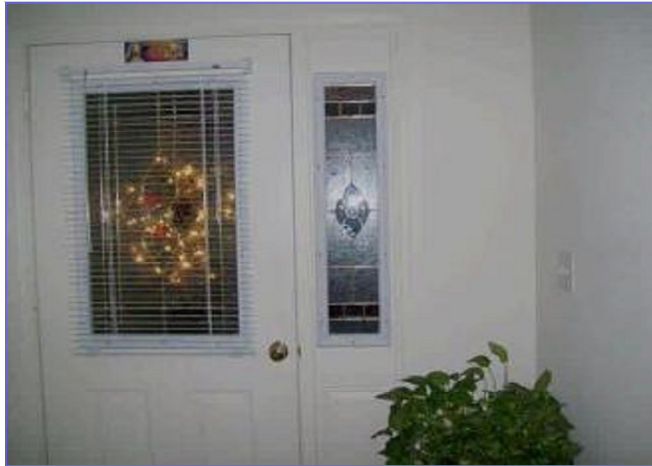
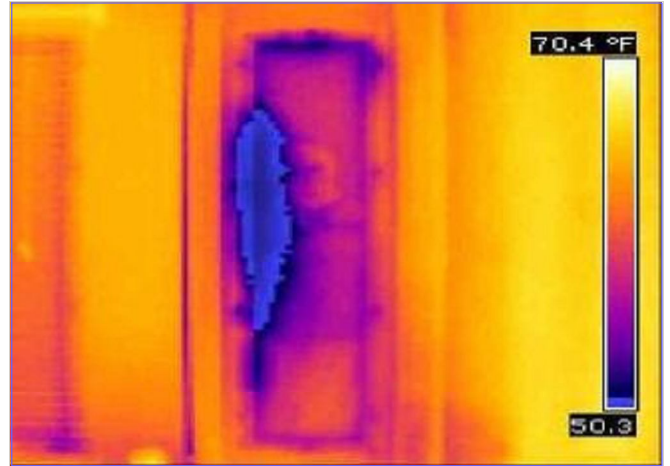
- 10.1 - ❖ The infrared images displayed thermal patterns (dark blue/purple) associated with cold air infiltration at the side panel window. This condition will allow significant energy loss, and contribute to higher energy bills and should be corrected by a qualified contractor.

- ❖ The infrared images displayed thermal patterns (dark blue/purple) associated with cold air infiltration at the side panel window. This condition will allow significant energy loss, and contribute to higher energy bills and should be corrected by a qualified contractor.

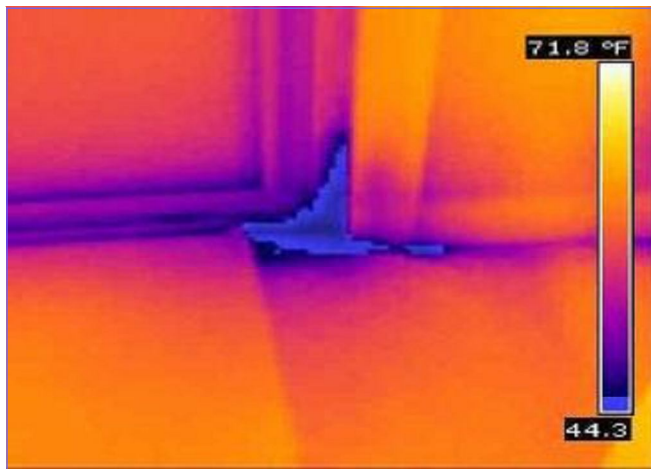
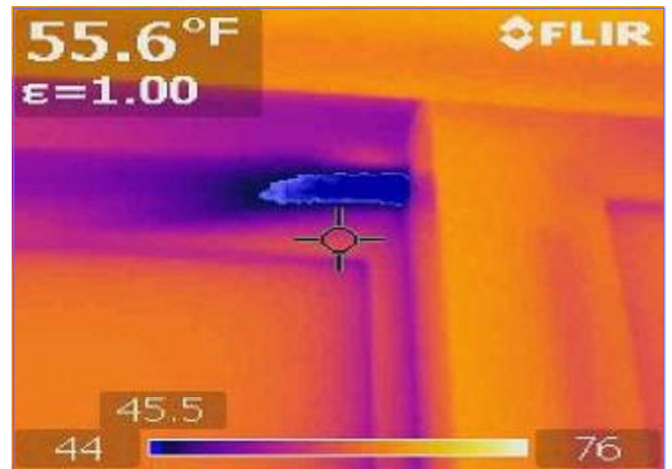
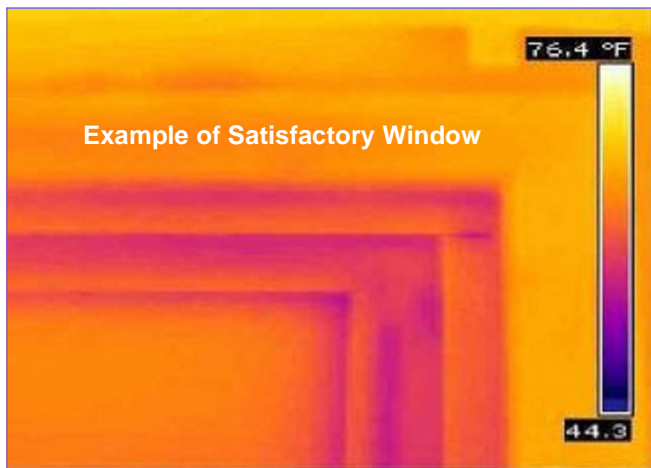
- 10.3 - ❖ The infrared images displayed thermal patterns (dark blue/purple) associated with cold air infiltration at the upper and lower right hand corner. The weather stripping and caulking are suspect. These conditions will allow significant energy loss and contribute to higher energy bills and should be corrected by a qualified contractor.

- ❖ The infrared images displayed thermal patterns (dark blue/purple) associated with cold air infiltration at the upper and lower right hand corner. The weather stripping and caulking are suspect. These conditions will allow significant energy loss and contribute to higher energy bills and should be corrected by a qualified contractor.

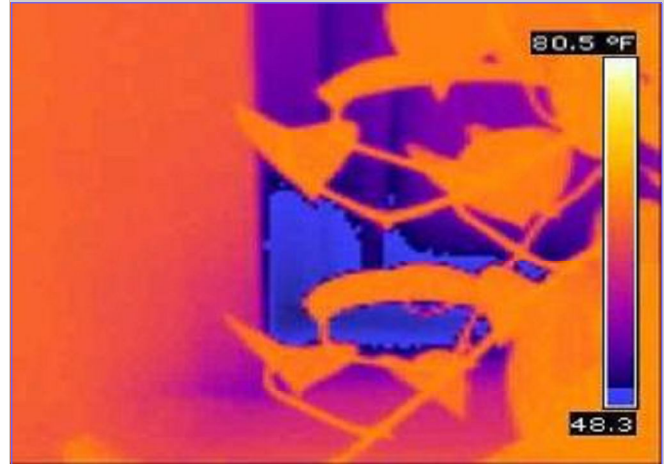
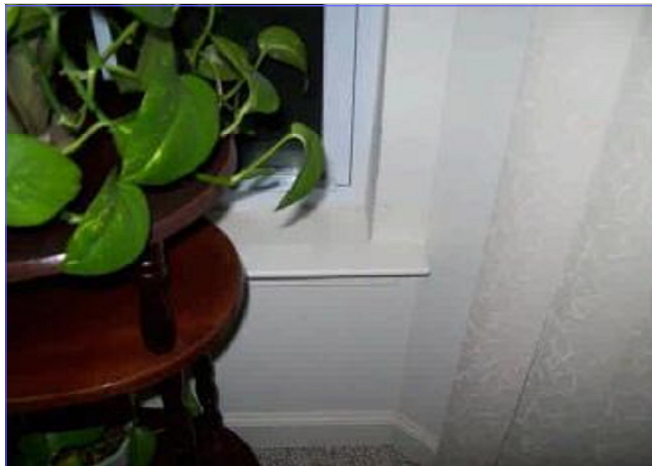
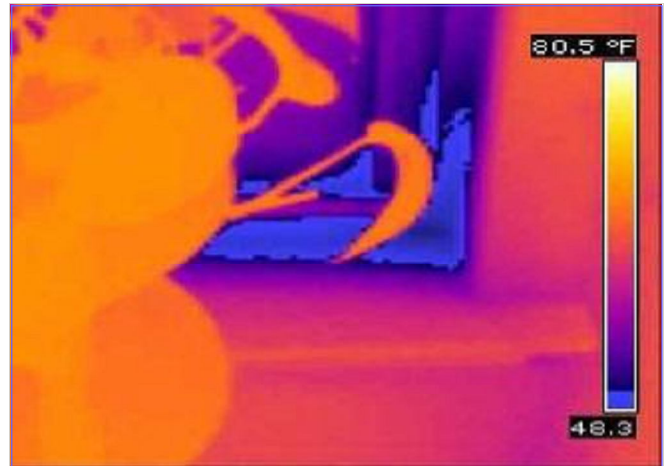
- ❖ The infrared images displayed thermal patterns (dark blue/purple) associated with cold air infiltration at the corners of the windows. The window weather stripping and caulking are suspect. These conditions will allow significant energy loss and contribute to higher energy bills and should be corrected by a qualified contractor.

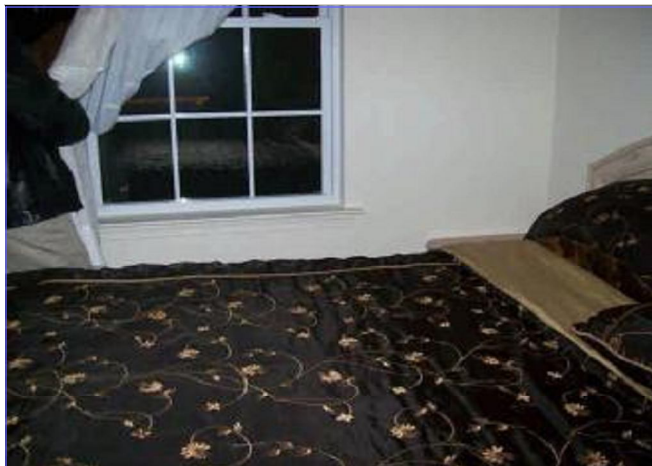
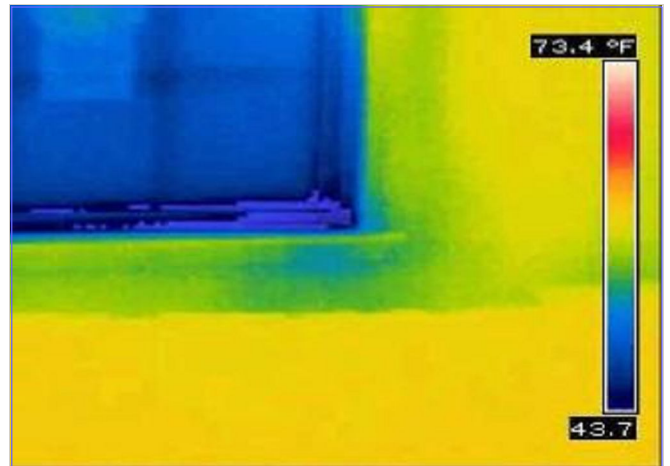
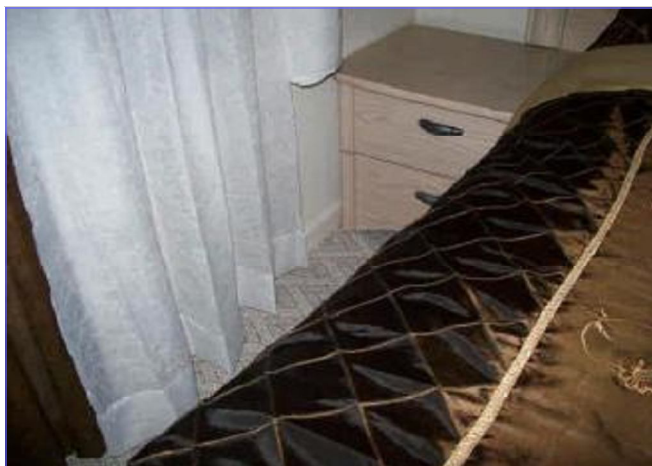
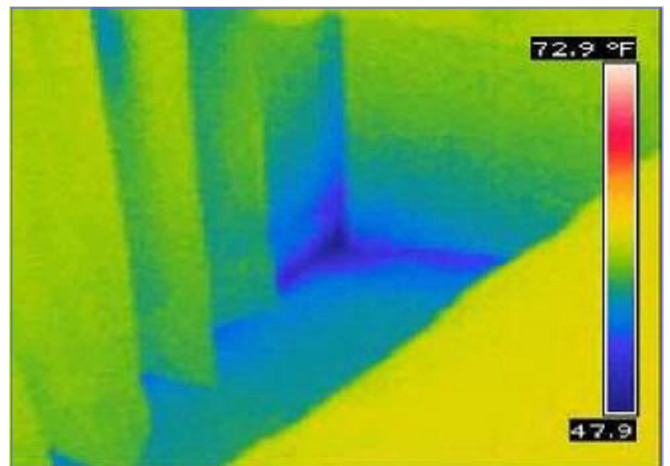
- ❖ The infrared images displayed thermal patterns (dark blue/purple) associated with cold air infiltration at the corners of the windows. The window weather stripping and caulking are suspect. The front wall area to the left of the window was cold, and wall insulation is suspect. These conditions will allow significant energy loss and contribute to higher energy bills, and should be corrected by a qualified contractor.

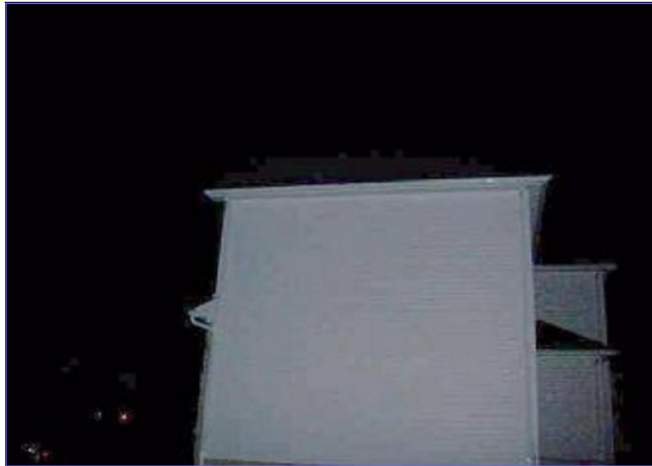
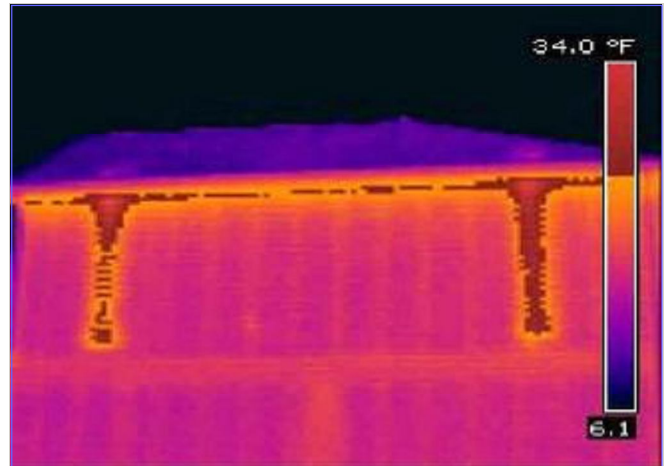
- 10.6 - ❖ The infrared images displayed thermal patterns ( dark red ) associated with energy loss as viewed at the exterior right side wall. This condition will allow significant energy loss and contribute to higher energy bills, and should be evaluated, and corrected by a qualified contractor.

- ❖ The infrared images displayed thermal patterns ( dark red ) associated with energy loss as viewed at the exterior right side wall. This condition will allow significant energy loss and contribute to higher energy bills, and should be evaluated, and corrected by a qualified contractor.

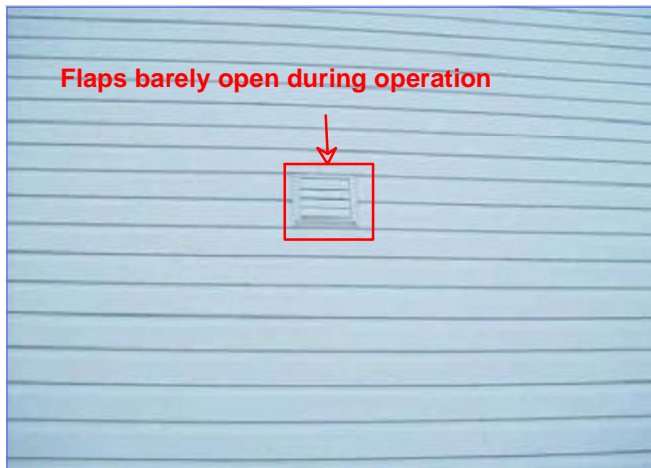
- 12.1 -  The kitchen exhaust fan is functional, but its exhaust duct did not produce adequate air flow to the exterior. A qualified technician should evaluate and correct this condition.

- The kitchen exhaust fan is functional, but its exhaust duct did not produce adequate air flow to the exterior. A qualified technician should evaluate and correct this condition.

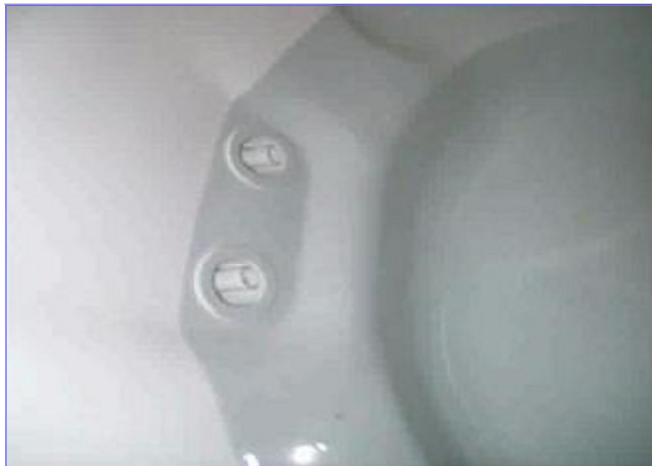
- ❖ The water flow at the two rear jets was inadequate and unsatisfactory. Further evaluation and repairs by a qualified technician are recommended.

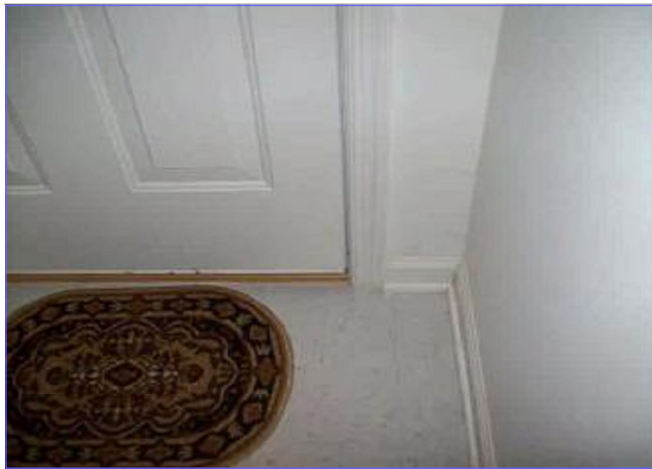
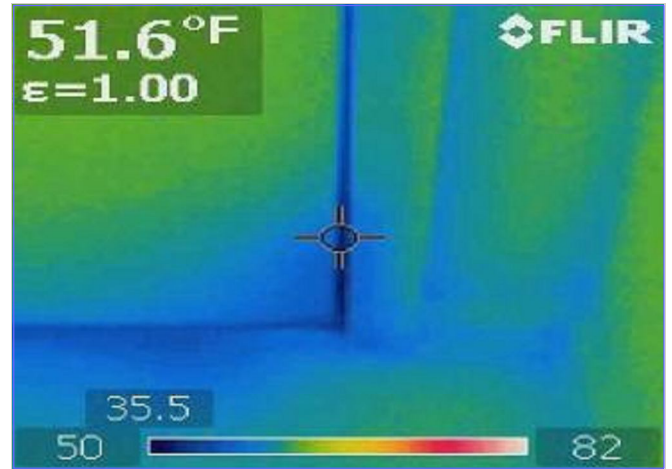
- 14.2 -  The weatherstripping at the bottom of the door is damaged, and should be repaired/replaced.

- The weatherstripping at the bottom of the door is damaged, and should be repaired/replaced.
