# Thermal Imaging Report

123 Renovation Street  
Manalapan, NJ 07726

Prepared by: A Full House Inspection Co. LLC

Date:12/22/08

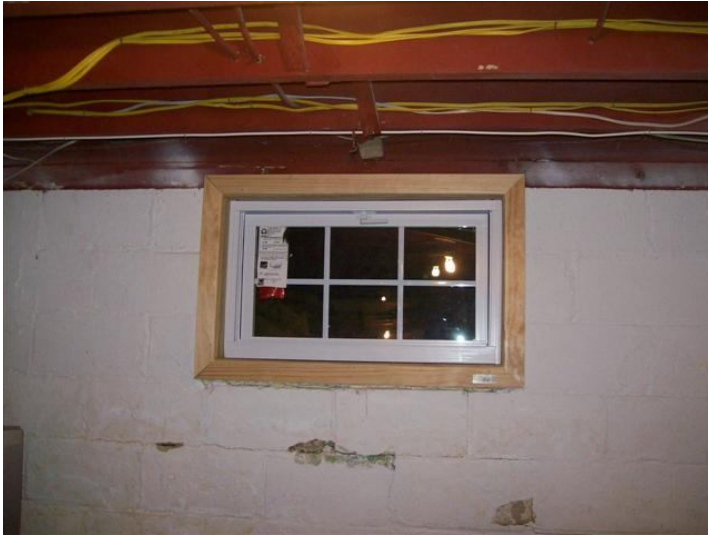
Location Floor: Basement  
Location Direction: Right Side Wall

**Observations:**  
Dark blue thermal patterns indicative of cold air infiltration. Correction is recommended to reduce energy loss and utility bills.

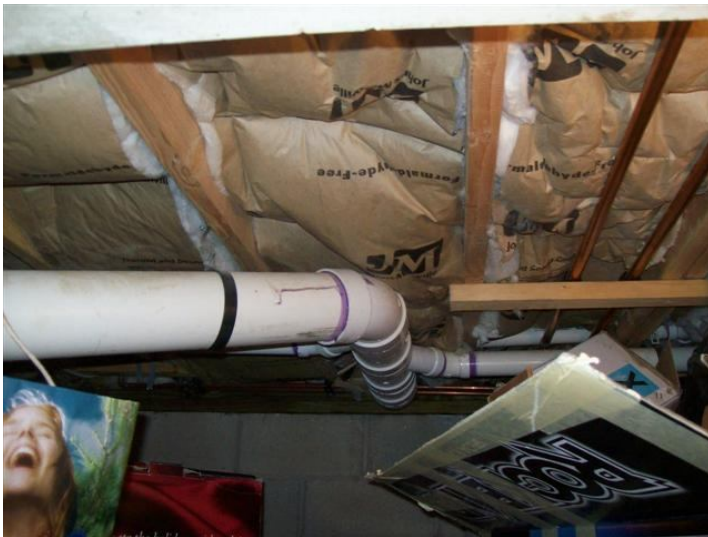
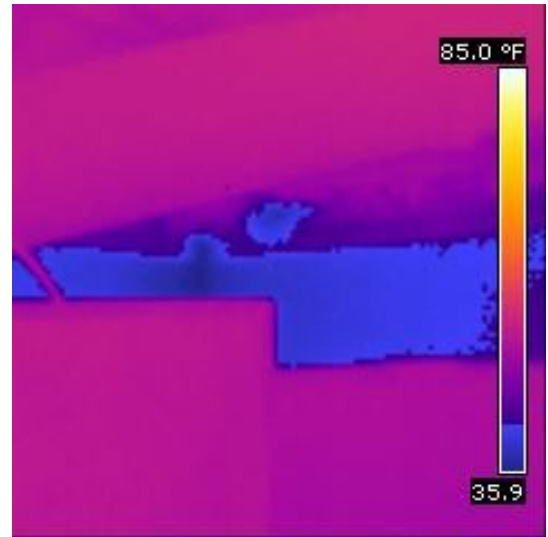
Location Floor: Crawlspace

**Observations:**  
Dark blue thermal patterns indicative of cold air infiltration. Correction is recommended to reduce energy loss and utility bills.

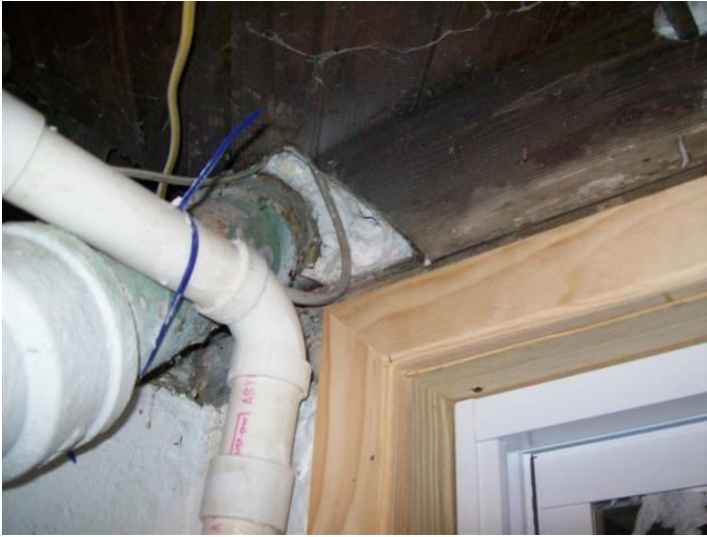
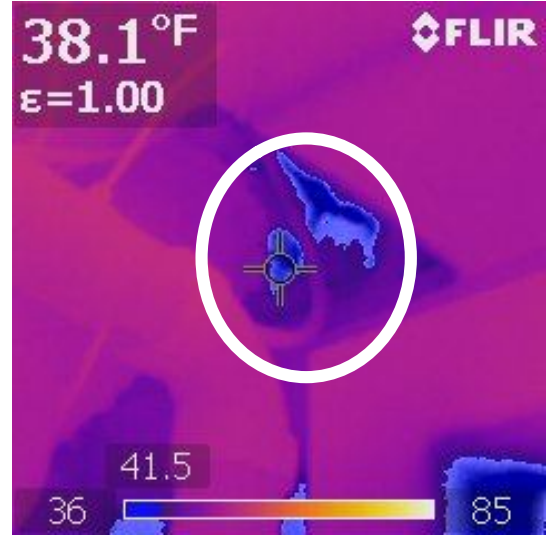
Location Floor: Basement  
Location Direction: Right Rear Corner

**Observations:**  
Dark blue thermal patterns indicative of cold air infiltration. Correction is recommended to reduce energy loss and utility bills.

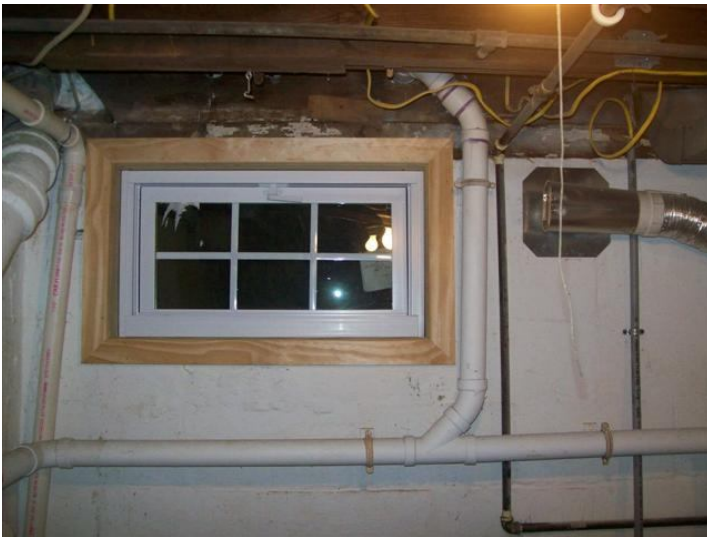
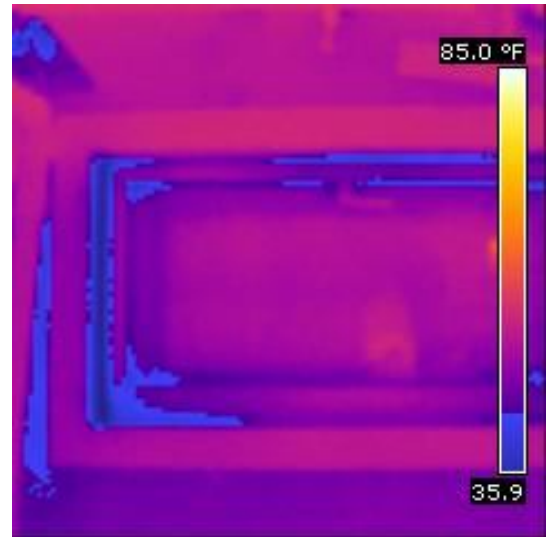
Location Floor: Basement  
Location Direction: Right Side Wall

**Observations:**  
Dark blue thermal patterns indicative of cold air infiltration. Correction is recommended to reduce energy loss and utility bills.

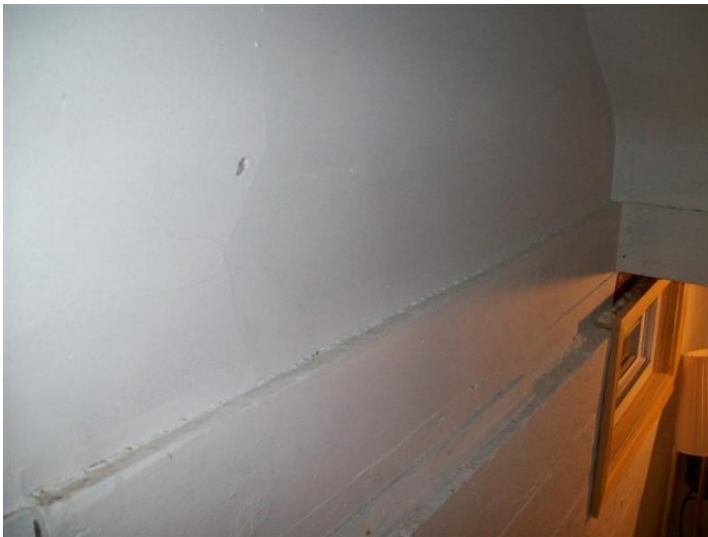
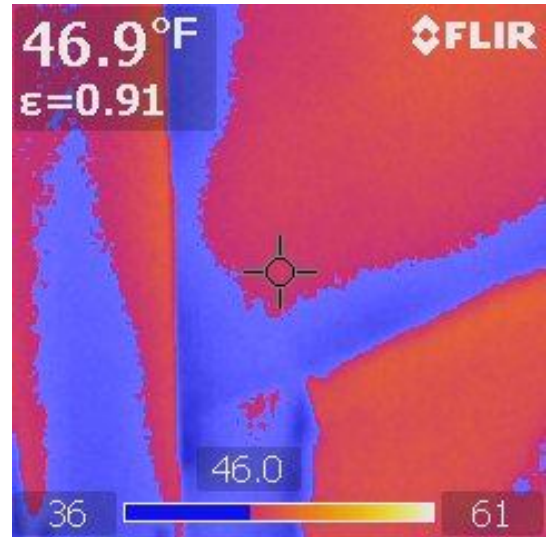
Location Floor: First Floor  
Location Direction: Right Side Wall Under Stairs

**Observations:**  
Dark blue thermal patterns indicative of cold air infiltration. Correction is recommended to reduce energy loss and utility bills.

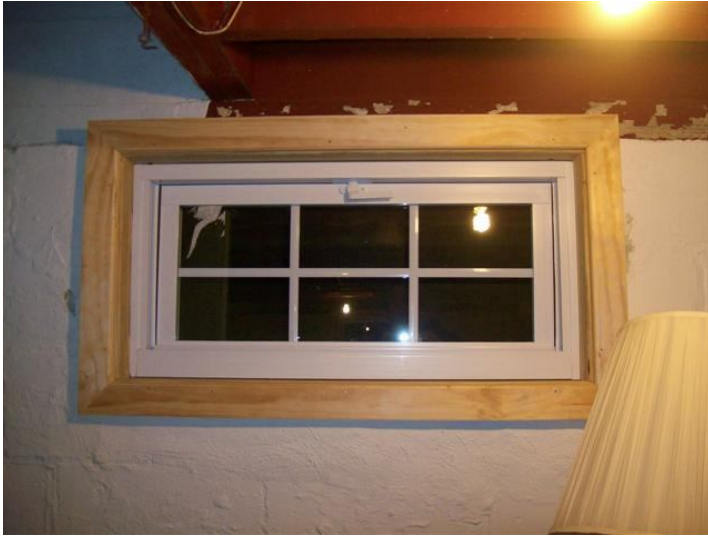
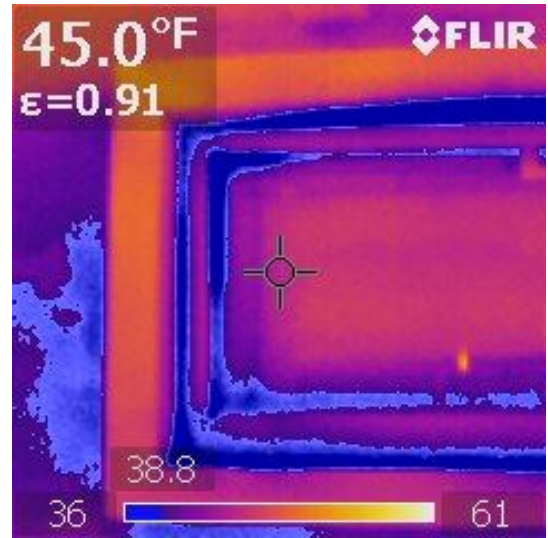
Location Floor: Basement  
Location Direction: Right Side Wall

**Observations:**  
Dark blue thermal patterns indicative of cold air infiltration. Correction is recommended to reduce energy loss and utility bills.

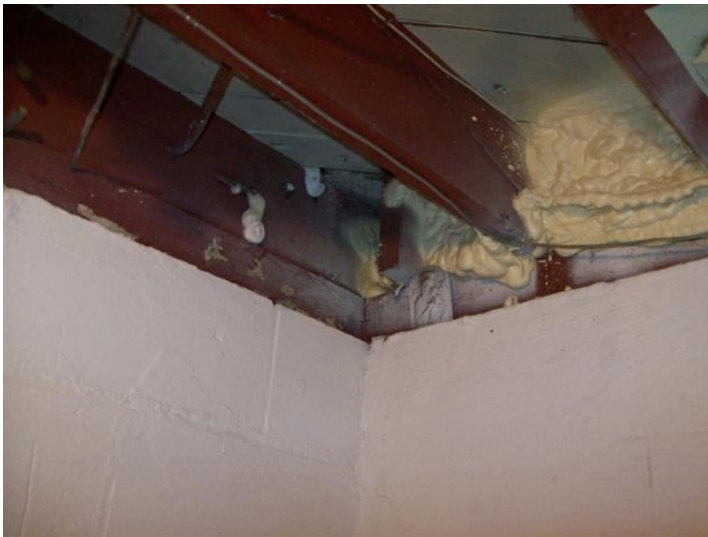
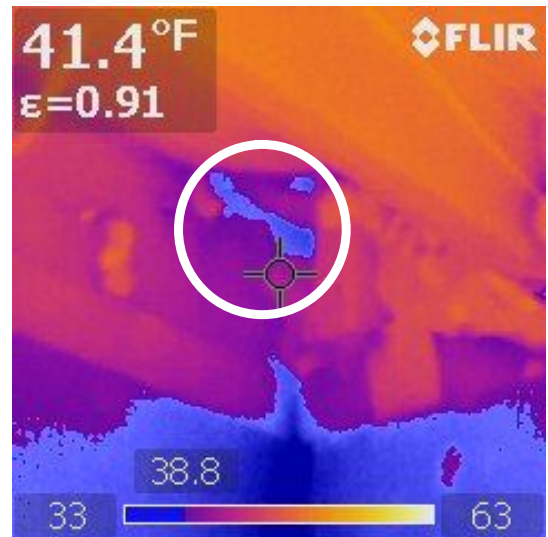
Location Floor: Basement  
Location Direction: Right Front Corner

**Observations:**  
Dark blue thermal patterns indicative of cold air infiltration. Correction is recommended to reduce energy loss and utility bills.

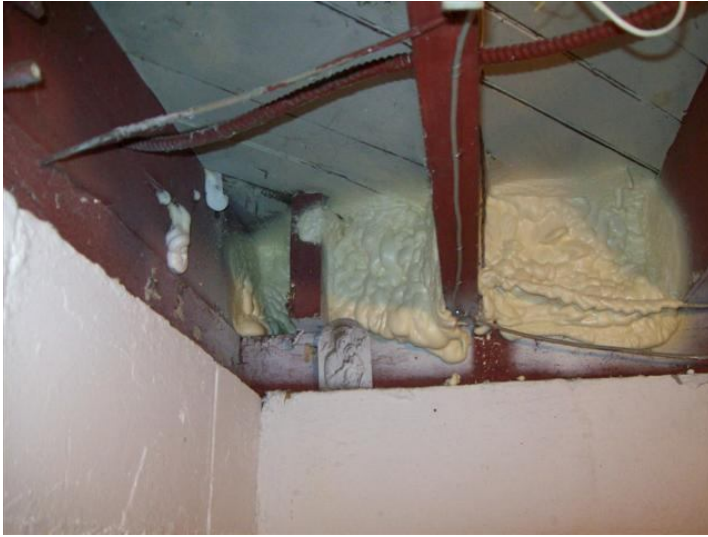
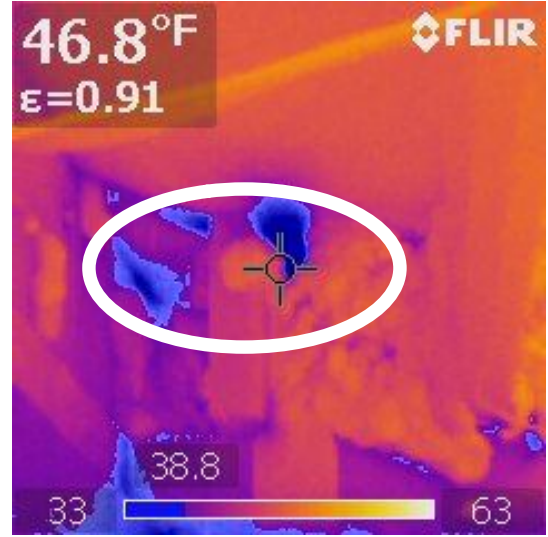
Location Floor: Basement  
 Location Direction: Front Wall

**Observations:**  
 Dark blue thermal patterns indicative of cold air infiltration. Correction is recommended to reduce energy loss and utility bills.

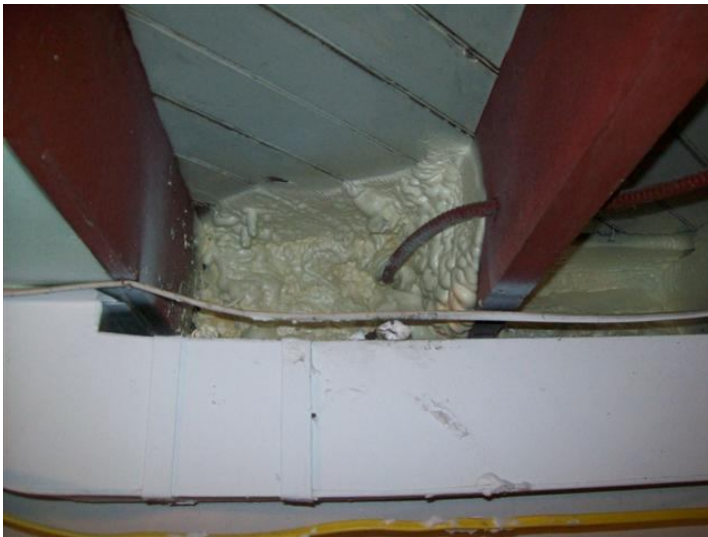
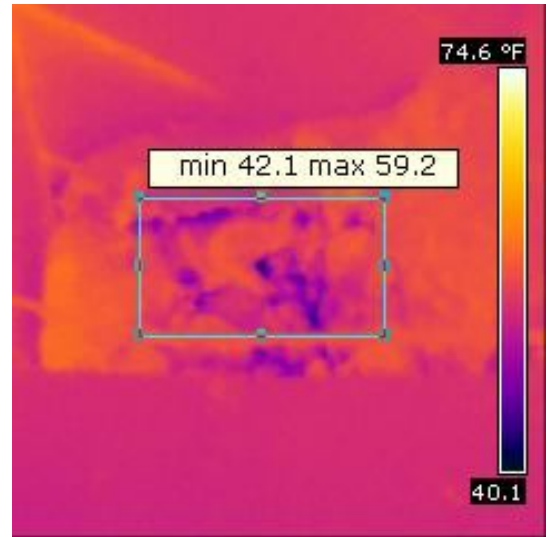
Location Floor: Basement  
 Location Direction: Front Wall

**Observations:**  
 Dark blue thermal patterns indicative of cold air infiltration. Correction is recommended to reduce energy loss and utility bills.

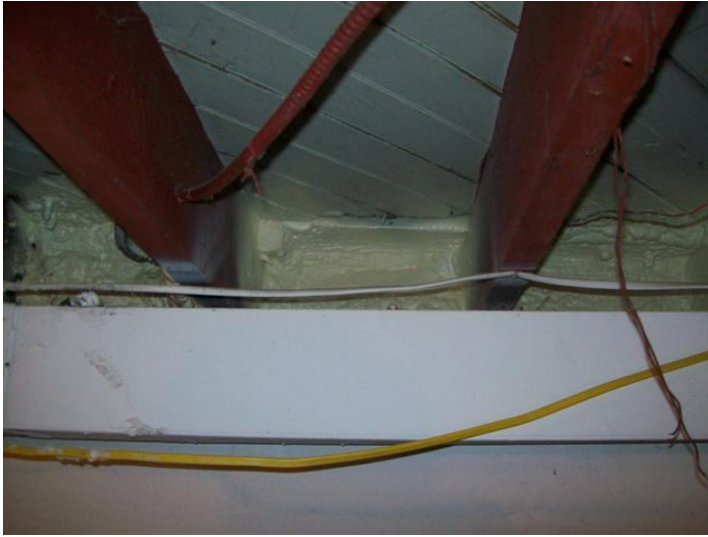
Location Floor: Basement  
Location Direction: Front Wall

**Observations:**  
Dark blue thermal patterns indicative of cold air infiltration. Correction is recommended to reduce energy loss and utility bills.

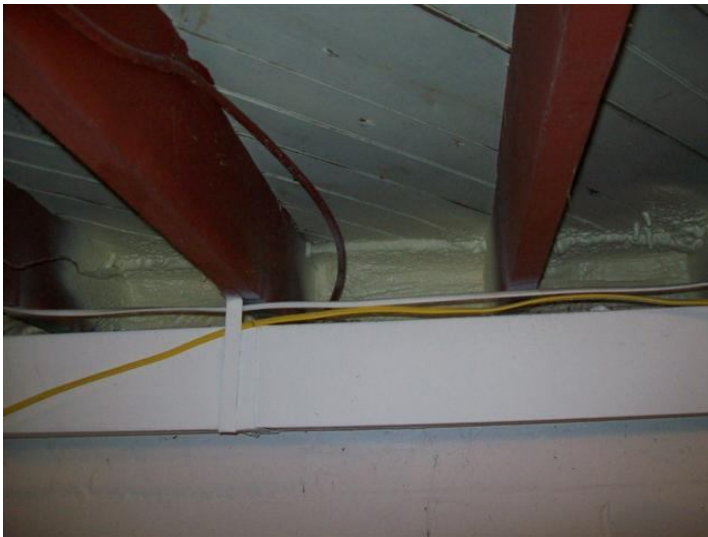
Location Floor: Basement  
Location Direction: Front Wall

**Observations:**  
Dark blue thermal patterns indicative of cold air infiltration. Correction is recommended to reduce energy loss and utility bills.

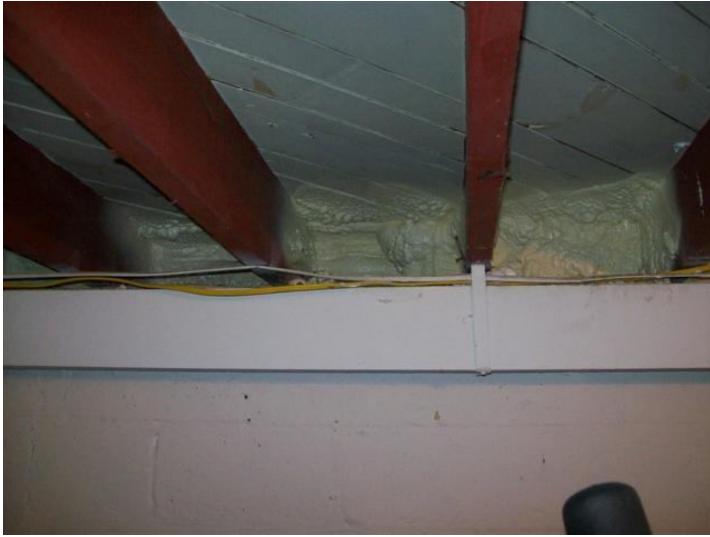
Location Floor: Basement  
Location Direction: Front Wall

**Observations:**  
Dark blue thermal patterns indicative of cold air infiltration. Correction is recommended to reduce energy loss and utility bills.

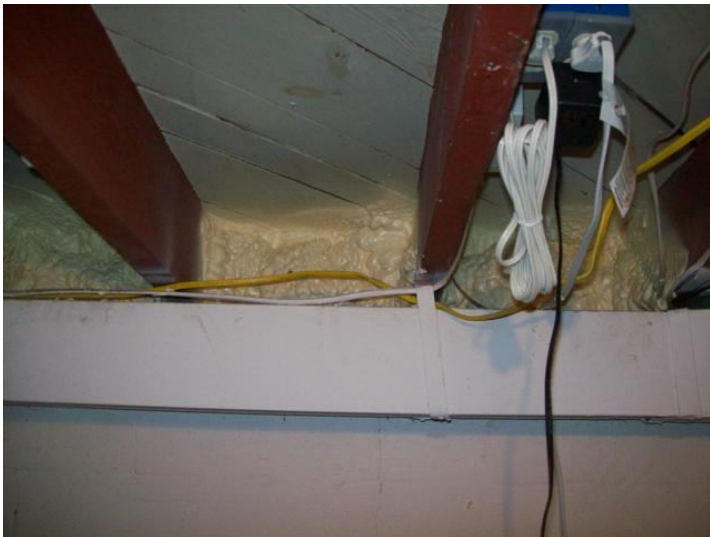
Location Floor: Basement  
Location Direction: Front Wall

**Observations:**  
Dark blue thermal patterns indicative of cold air infiltration. Correction is recommended to reduce energy loss and utility bills.

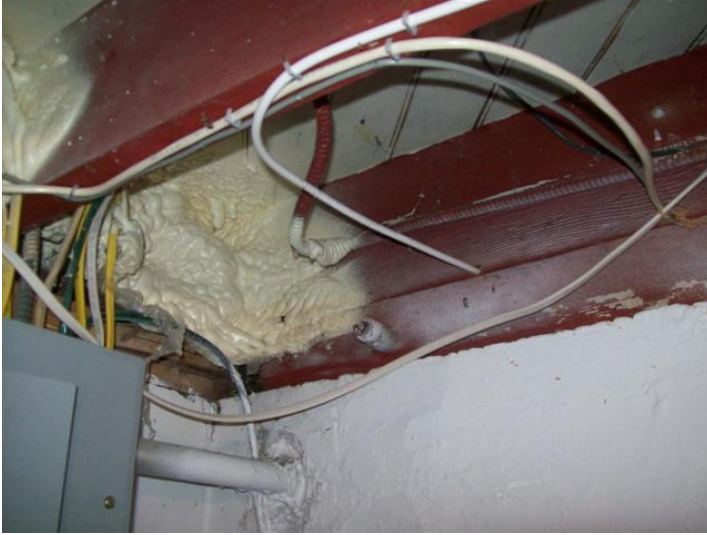
Location Floor: Basement  
Location Direction: Left Front Corner

**Observations:**  
Dark blue thermal patterns indicative of cold air infiltration. Correction is recommended to reduce energy loss and utility bills.

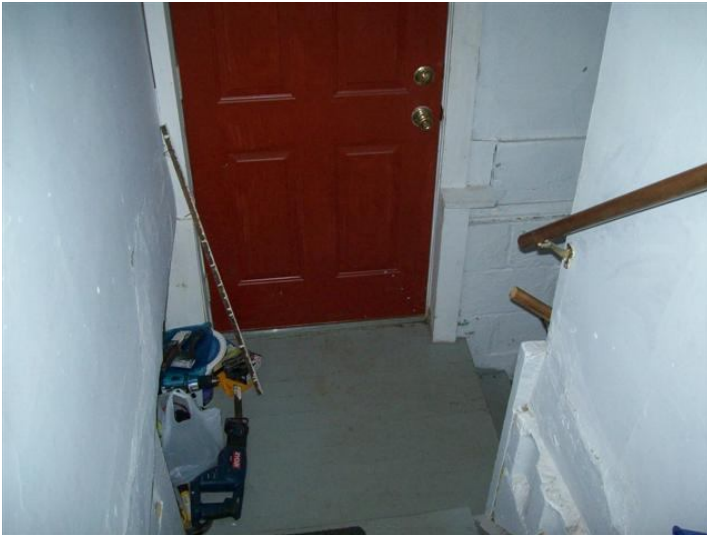
Location Floor: First Floor  
Location Direction: Right Side Wall

**Observations:**  
Dark blue thermal patterns indicative of cold air infiltration. Correction is recommended to reduce energy loss and utility bills.

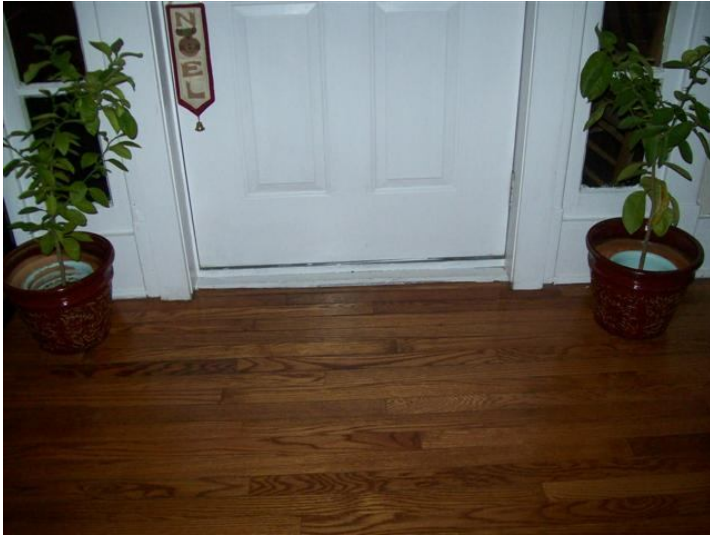
Location Floor: First Floor  
Location Room: Living

**Observations:**  
Dark blue thermal patterns indicative of cold air infiltration. Correction is recommended to reduce energy loss and utility bills.

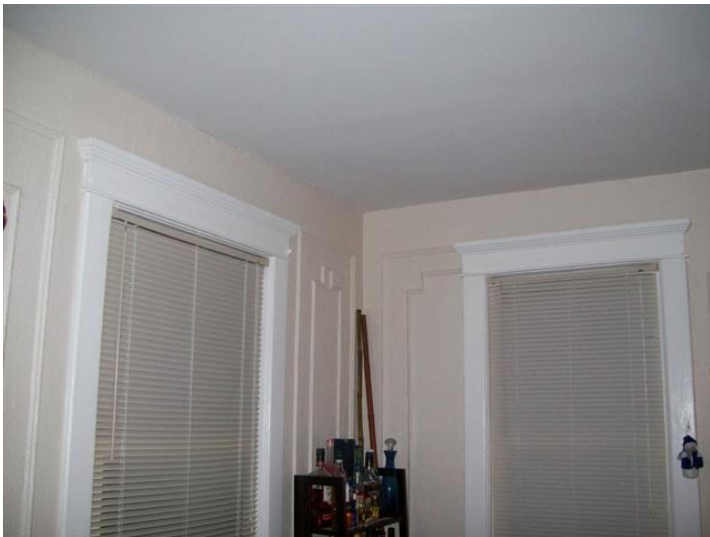
Location Floor: First Floor  
Location Direction: Left Front Corner

**Observations:**  
Dark blue thermal patterns indicative of cold air infiltration. Correction is recommended to reduce energy loss and utility bills.

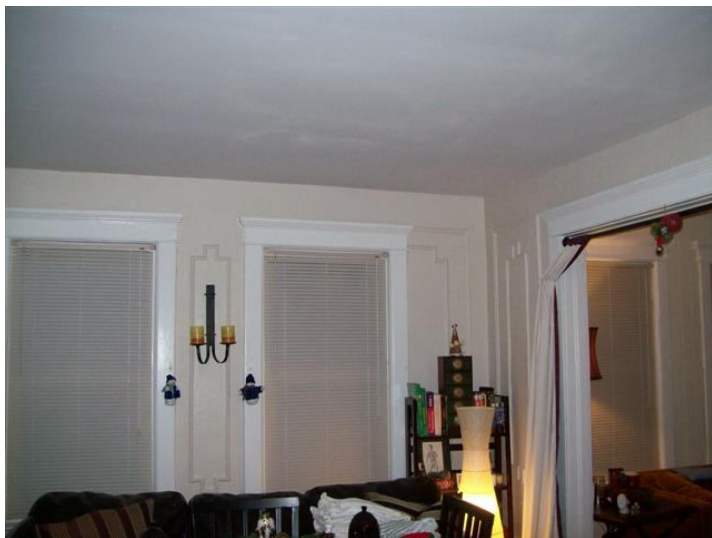
Location Floor: First  
 Location Room: Living  
 Location Direction: Left Side Wall

**Observations:**  
 Dark blue thermal patterns indicative of cold air infiltration. Correction is recommended to reduce energy loss and utility bills.

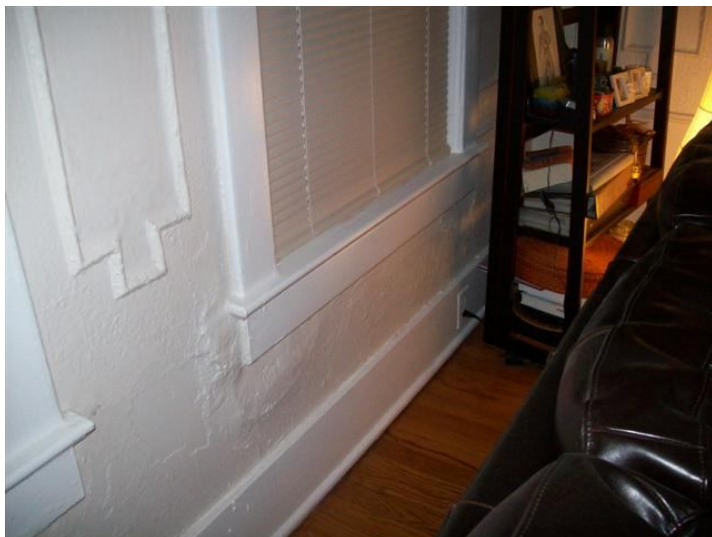
Location Floor: First  
 Location Room: Living  
 Location Direction: Left Side Wall

**Observations:**  
 Dark blue thermal patterns indicative of cold air infiltration. Correction is recommended to reduce energy loss and utility bills.

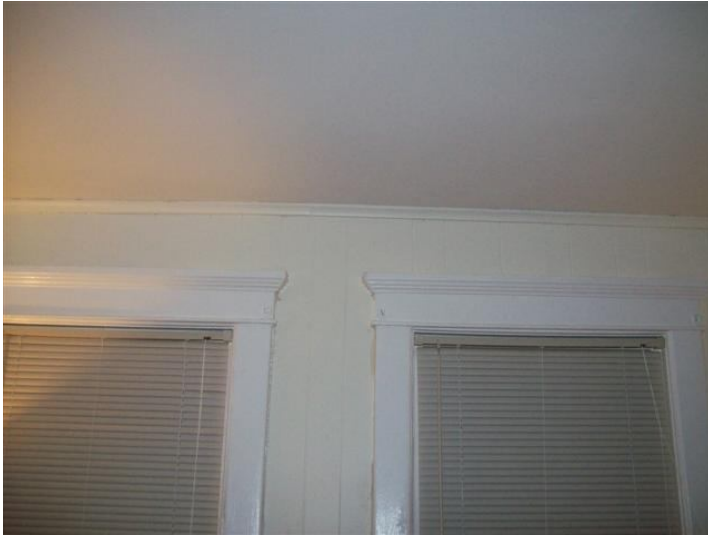
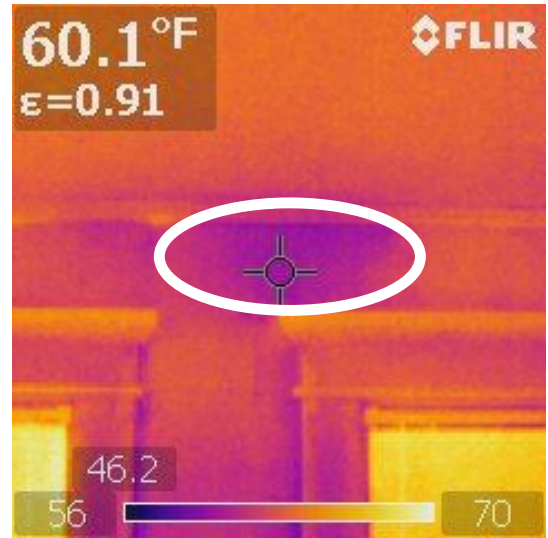
Location Floor: First  
 Location Room: Living

**Observations:**  
 Dark blue thermal patterns indicative of cold air infiltration. Correction is recommended to reduce energy loss and utility bills.

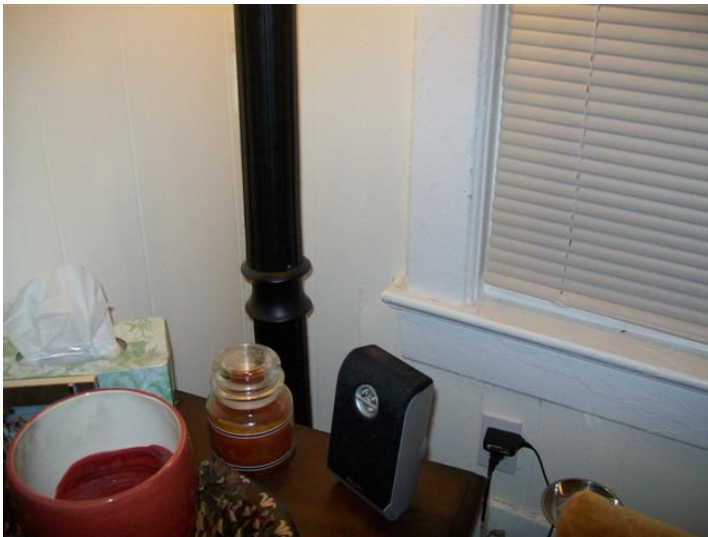
Location Floor: First  
 Location Room: Family  
 Location Direction: Left Side Wall

**Observations:**  
 Dark blue thermal patterns indicative of cold air infiltration. Correction is recommended to reduce energy loss and utility bills.

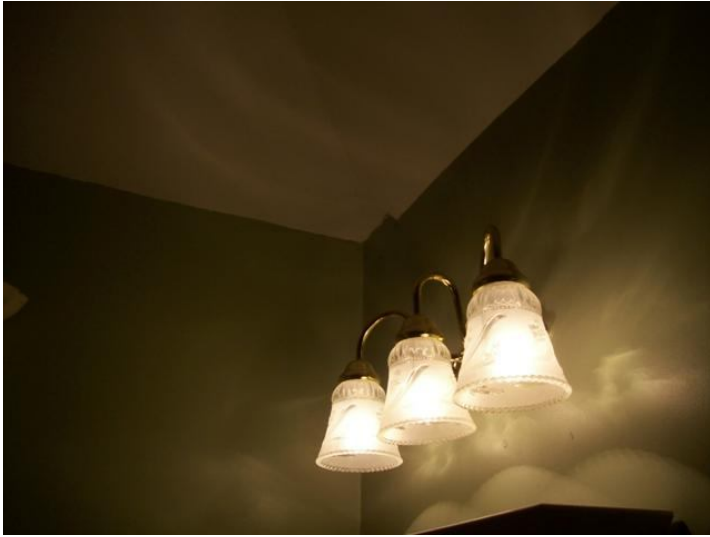
Location Floor: First  
Location Room: Bathroom

**Observations:**  
Dark blue thermal patterns indicative of cold air infiltration. Correction is recommended to reduce energy loss and utility bills.

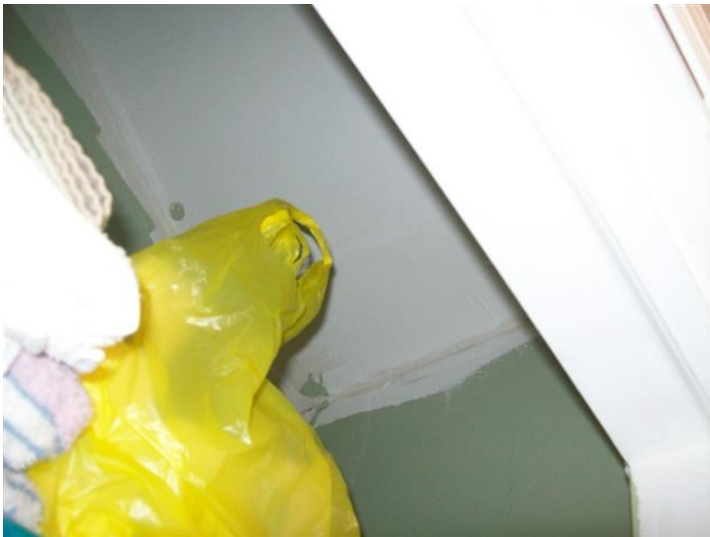
Location Floor: First  
Location Room: Bathroom  
Location Direction: Closet

**Observations:**  
Dark blue thermal patterns indicative of cold air infiltration. Correction is recommended to reduce energy loss and utility bills.

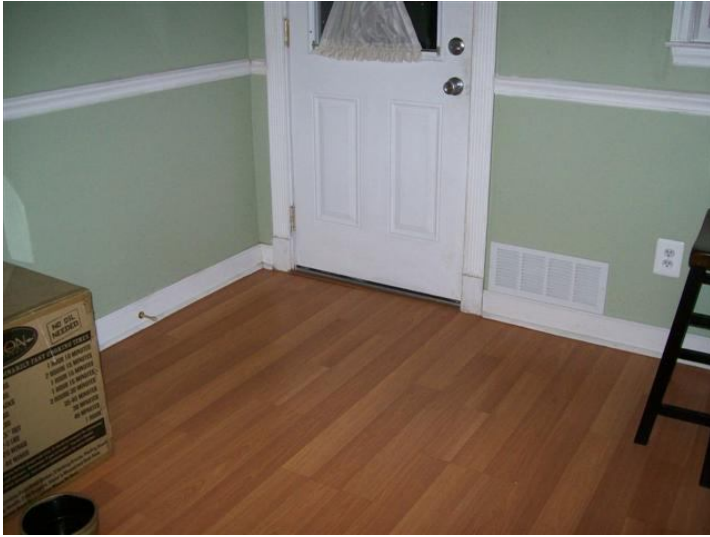
Location Floor: First  
 Location Room: Breakfast  
 Location Direction: Rear

**Observations:**  
 Dark blue thermal patterns indicative of cold air infiltration. Correction is recommended to reduce energy loss and utility bills.

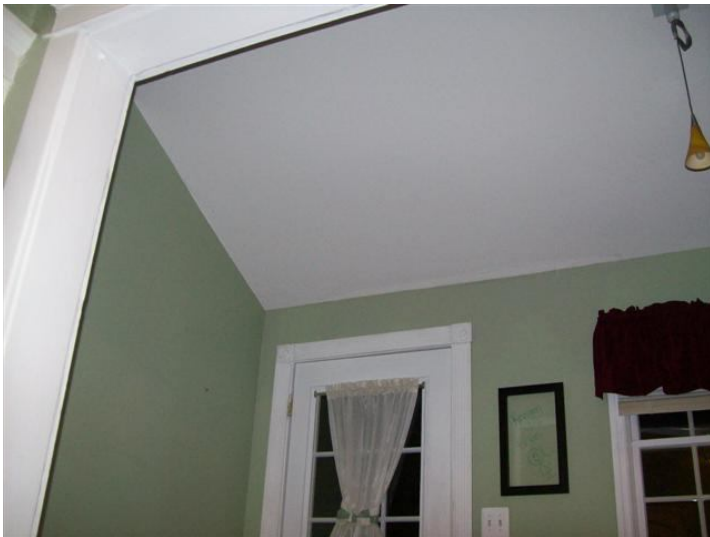
Location Floor: First Floor  
 Location Room: Breakfast

**Observations:**  
 Dark blue thermal patterns indicative of cold air infiltration. Correction is recommended to reduce energy loss and utility bills.

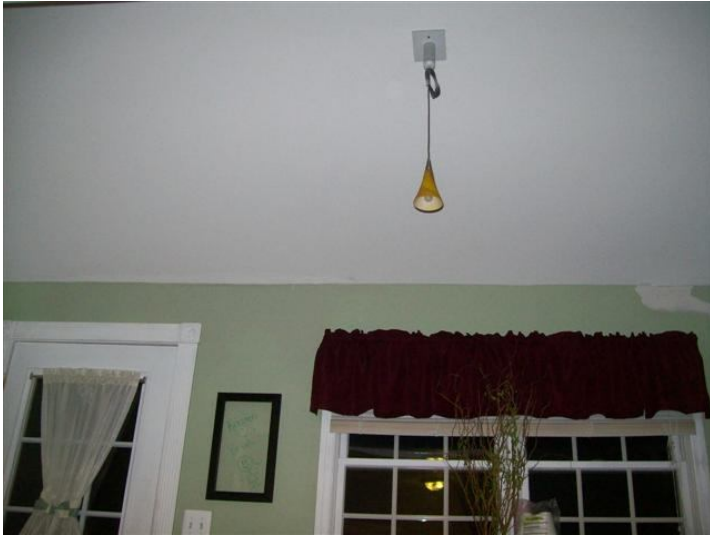
Location Floor: First  
Location Room: Breakfast

**Observations:**  
Dark blue thermal patterns indicative of cold air infiltration. Correction is recommended to reduce energy loss and utility bills.

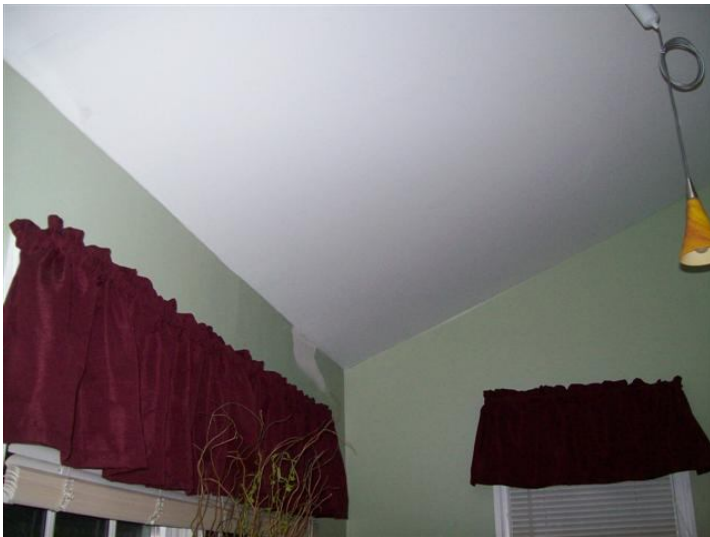
Location Floor: First Floor  
Location Room: Breakfast

**Observations:**  
Dark blue thermal patterns indicative of cold air infiltration. Correction is recommended to reduce energy loss and utility bills.

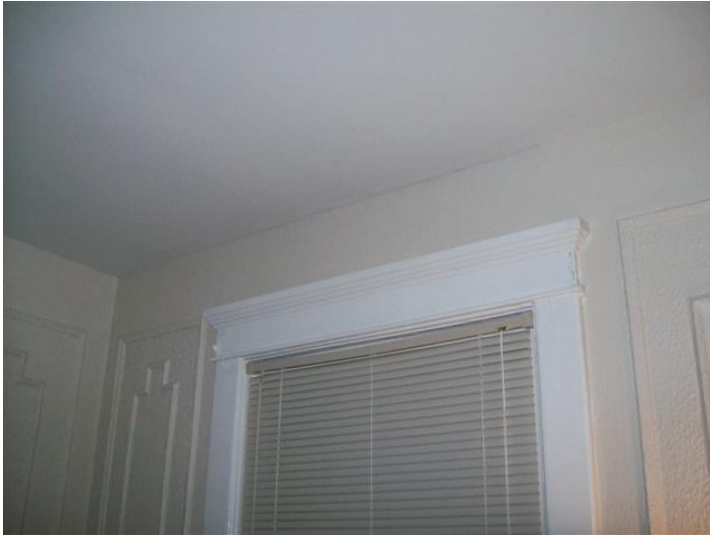
Location Floor: First  
Location Room: Living  
Location Direction: Right Front Corner

**Observations:**  
Dark blue thermal patterns indicative of cold air infiltration. Correction is recommended to reduce energy loss and utility bills.

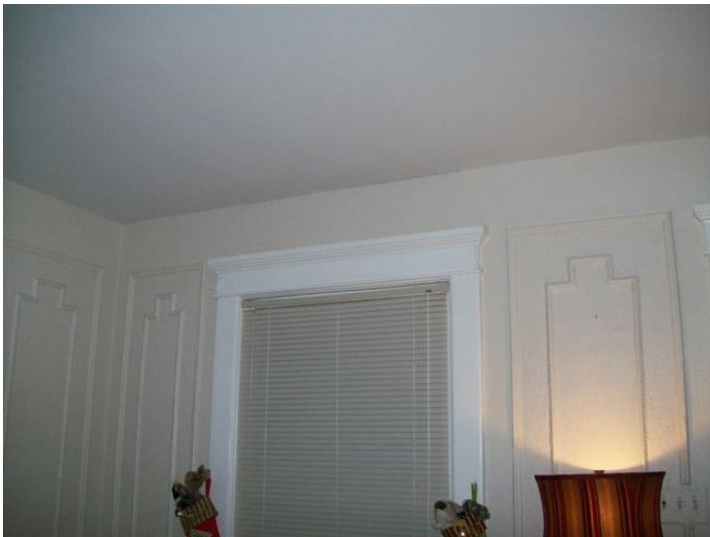
Location Floor: First  
Location Room: Living  
Location Direction: Right Front Corner

**Observations:**  
Dark blue thermal patterns indicative of cold air infiltration. Correction is recommended to reduce energy loss and utility bills.

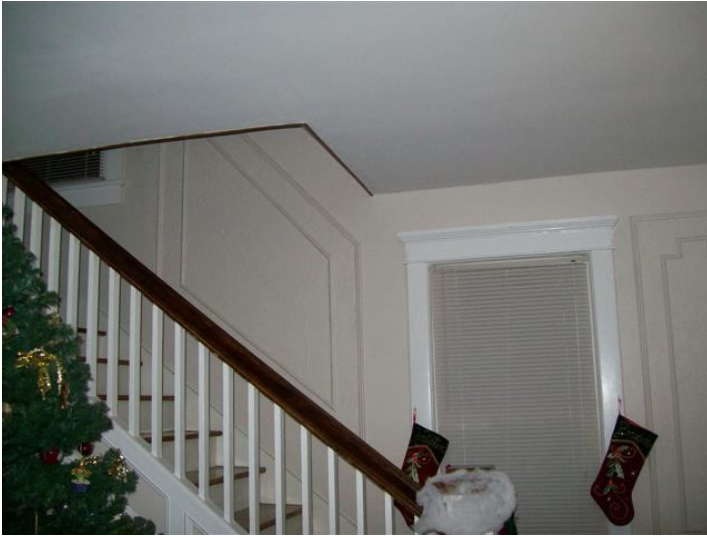
Location Floor: First  
 Location Room: Living  
 Location Direction: Right Front Wall

**Observations:**  
 Dark blue thermal patterns indicative of cold air infiltration. Correction is recommended to reduce energy loss and utility bills.

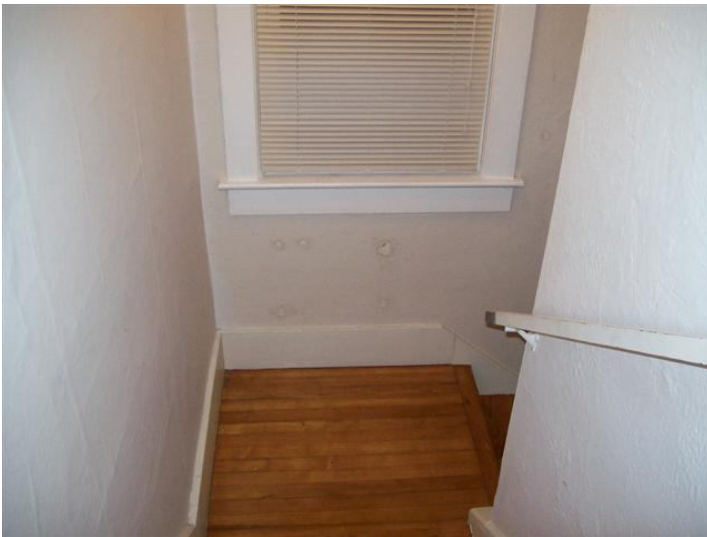
Location Floor: Second Floor  
 Location Room: Stairs  
 Location Direction: Right Side Wall

**Observations:**  
 Dark blue thermal patterns indicative of cold air infiltration. Correction is recommended to reduce energy loss and utility bills.

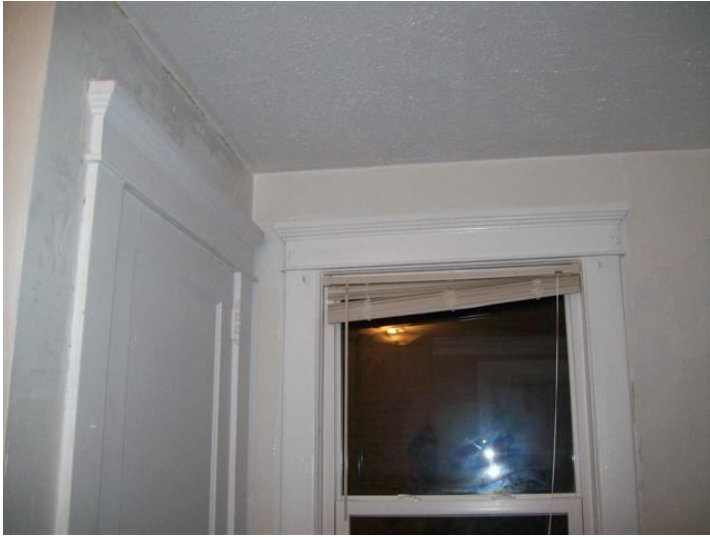
Location Floor: Second  
Location Room: Right Front Bedroom

**Observations:**  
Dark blue thermal patterns indicative of cold air infiltration. Correction is recommended to reduce energy loss and utility bills.

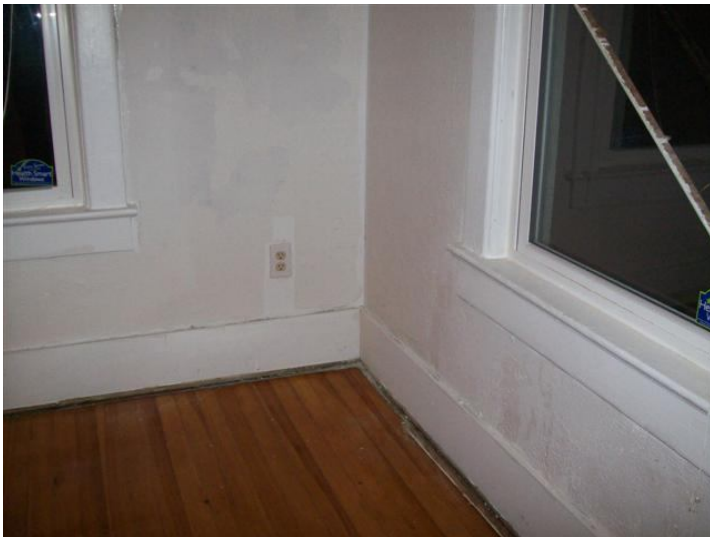
Location Floor: Second  
Location Room: Right Front

**Observations:**  
Dark blue thermal patterns indicative of cold air infiltration. Correction is recommended to reduce energy loss and utility bills.

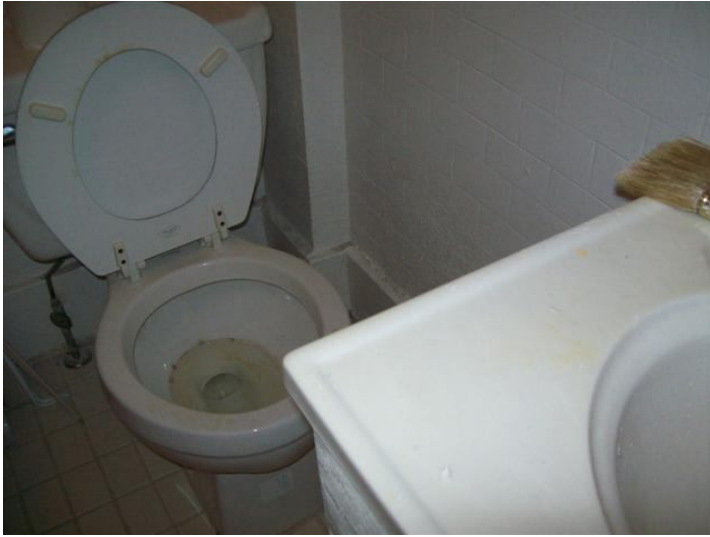
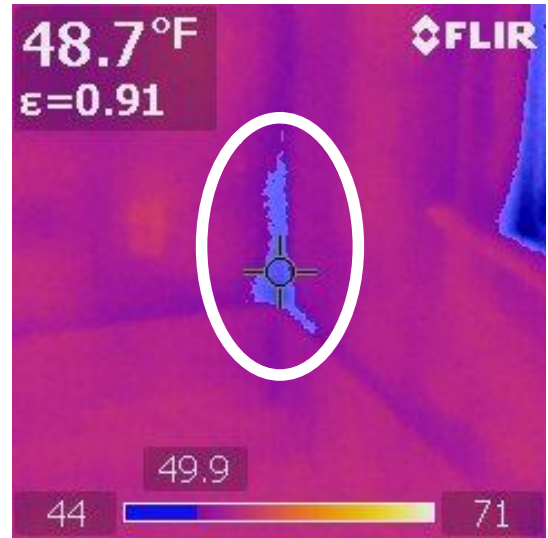
Location Floor: Second  
Location Room: Bathroom

Dark blue thermal patterns indicative of cold air infiltration. Correction is recommended to reduce energy loss and utility bills.

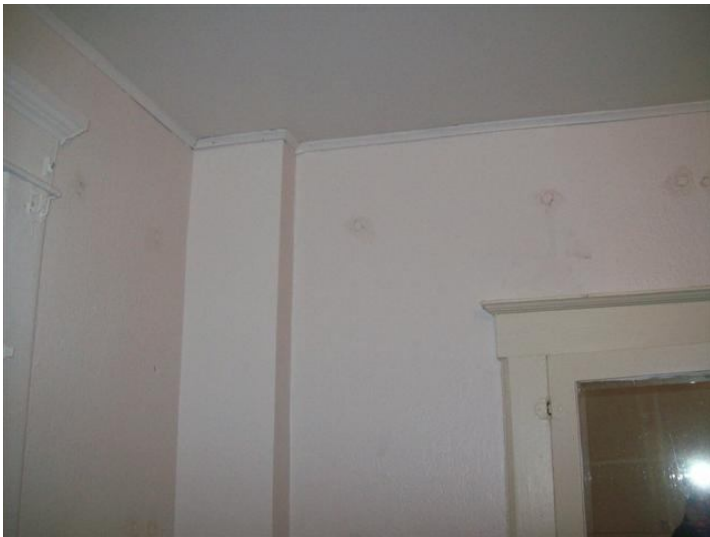
Location Floor: Second  
Location Room: Bathroom  
Location Direction: Right Side Wall

Dark blue thermal patterns indicative of cold air infiltration. Correction is recommended to reduce energy loss and utility bills.

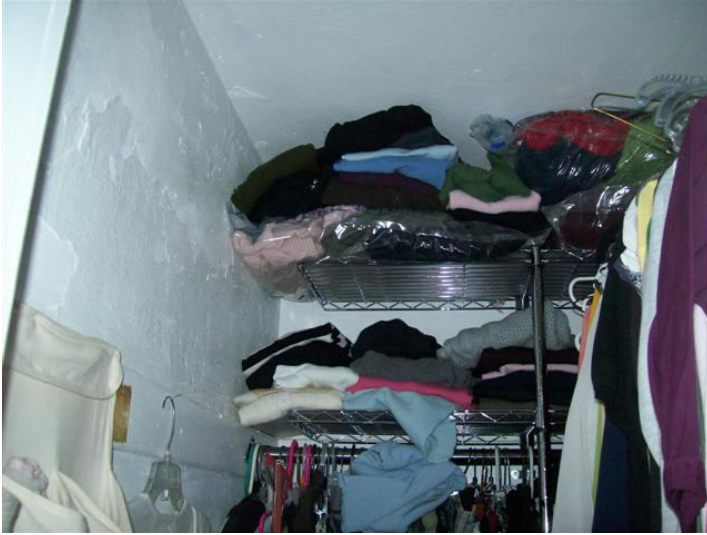
Location Floor: Second Floor

**Observations:**  
Dark blue thermal patterns indicative of cold air infiltration. Correction is recommended to reduce energy loss and utility bills.

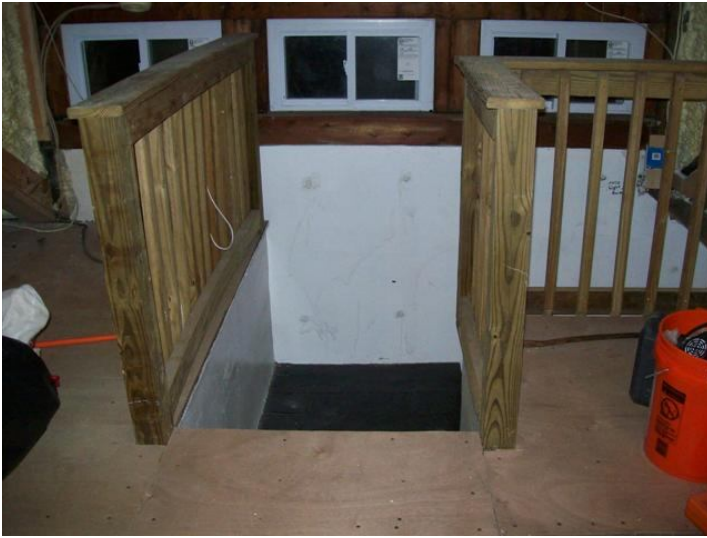
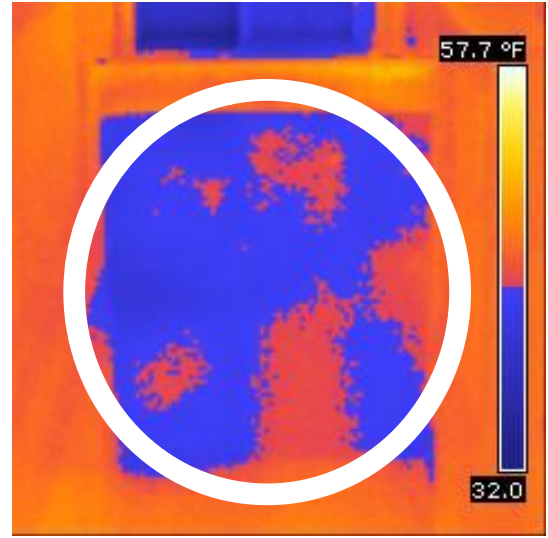
Location Floor: Attic

**Observations:**  
Dark blue thermal patterns indicative of cold air infiltration. Correction is recommended to reduce energy loss and utility bills.

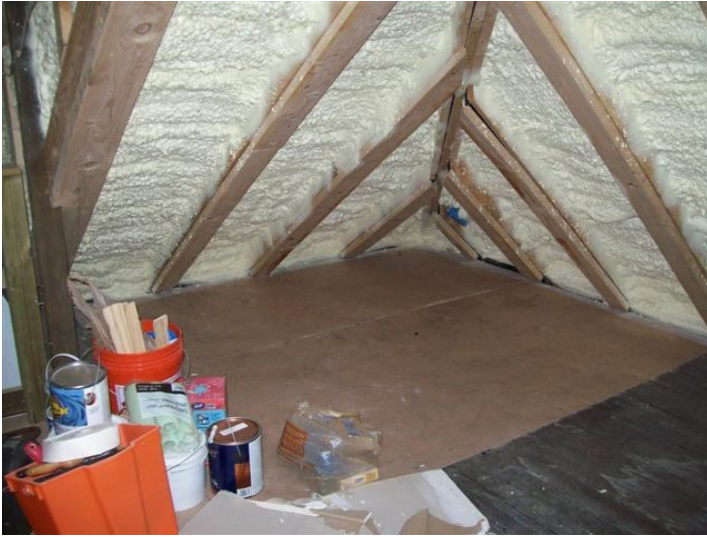
Location Floor: Attic  
 Location Direction: Right Front Corner

**Observations:**  
 Dark blue thermal patterns indicative of cold air infiltration. Correction is recommended to reduce energy loss and utility bills.

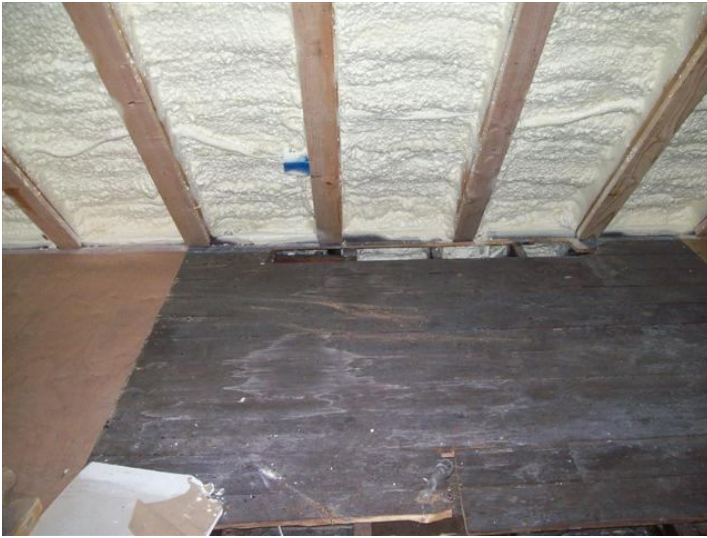
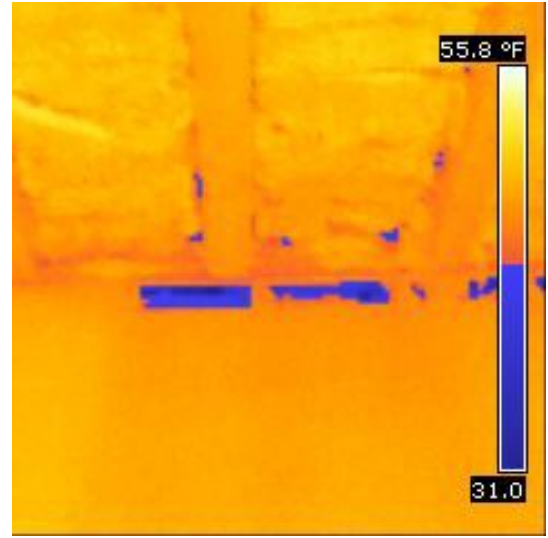
Location Floor: Attic  
 Location Direction: Front

**Observations:**  
 Dark blue thermal patterns indicative of cold air infiltration. Correction is recommended to reduce energy loss and utility bills.

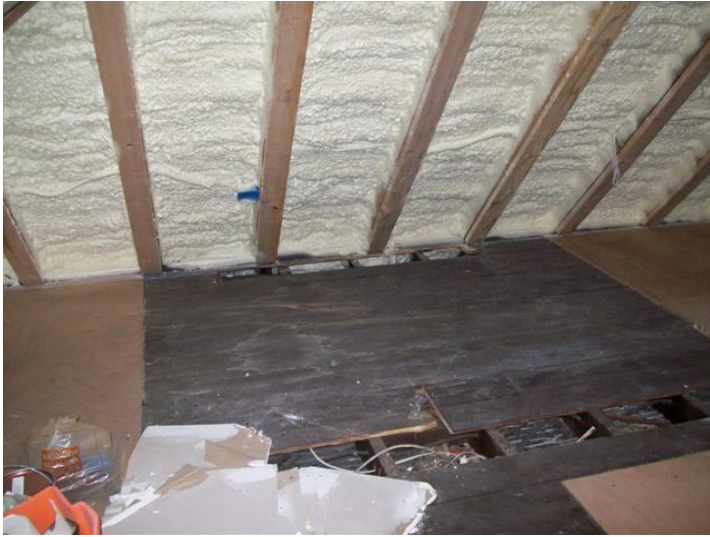
Location Floor: Attic

**Observations:**  
Dark blue thermal patterns indicative of cold air infiltration. Correction is recommended to reduce energy loss and utility bills.

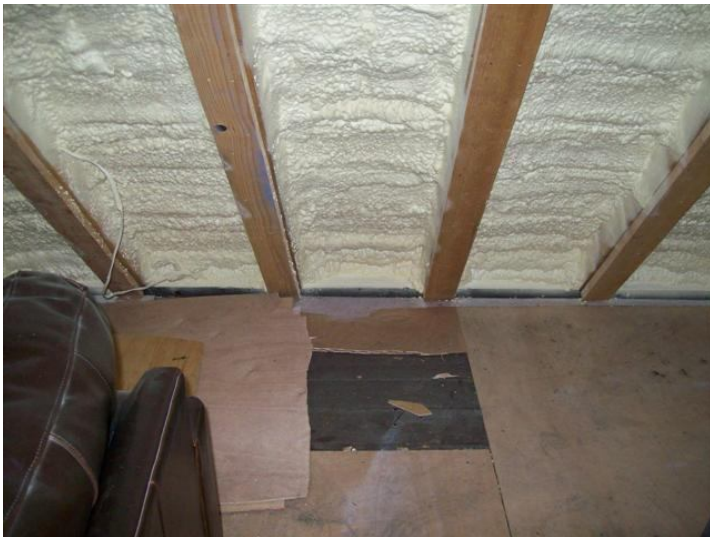
Location Floor: Attic  
Location Direction: Front

**Observations:**  
Dark blue thermal patterns indicative of cold air infiltration. Correction is recommended to reduce energy loss and utility bills.

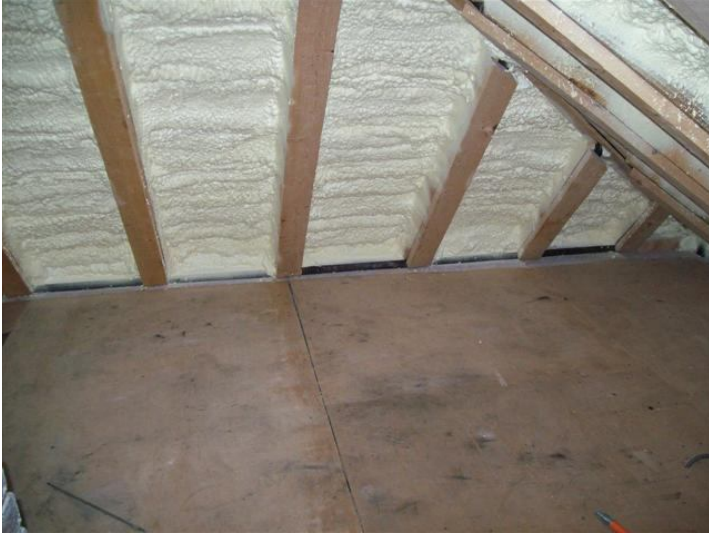
Location Floor: Attic

**Observations:**  
Dark blue thermal patterns indicative of cold air infiltration. Correction is recommended to reduce energy loss and utility bills.

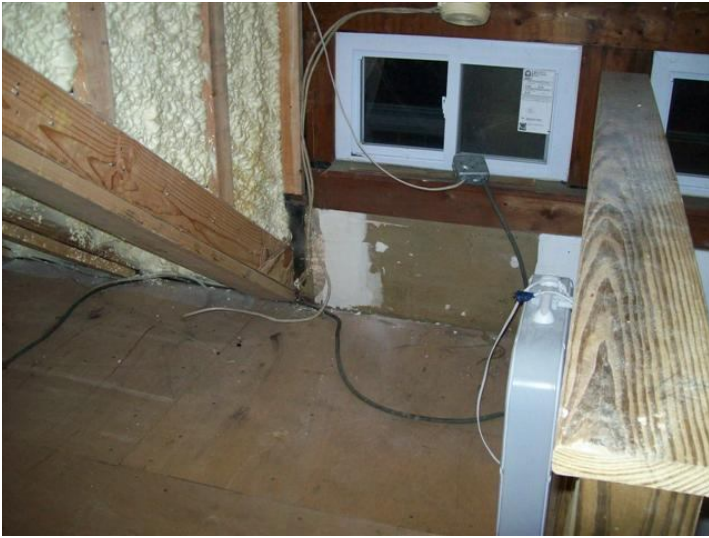
Location Floor: Attic  
Location Direction: Right Front Wall

**Observations:**  
Dark blue thermal patterns indicative of cold air infiltration. Correction is recommended to reduce energy loss and utility bills.

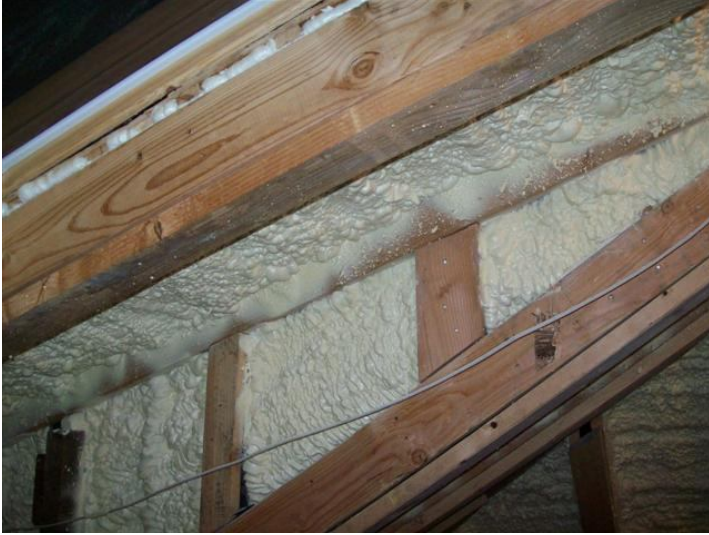
Location Floor: Attic

**Observations:**  
Dark blue thermal patterns indicative of cold air infiltration. Correction is recommended to reduce energy loss and utility bills.
