# Thermal Imaging Report

123 Renovation Street  
Manalapan, NJ 07726

Prepared by: A Full House Inspection Co. LLC

Date:12/22/08

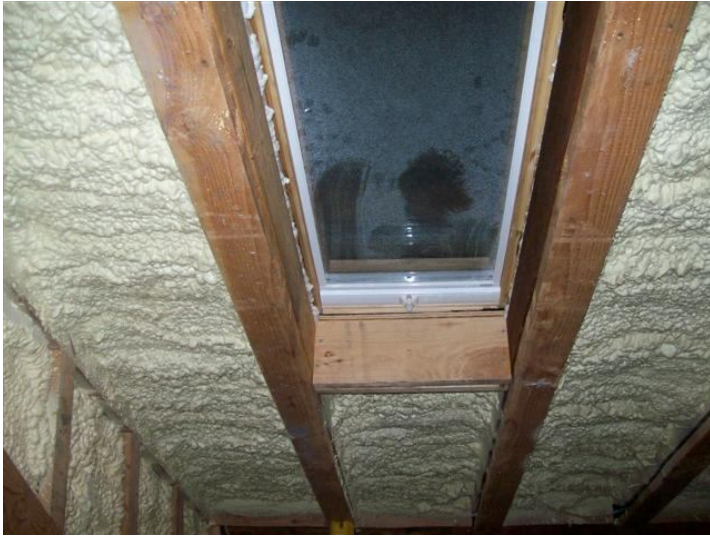
Location Floor: Attic

**Observations:**  
 Dark blue thermal patterns indicative of cold air infiltration. Correction is recommended to reduce energy loss and utility bills.

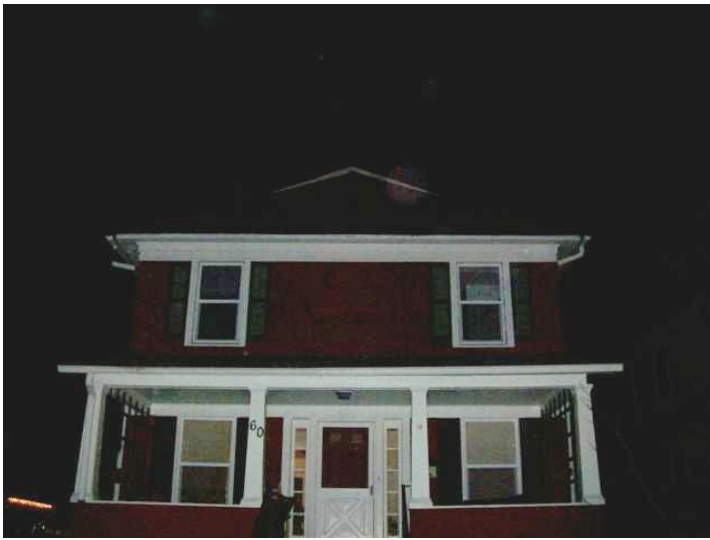
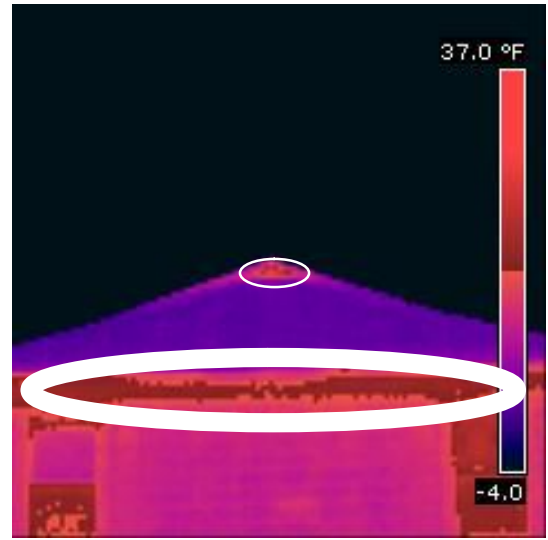
Location Direction: Front

**Observations:**  
 Dark Red thermal patterns indicative of energy loss. Correction is recommended to reduce energy loss and utility bills.

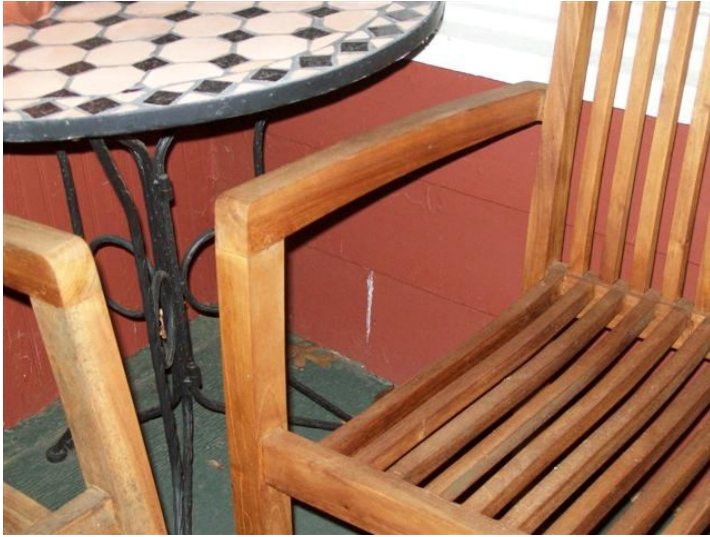
Location Direction: Front Porch

**Observations:**  
 Dark Red thermal patterns indicative of energy loss. Correction is recommended to reduce energy loss and utility bills.

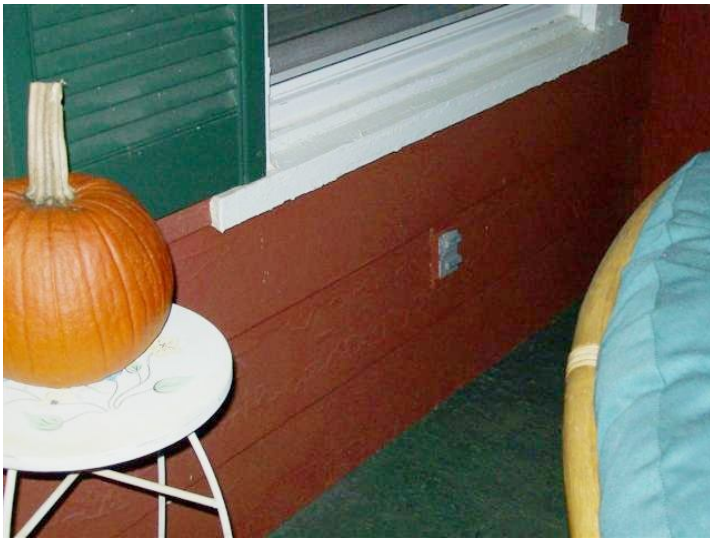
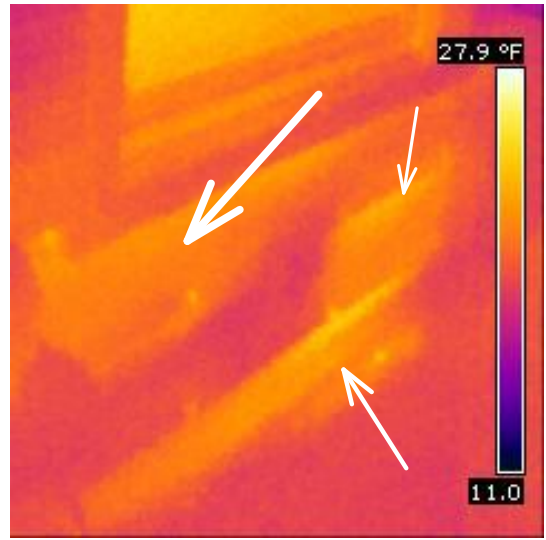
Location Direction: Front Porch

**Observations:**  
 Dark Red thermal patterns indicative of energy loss. Correction is recommended to reduce energy loss and utility bills.

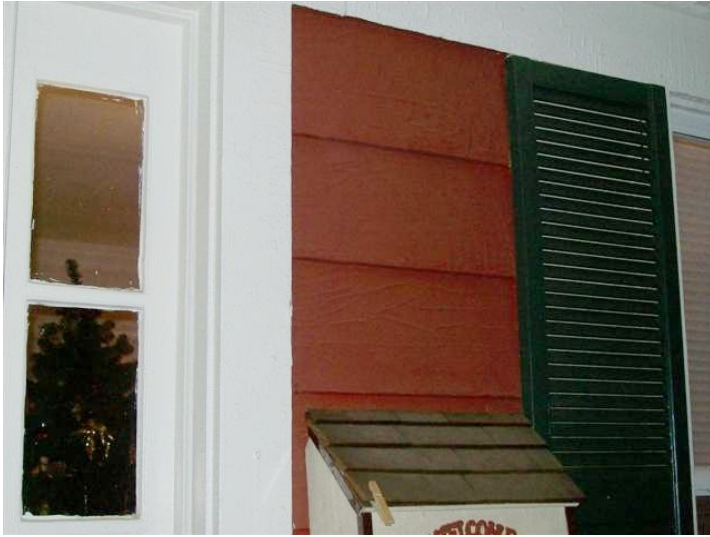
Location Direction: Front Porch

**Observations:**  
 Dark Red thermal patterns indicative of energy loss. Correction is recommended to reduce energy loss and utility bills.

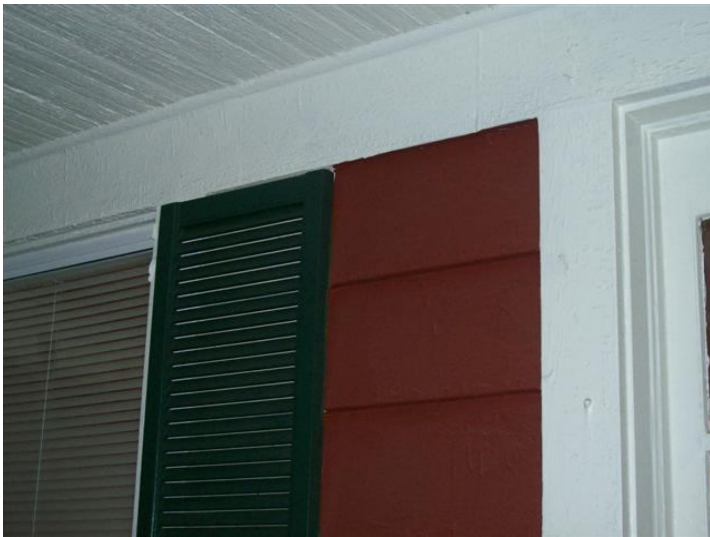
Location Direction: Front Porch

**Observations:**  
 Dark Red thermal patterns indicative of energy loss. Correction is recommended to reduce energy loss and utility bills.

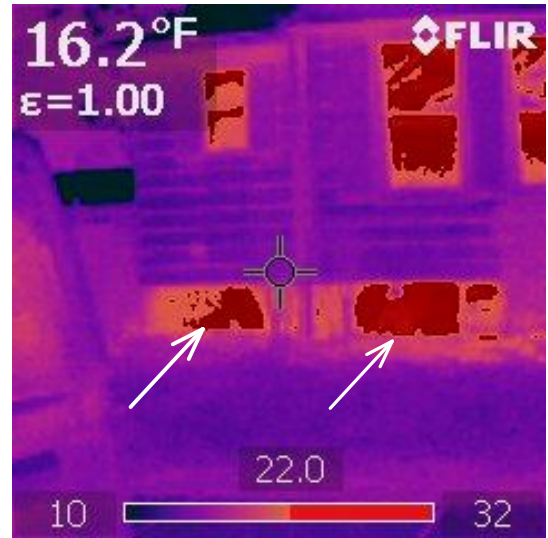
Location Direction: Rear Wall

Red thermal patterns indicative of energy loss. Correction is recommended to reduce energy loss and utility bills.

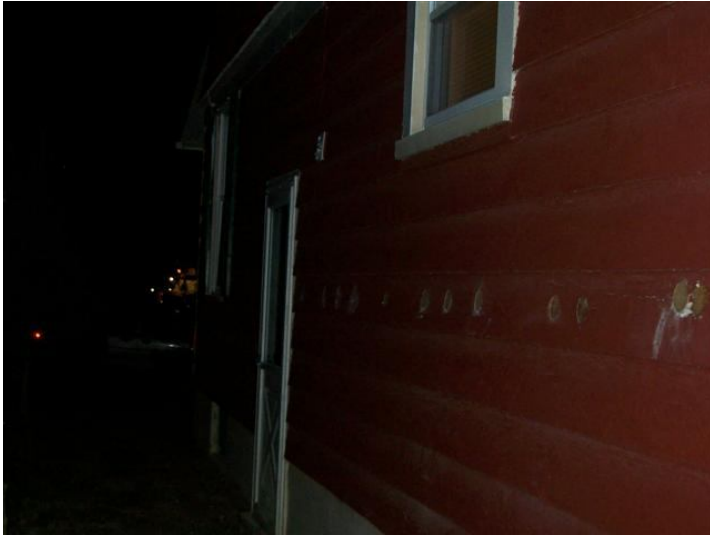
Location Direction: Right Side Wall

**Observations:**  
Dark Red thermal patterns indicative of energy loss. Correction is recommended to reduce energy loss and utility bills.

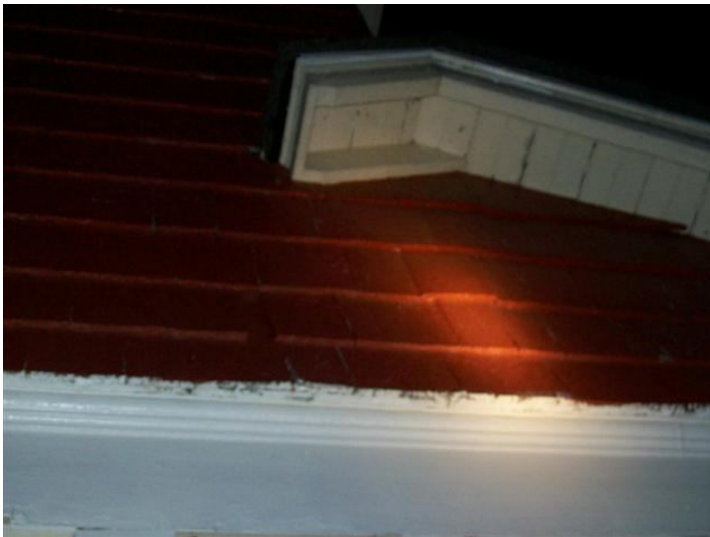
Location Direction: Right Side Wall

**Observations:**  
Dark Red thermal patterns indicative of energy loss. Correction is recommended to reduce energy loss and utility bills.

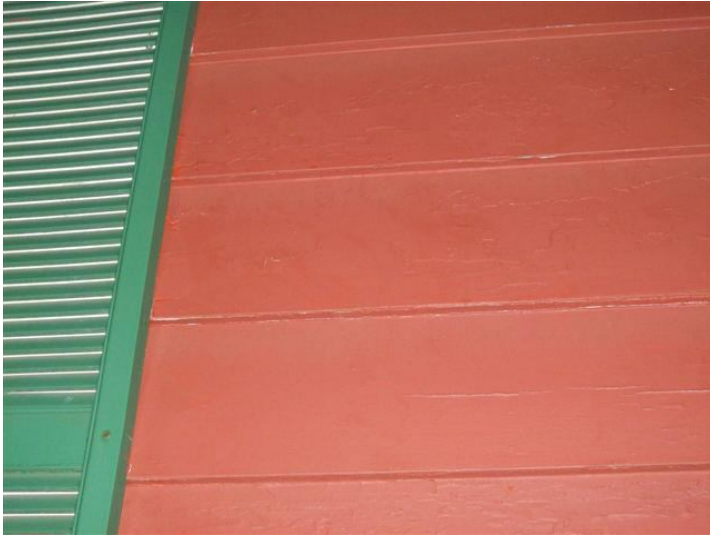
Location Direction: Right Side Wall at Stairs

Observations:  
Dark Red thermal patterns indicative of energy loss. Correction is recommended to reduce energy loss and utility bills.

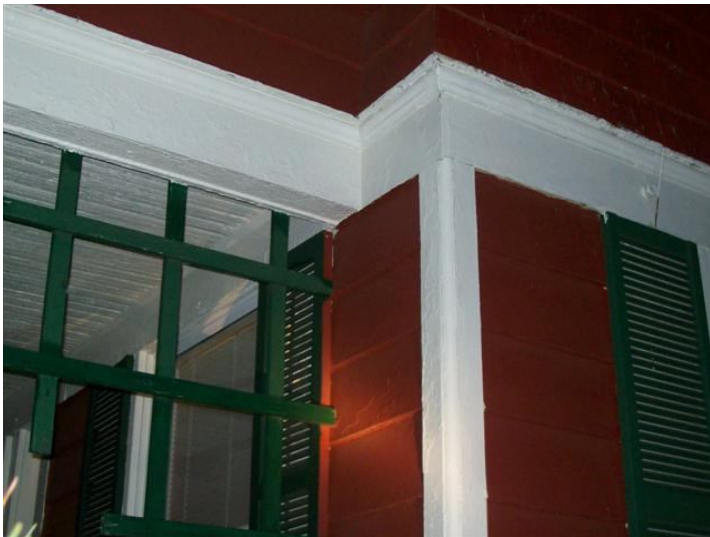
Location Direction: Right Front Corner

Observations:  
Dark Red thermal patterns indicative of energy loss. Correction is recommended to reduce energy loss and utility bills.
