Qualitative Infrared Moisture Survey Report

The Sample Residence

QUALITATIVE INFRARED THERMOGRAPHIC REPORT

Subject Areas – Front exterior and exterior wall and window above front bedroom only.

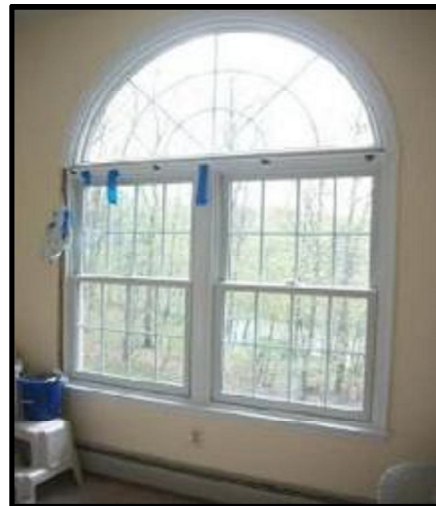
Bedroom

A significant leak and moisture entry was noted at the right front corner where the half moon window joins the double hung window on top of, below and under the metal bracket which appears to fasten the half moon window to the lower double window. Moisture levels of approximately 21.5 % were noted above the metal bracket before the use of the garden hose. After soaking the exterior area, the moisture levels were the same, but the leak was only below the bracket area. Moisture levels of 90% were noted below and inside the bracket. This area strongly indicates leakage at the window and not the exterior wall assembly. The infrared thermal imaging scan did not detect cold patterns associated with leaks at any other location, except where the active leak was visibly noted. Note: the leaks occurred with and without the blower door fan in operation.

It is the inspector's opinion that the moisture entry is at the aforementioned area of the window. The window manufacturer should be retained for further evaluation and all necessary repairs to determine and eliminate all sources of moisture entry to provide a weathertight seal against leaks.
