Thermal Imaging Report

123 High Utility Bill Street
Red Bank, NJ 07701

Prepared for: Mr. and Mrs. Homeowner

Prepared by: A Full House Inspection Co. LLC

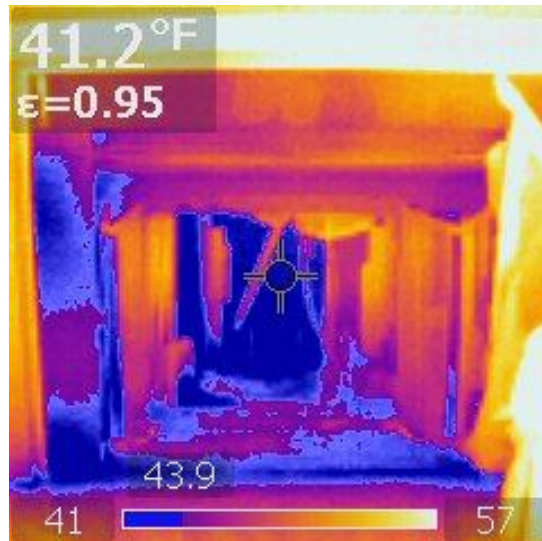
Location Room: Family

Observations:
 Cold air infiltration noted in blue. Retain a qualified contractor to check for missing insulation and correct condition. Priority 1.

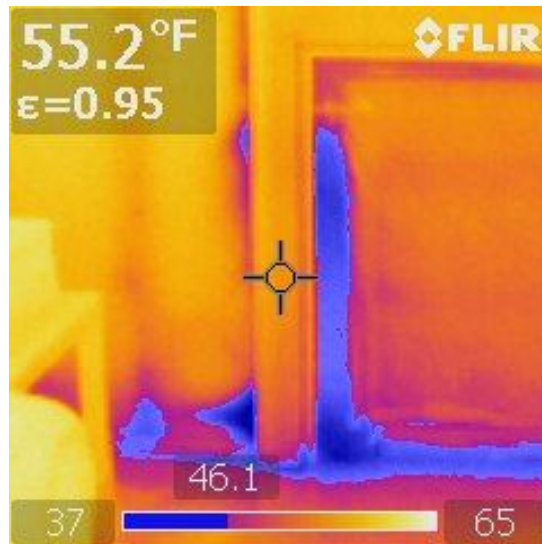
Location Room: Family

Observations:
 Cold air infiltration noted in blue around fireplace. Retain a qualified contractor to check for missing insulation and correct condition. Priority 1.

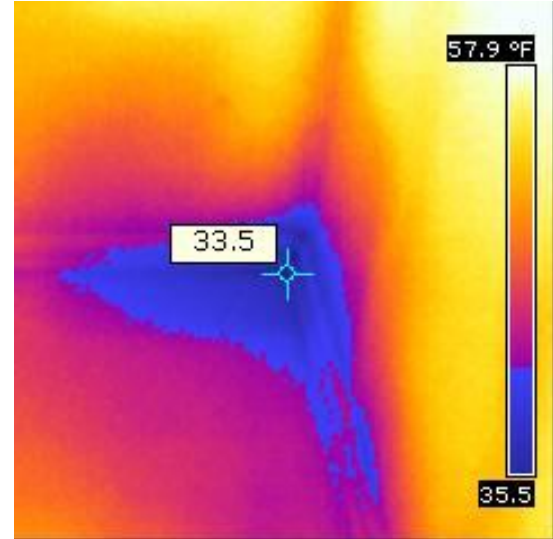
Location Room: Family

Observations:
Cold air infiltration noted in blue. Check for missing insulation at corresponding area in basement and correct condition. Priority 2.

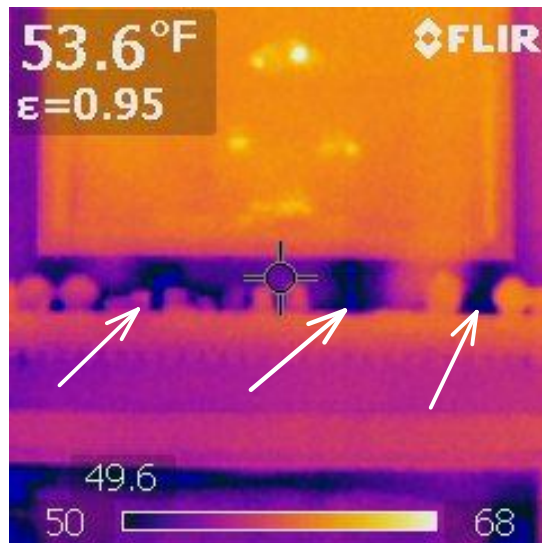
Location Room: Family

Observations:
 Cold air infiltration noted above fireplace. Retain a qualified contractor to correct condition. Priority 1.

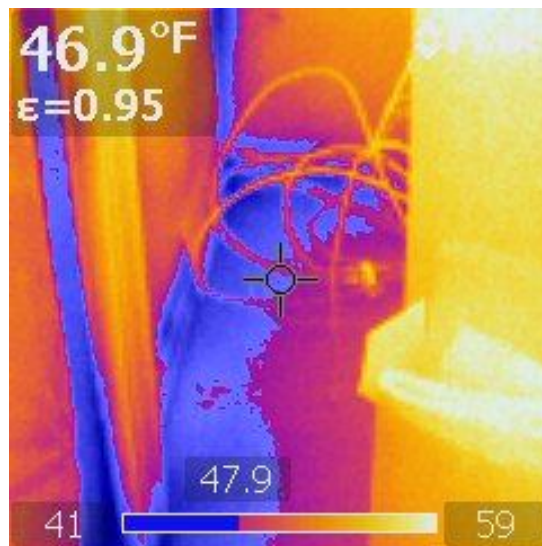
Location Room: Family

Observations:
 Cold air infiltration noted in blue around fireplace. Retain a qualified contractor to check for missing insulation and correct condition. Priority 1.

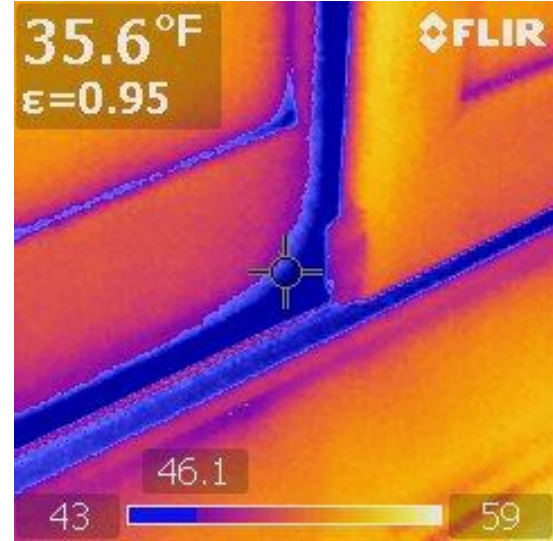
Location Room: Family

Observations:
Cold air infiltration noted in blue. Retain a qualified contractor to check for missing damaged/missing weather stripping and correct condition. Priority 2.

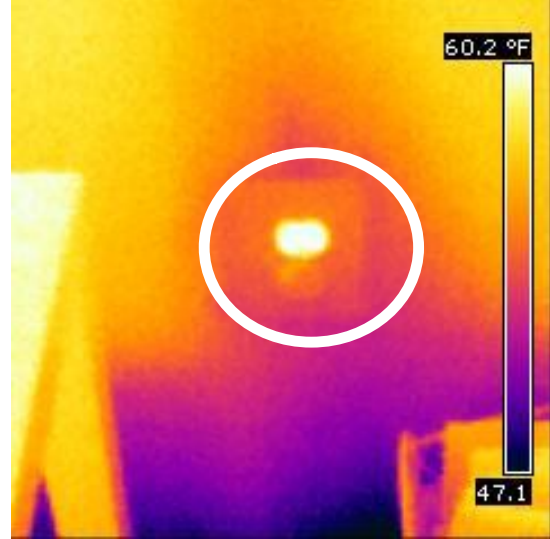
Location Room: Family

Observations:
Cold air infiltration at receptacle. Install foam gasket sealers. Priority 2.

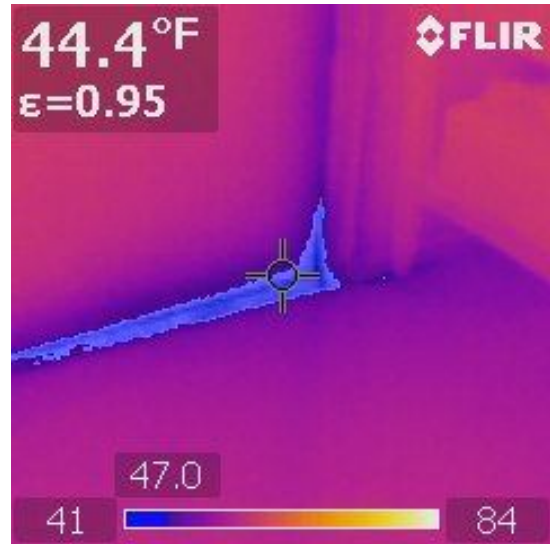
Location Room: Family

Observations:
Cold air infiltration at door. Replace weather stripping. Priority 1.

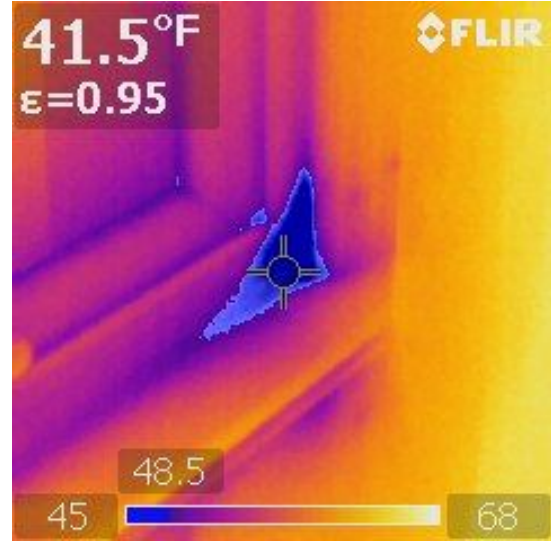
Location Room: Breakfast

Observations:
Cold air infiltration noted in blue. Caulk and seal at the interior and exterior. Priority 1.

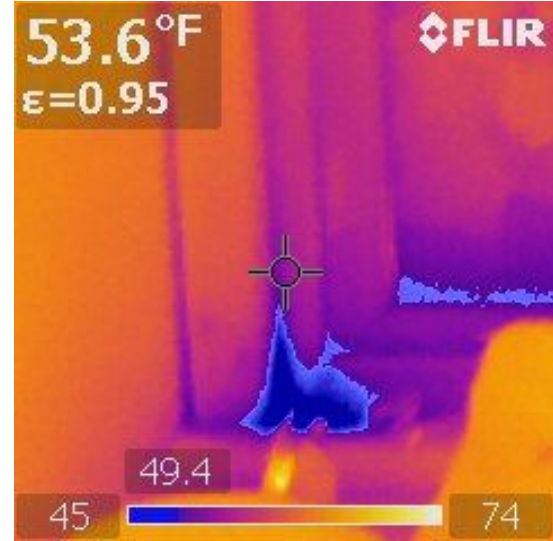
Location Room: Kitchen

Cold air infiltration noted in blue. Caulk and seal at the interior and exterior. Retain a qualified contactor for evaluation to correct condition. Priority 1.

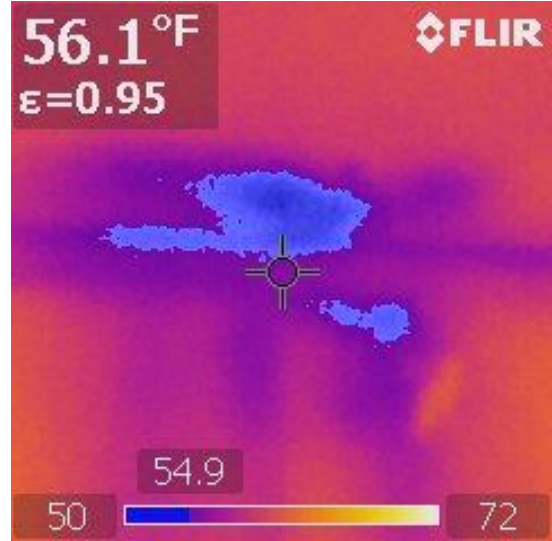
Observations:
Cold air infiltration noted in blue. Retain a qualified contractor to check for missing insulation and correct condition. Priority 1.

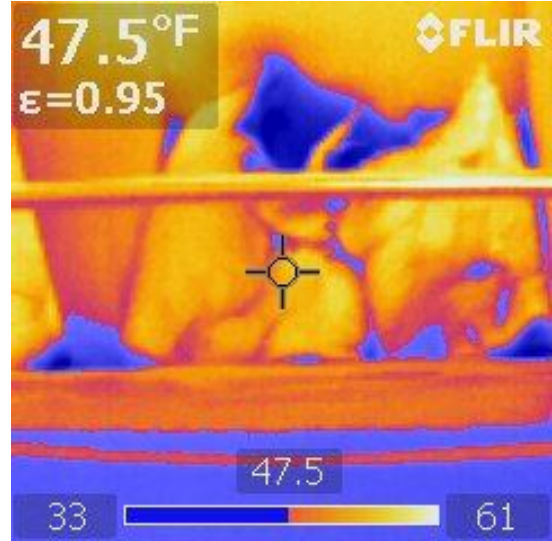
Location Room: Basement

Observations:
Cold air infiltration noted in blue. Correct insulation defect. Priority 1.

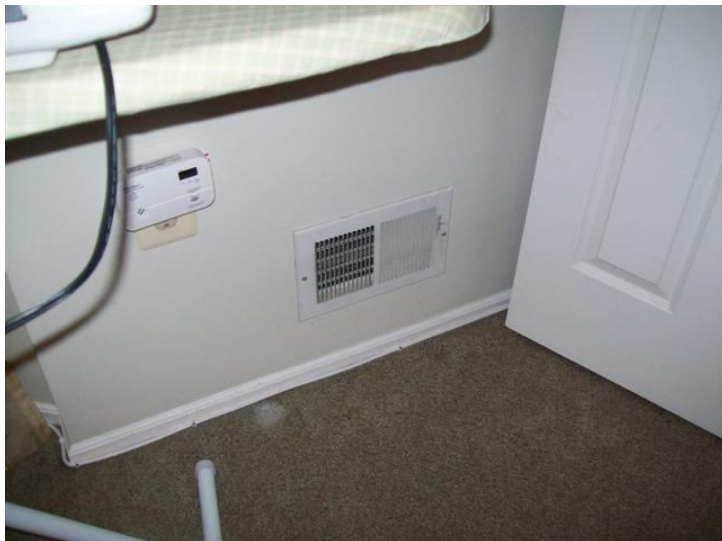
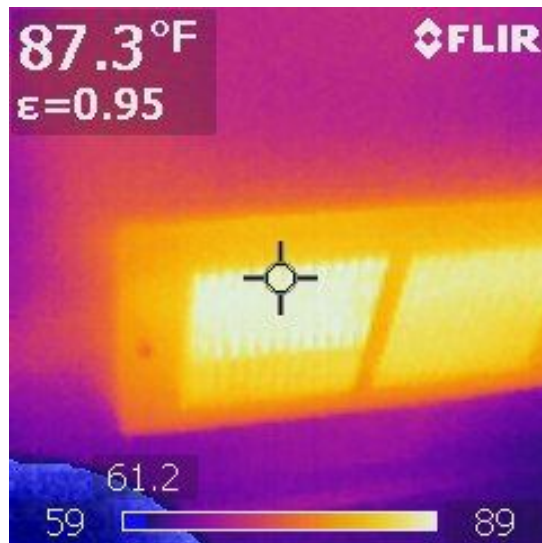
Location Room: Master Bedroom

Poor air flow noted at several supply registers. Retain a qualified HVAC contractor for further evaluation to correct this condition. Priority 1.

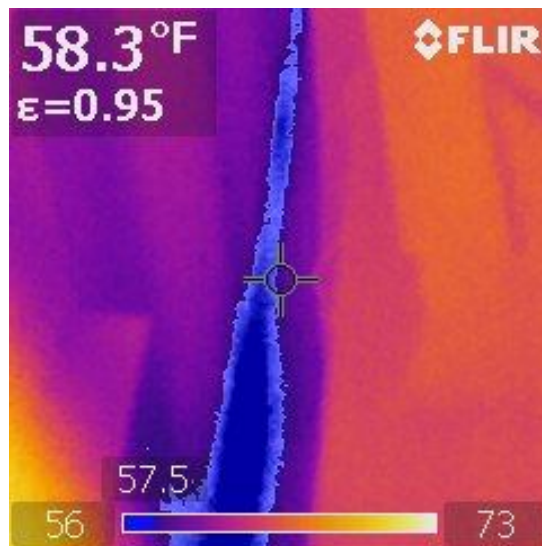
Location Room: Master Bedroom

Cold air infiltration noted in blue. Correct insulation defect. Retain qualified for further evaluation. Priority 2

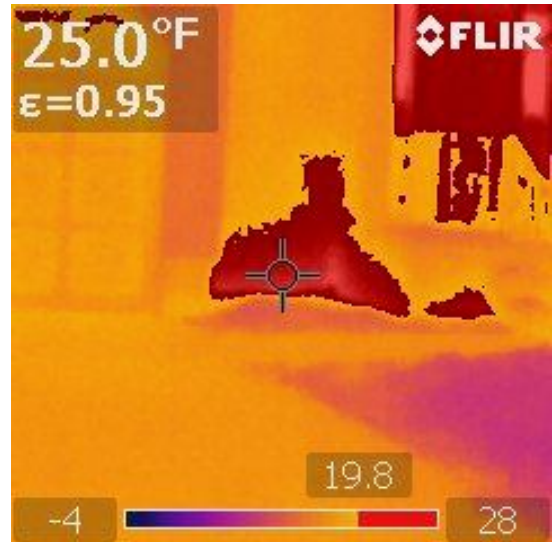
Location Direction: Front

Observations:
Hot area in red corresponds to cold air infiltration in basement.

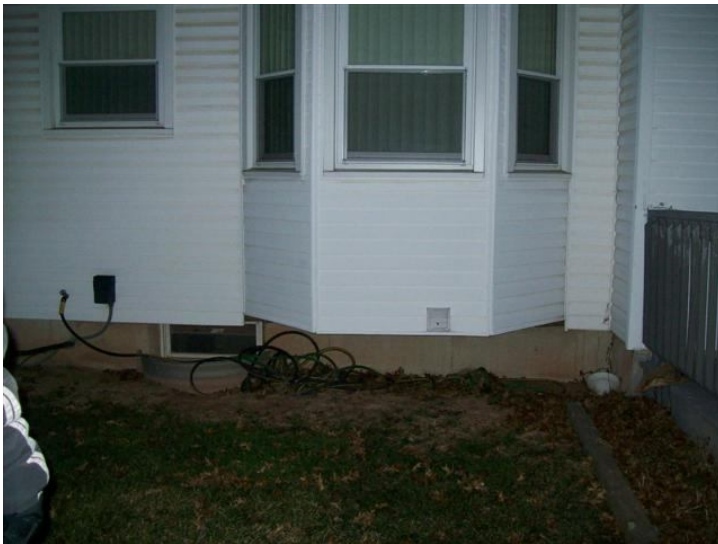
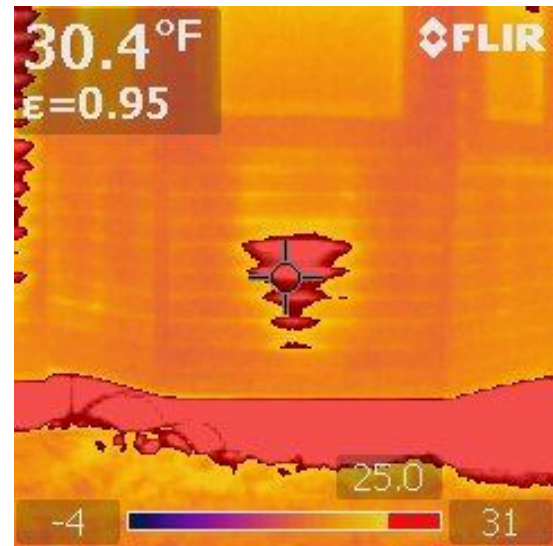
Location Direction: Exterior Rear Wall at Breakfast Area

Observations:
 Hot area in red indicates energy loss. Retain qualified contractor for evaluation. Priority 2
