# A Full House Inspection Co. LLC

## EXECUTIVE SUMMARY OVERVIEW REPORT

**Client:** Mr. & Mrs. New Homeowner  
**Inspection Address:** 555 Warranty Road Road, Camelot, NJ 07739  
**Inspection Date:** 12/13/2008 Start: 2:00 pm End: 6:30 pm  
**Inspected by:** Peter W. Bennett

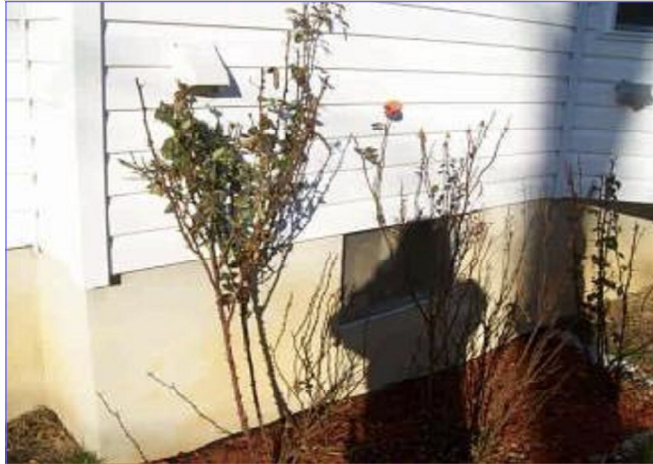
- The parge coating on the exterior foundation at the right side garage wall is crack and should be repaired.

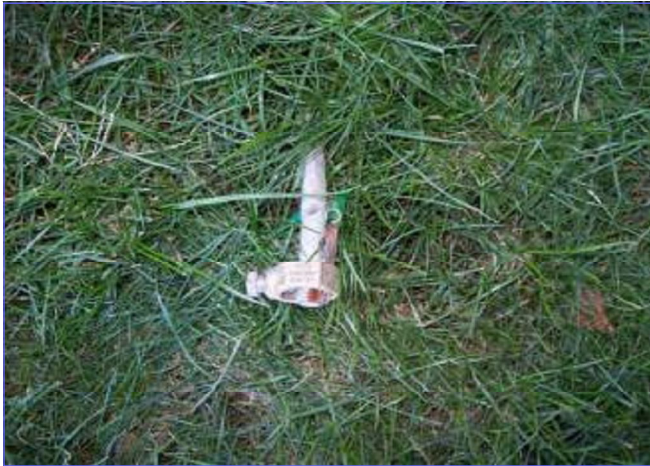
- A driven rod is loose and bent over. The rod should be re-installed or replaced in accordance with industry standards, and protected from future damage.

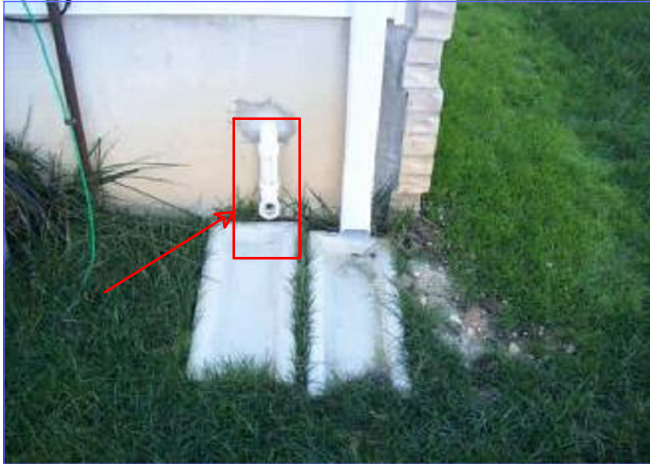
- The exterior sump pump discharge pipe terminates at the foundation which permits moisture to recirculate, and enter the dwelling. This configuration can allow the pump to excessively operate, and shorten its life expectancy. The discharge pipe should be extended/redirected.

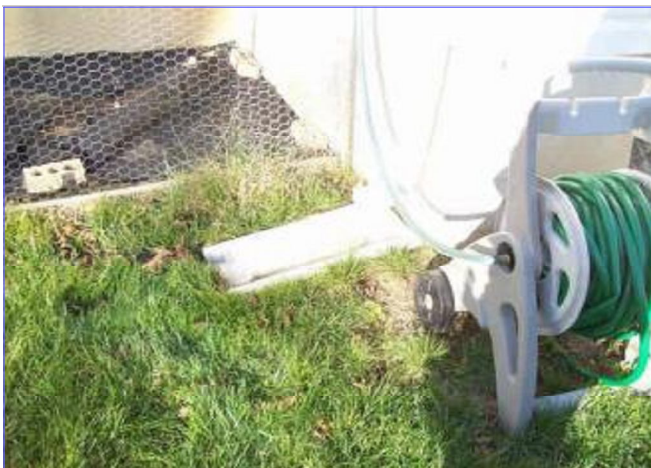
- One or more of the downspouts terminate adjacent the dwelling and should be extended to help prevent moisture and related issues from affecting the building.

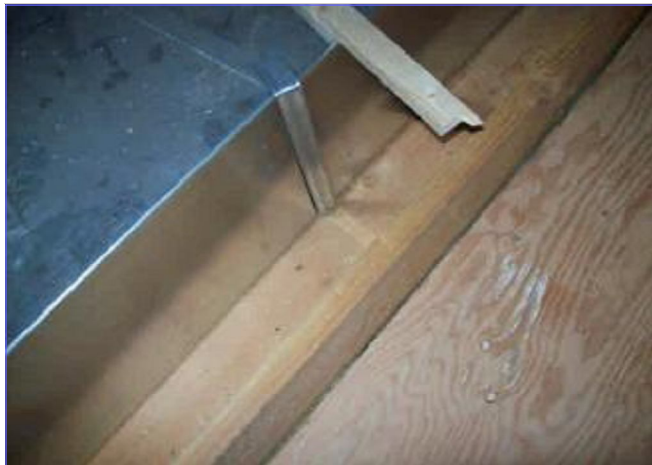
- The supply trunkline for the second floor HVAC system is leaking conditioned air at several locations. Evaluation and repairs by a qualified HVAC contractor are recommended.

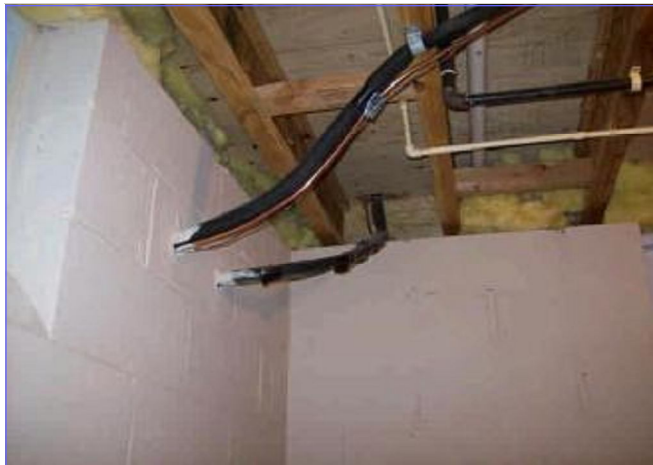
- ❖ The infrared images displayed thermal patterns (dark blue/purple) associated with cold air infiltration at the front, side and rear rim/band joist areas. Insulation has been incorrectly installed ( voids, missing, compressed ) These conditions will allow significant energy loss and contribute to higher energy bills. A qualified contractor should inspect the rim/band joist areas and correct all insulation defects in accordance with industry standards.

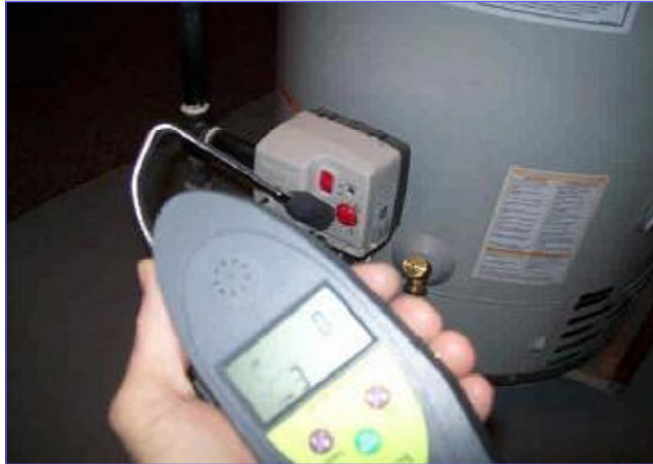
- There is a gas leak in the area of the control valve. A licensed plumber should evaluate this condition, and make all necessary repairs.

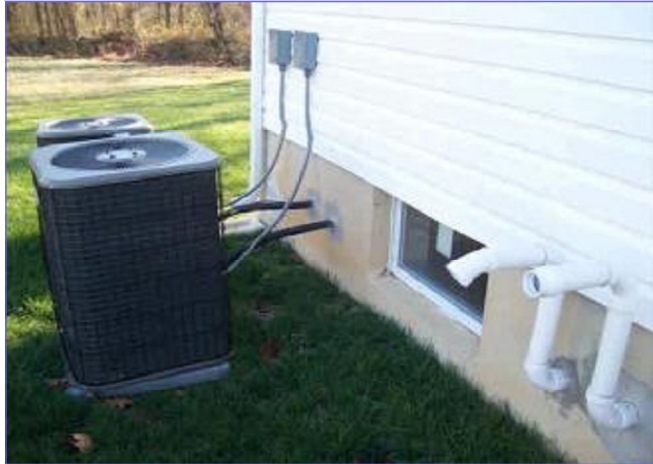
- The larger, front CAC condensing unit is unlevel which can shorten its life expectancy. The unit should be re-leveled.

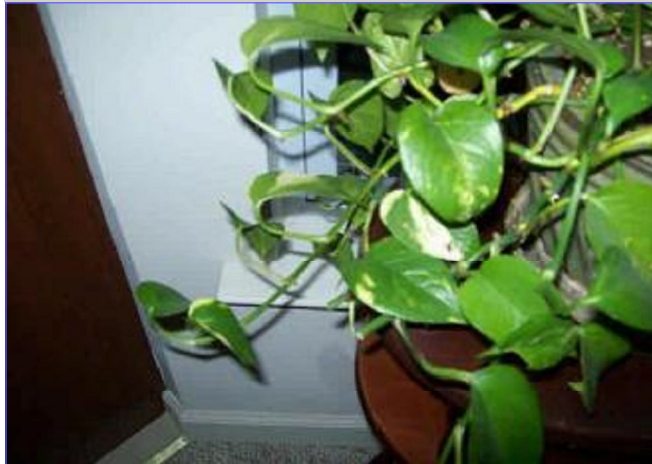
- ❖ The infrared images displayed thermal patterns (dark blue/purple) associated with cold air infiltration at the corners of the windows. The window weather stripping and caulking are suspect. These conditions will allow significant energy loss and contribute to higher energy bills and should be corrected by a qualified contractor.

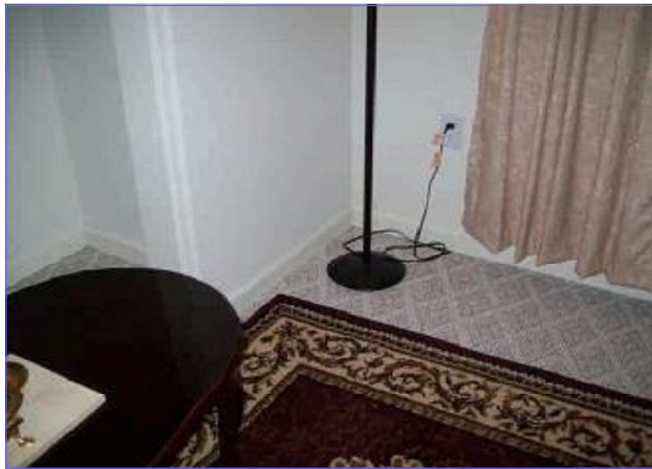
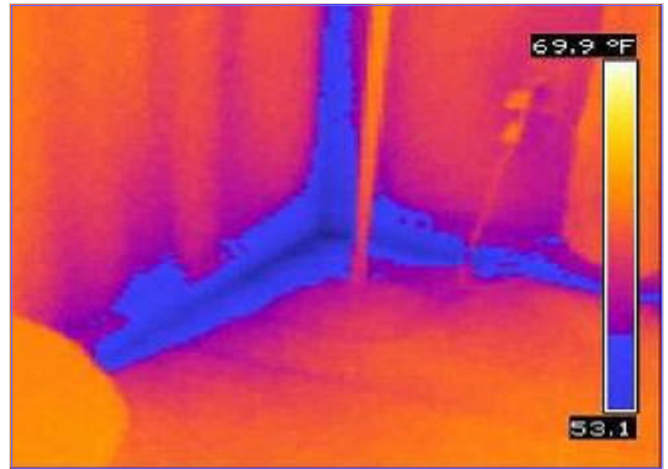
- ❖ The first guest bedroom is located at the second floor left front side. The infrared images displayed thermal patterns (dark blue/purple) associated with cold air infiltration at the lower front wall area next to the closet and wall insulation is suspect. These conditions will allow significant energy loss and contribute to higher energy bills, and should be corrected by a qualified contractor.

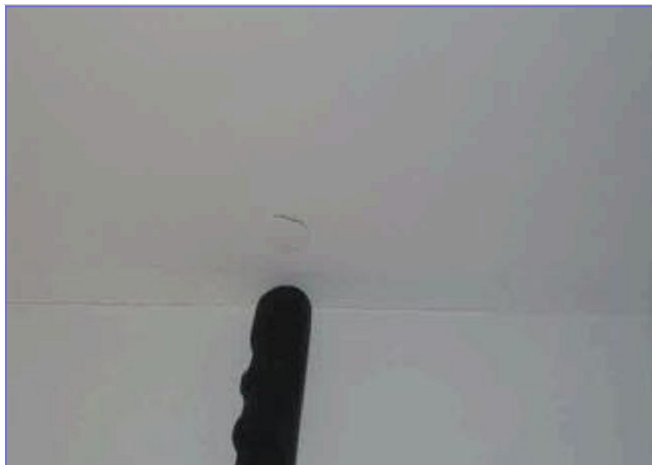
- Several sheetrock nails have popped through the surface, and should be repaired.

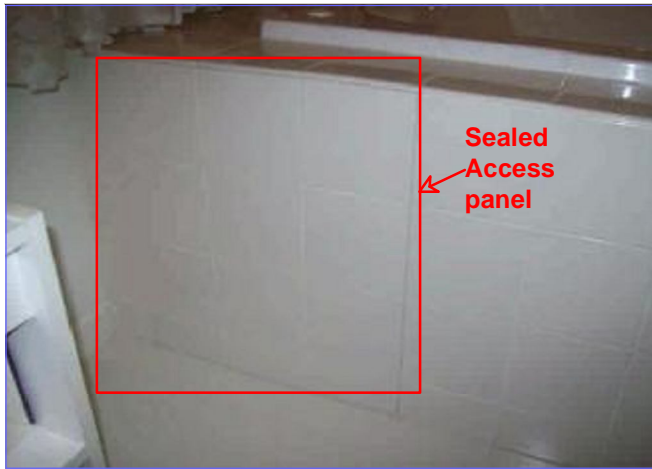
- ❖ The water flow at the two rear jets was inadequate and unsatisfactory. Further evaluation and repairs by a qualified technician are recommended.
