# Thermal Imaging Report

123 Renovation Street  
Manalapan, NJ 07726

Prepared by: A Full House Inspection Co. LLC

Date:12/22/08

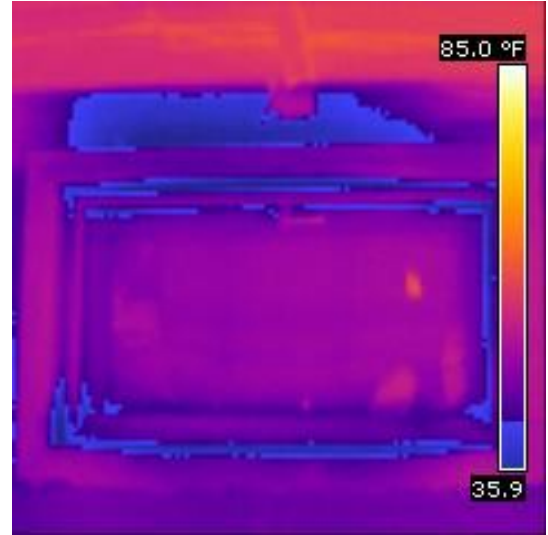
Location Floor: Basement  
Location Direction: Right Side Wall

**Observations:**  
Dark blue thermal patterns indicative of cold air infiltration. Correction is recommended to reduce energy loss and utility bills.

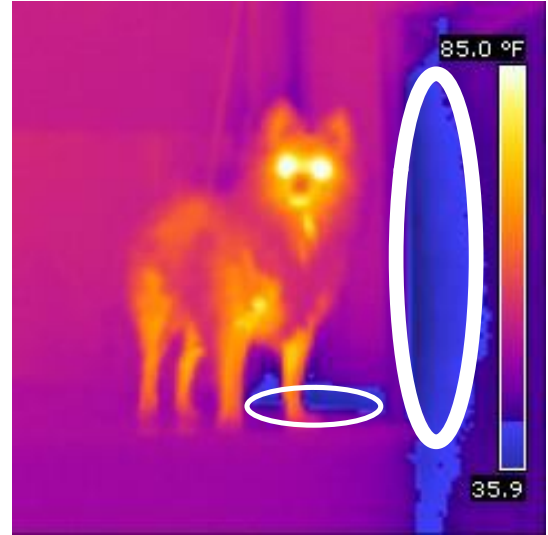
Location Floor: Basement  
Location Direction: Right Side Wall

**Observations:**  
Dark blue thermal patterns indicative of cold air infiltration. Correction is recommended to reduce energy loss and utility bills.

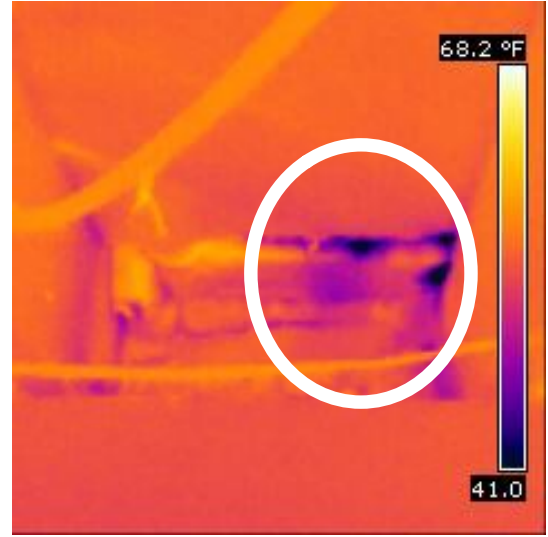
Location Floor: Basement  
Location Direction: Front Wall

**Observations:**  
Dark blue thermal patterns indicative of cold air infiltration. Correction is recommended to reduce energy loss and utility bills.

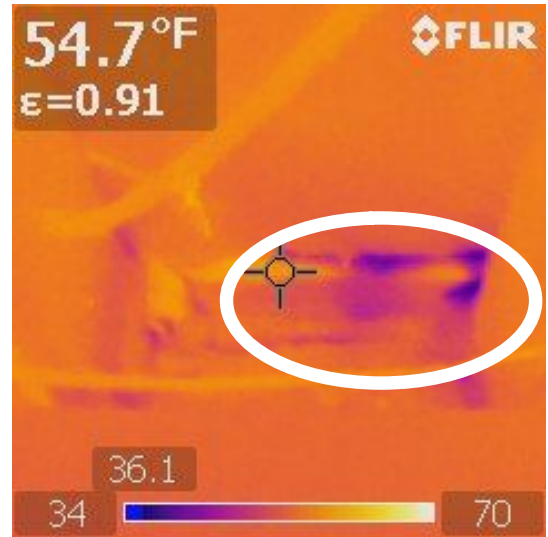
Location Floor: Basement  
Location Direction: Front Wall

**Observations:**  
Dark blue thermal patterns indicative of cold air infiltration. Correction is recommended to reduce energy loss and utility bills.

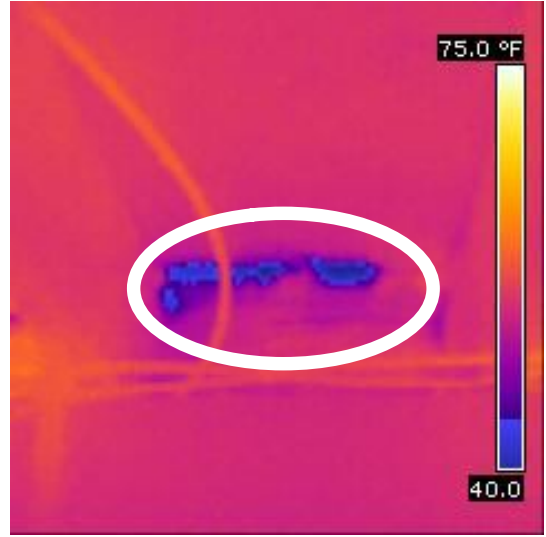
Location Floor: Basement  
Location Direction: Front Wall

**Observations:**  
Dark blue thermal patterns indicative of cold air infiltration. Correction is recommended to reduce energy loss and utility bills.

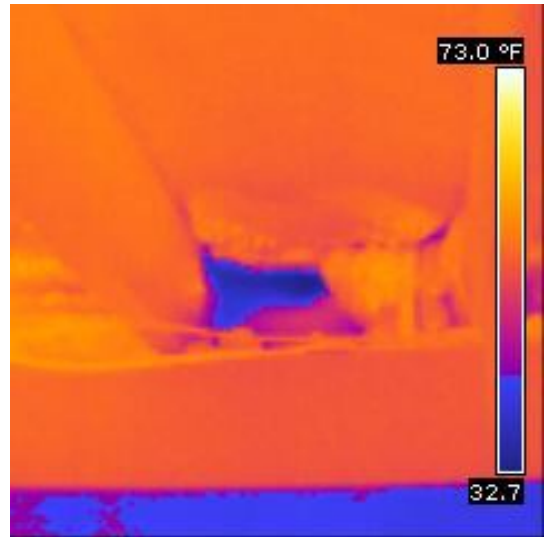
Location Floor: Basement  
Location Direction: Front Wall

**Observations:**  
Dark blue thermal patterns indicative of cold air infiltration. Correction is recommended to reduce energy loss and utility bills.

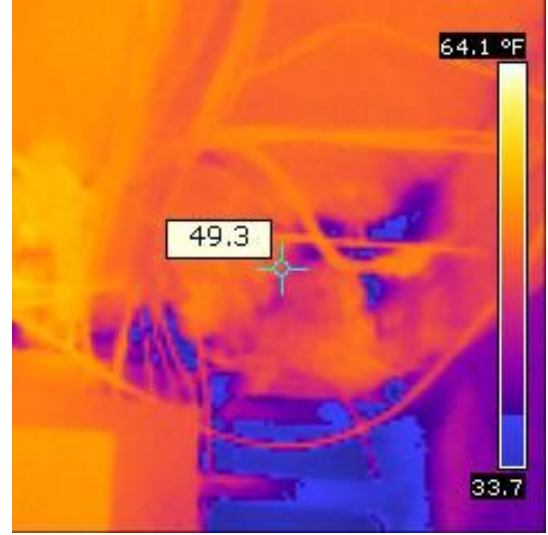
Location Floor: Basement  
Location Direction: Left Front Corner

**Observations:**  
Dark blue thermal patterns indicative of cold air infiltration. Correction is recommended to reduce energy loss and utility bills.

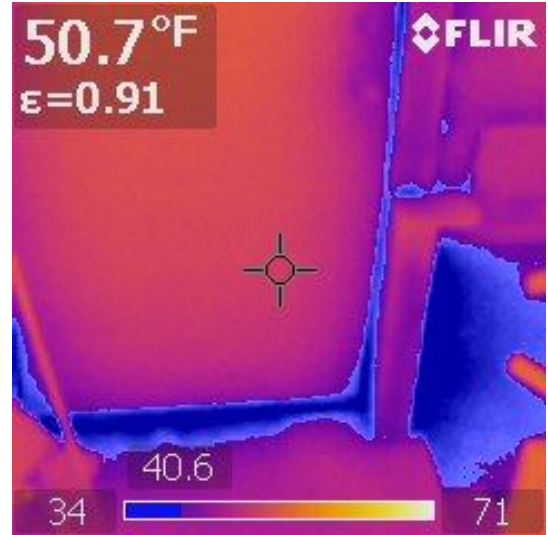
Location Floor: First Floor  
Location Direction: Right Side Wall

**Observations:**  
Dark blue thermal patterns indicative of cold air infiltration. Correction is recommended to reduce energy loss and utility bills.

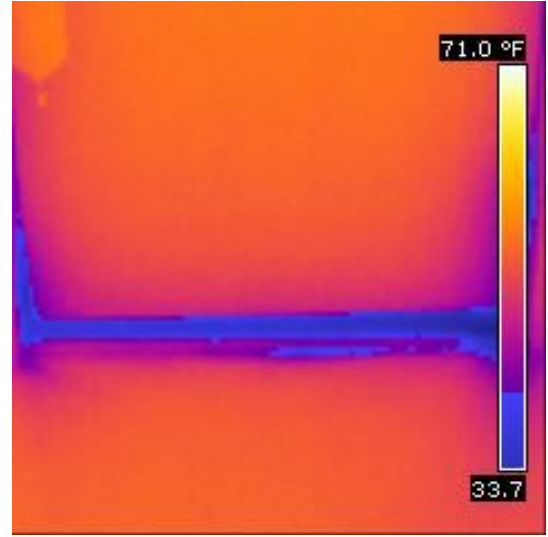
Location Floor: First Floor  
Location Room: Living

**Observations:**  
Dark blue thermal patterns indicative of cold air infiltration. Correction is recommended to reduce energy loss and utility bills.

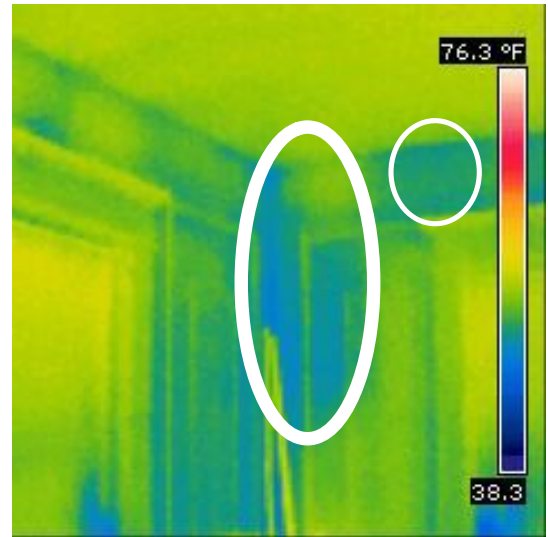
Location Floor: First Floor  
Location Direction: Left Front Corner

**Observations:**  
Dark blue thermal patterns indicative of cold air infiltration. Correction is recommended to reduce energy loss and utility bills.

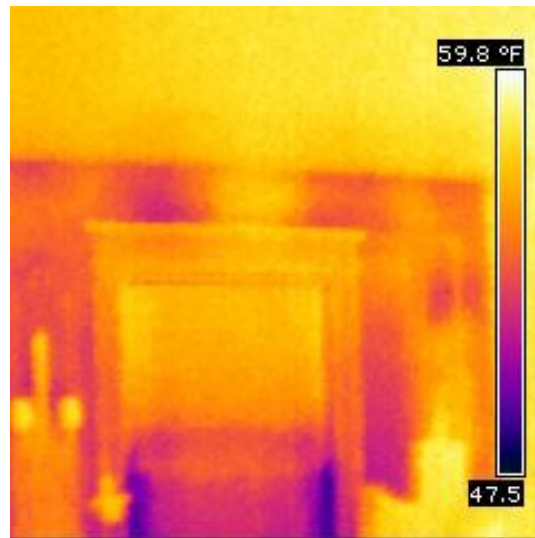
Location Floor: First  
 Location Room: Living  
 Location Direction: Left Side Wall

**Observations:**  
 Dark blue thermal patterns indicative of cold air infiltration. Correction is recommended to reduce energy loss and utility bills.

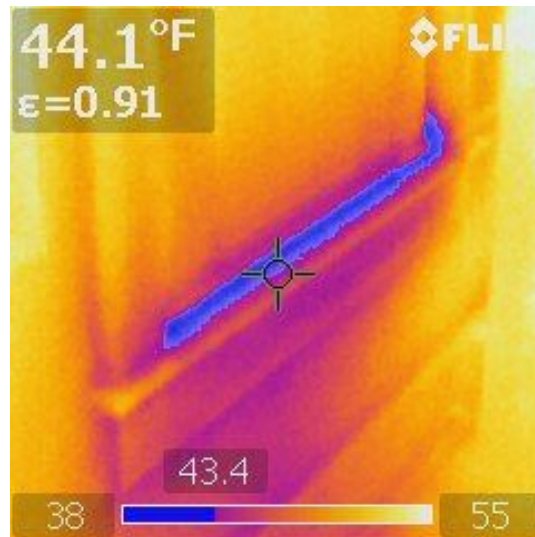
Location Floor: First  
 Location Room: Living  
 Location Direction: Left Side Wall

**Observations:**  
 Dark blue thermal patterns indicative of cold air infiltration. Correction is recommended to reduce energy loss and utility bills.

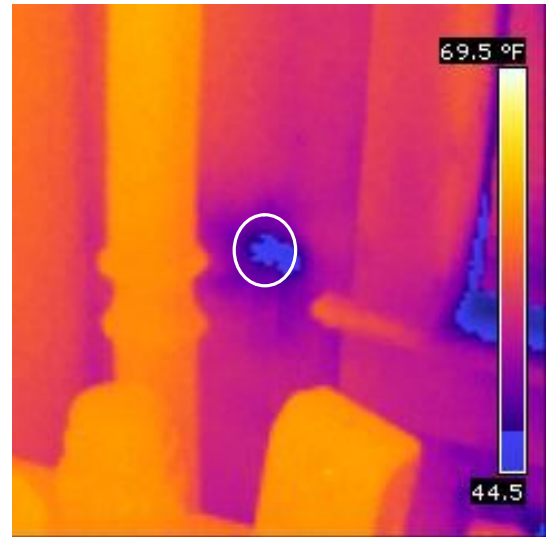
Location Floor: First  
 Location Room: Family  
 Location Direction: Left Side Wall

**Observations:**  
 Dark blue thermal patterns indicative of cold air infiltration. Correction is recommended to reduce energy loss and utility bills.

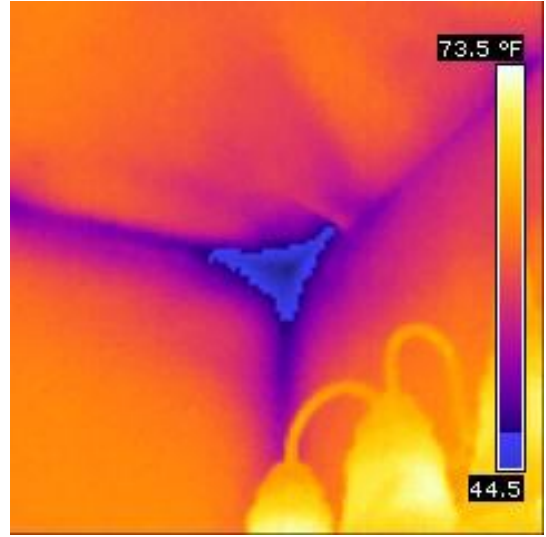
Location Floor: First  
Location Room: Bathroom

**Observations:**  
Dark blue thermal patterns indicative of cold air infiltration. Correction is recommended to reduce energy loss and utility bills.

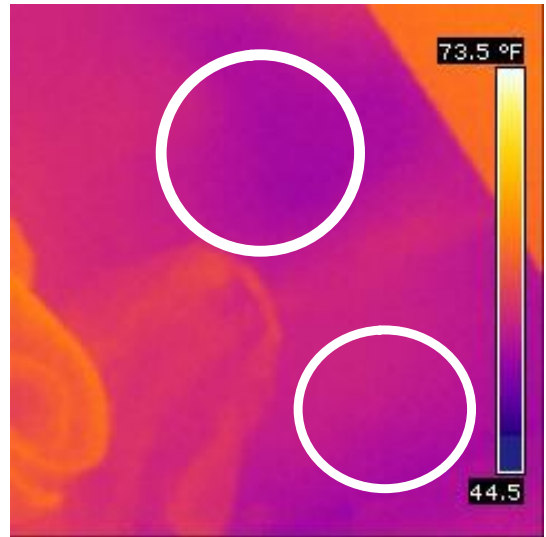
Location Floor: First  
Location Room: Bathroom  
Location Direction: Closet

**Observations:**  
Dark blue thermal patterns indicative of cold air infiltration. Correction is recommended to reduce energy loss and utility bills.

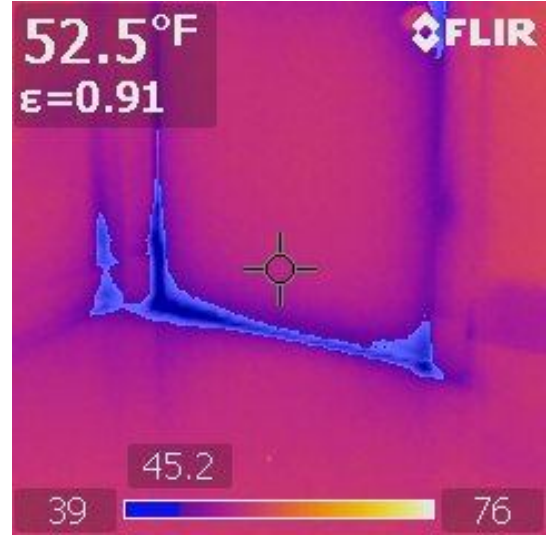
Location Floor: First  
 Location Room: Breakfast  
 Location Direction: Rear

**Observations:**  
 Dark blue thermal patterns indicative of cold air infiltration. Correction is recommended to reduce energy loss and utility bills.

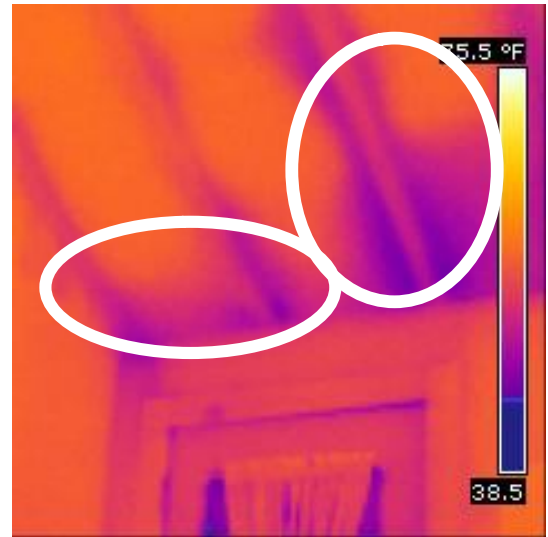
Location Floor: First Floor  
 Location Room: Breakfast

**Observations:**  
 Dark blue thermal patterns indicative of cold air infiltration. Correction is recommended to reduce energy loss and utility bills.

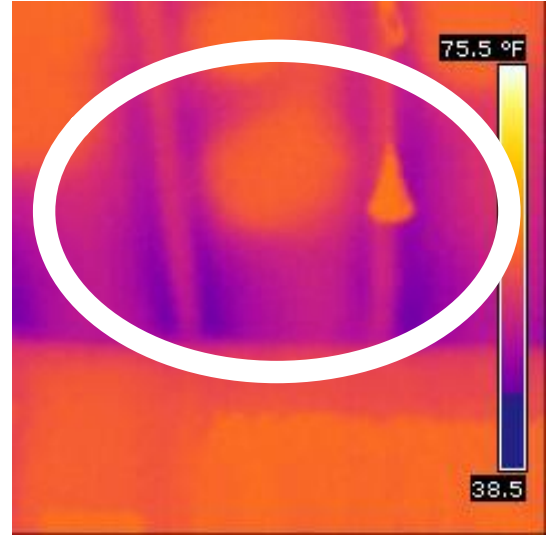
Location Floor: First  
Location Room: Breakfast

**Observations:**  
Dark blue thermal patterns indicative of cold air infiltration. Correction is recommended to reduce energy loss and utility bills.

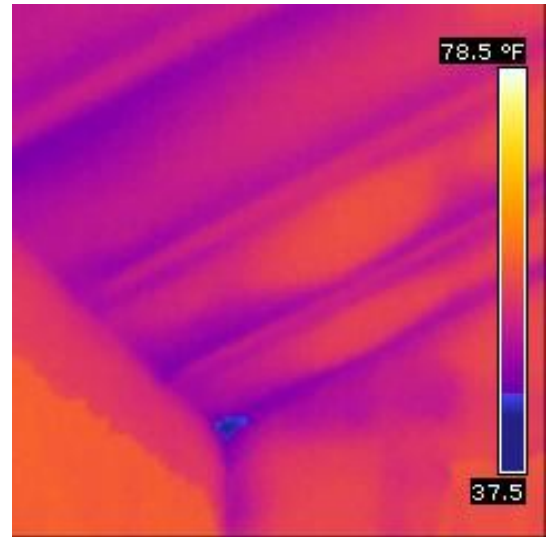
Location Floor: First Floor  
Location Room: Breakfast

**Observations:**  
Dark blue thermal patterns indicative of cold air infiltration. Correction is recommended to reduce energy loss and utility bills.

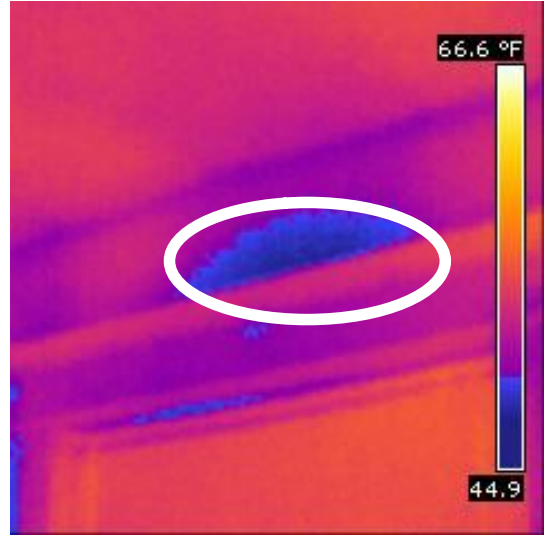
Location Floor: First  
Location Room: Living  
Location Direction: Right Front Corner

**Observations:**  
Dark blue thermal patterns indicative of cold air infiltration. Correction is recommended to reduce energy loss and utility bills.

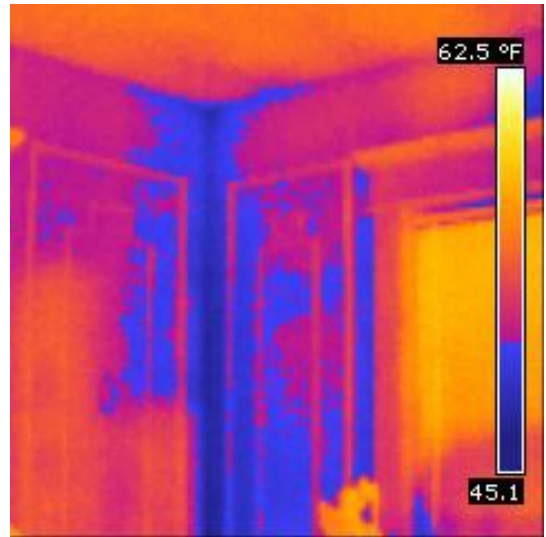
Location Floor: First  
Location Room: Living  
Location Direction: Right Front Corner

**Observations:**  
Dark blue thermal patterns indicative of cold air infiltration. Correction is recommended to reduce energy loss and utility bills.

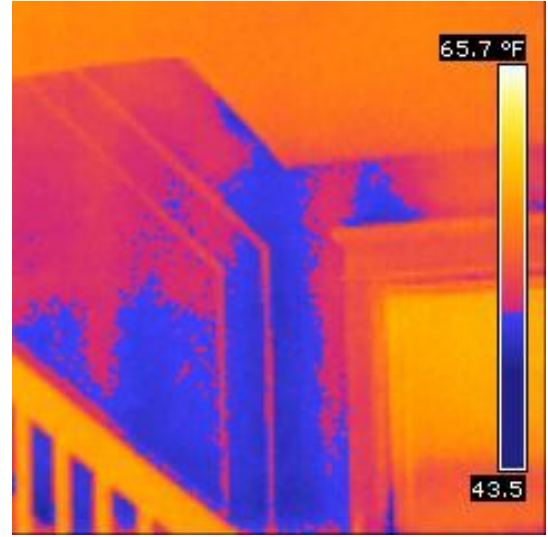
Location Floor: First  
 Location Room: Living  
 Location Direction: Right Front Wall

**Observations:**  
 Dark blue thermal patterns indicative of cold air infiltration. Correction is recommended to reduce energy loss and utility bills.

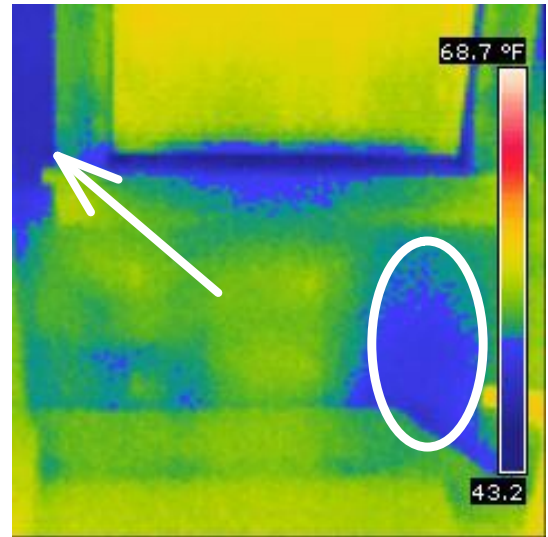
Location Floor: Second Floor  
 Location Room: Stairs  
 Location Direction: Right Side Wall

**Observations:**  
 Dark blue thermal patterns indicative of cold air infiltration. Correction is recommended to reduce energy loss and utility bills.

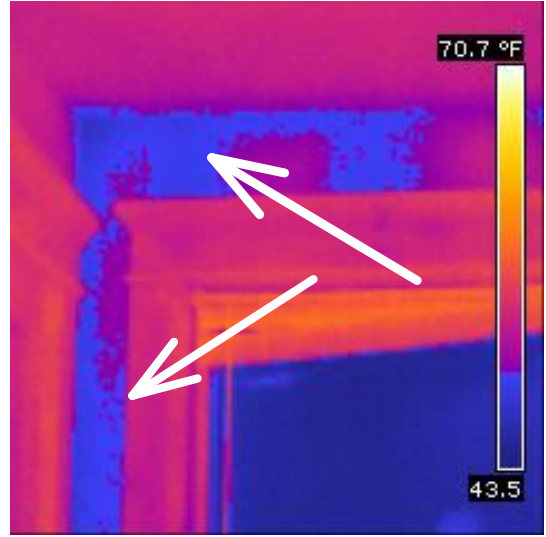
Location Floor: Second  
Location Room: Right Front Bedroom

**Observations:**  
Dark blue thermal patterns indicative of cold air infiltration. Correction is recommended to reduce energy loss and utility bills.

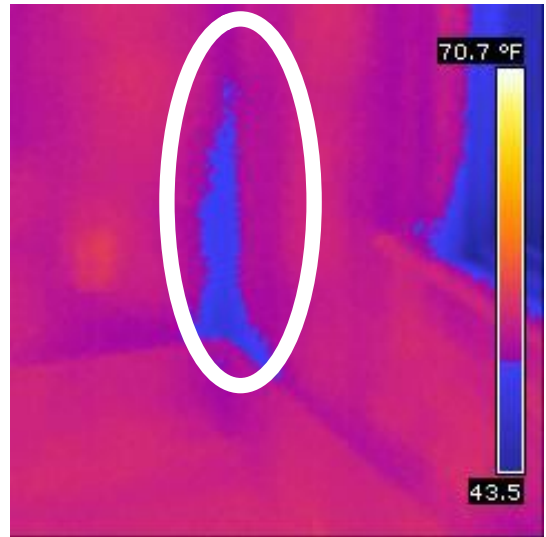
Location Floor: Second  
Location Room: Right Front

**Observations:**  
Dark blue thermal patterns indicative of cold air infiltration. Correction is recommended to reduce energy loss and utility bills.

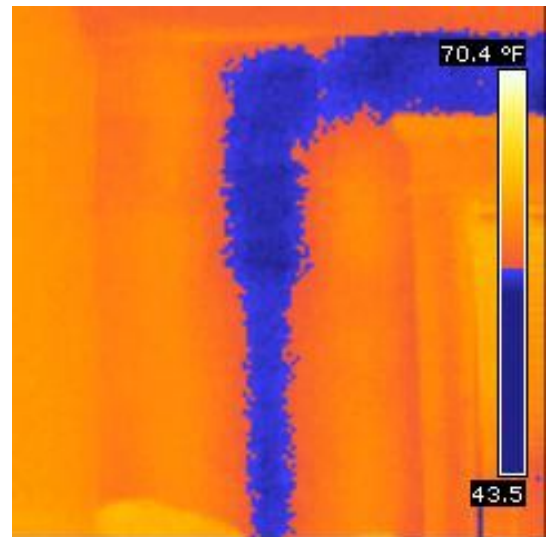
Location Floor: Second  
Location Room: Bathroom  
Location Direction: Right Side Wall

Dark blue thermal patterns indicative of cold air infiltration. Correction is recommended to reduce energy loss and utility bills.

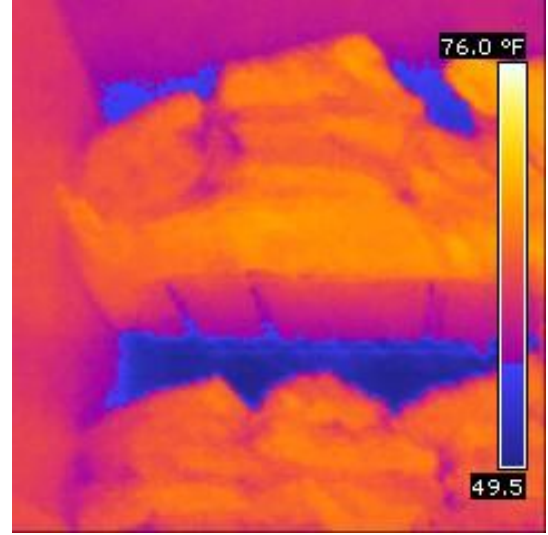
Location Floor: Second Floor

**Observations:**  
Dark blue thermal patterns indicative of cold air infiltration. Correction is recommended to reduce energy loss and utility bills.

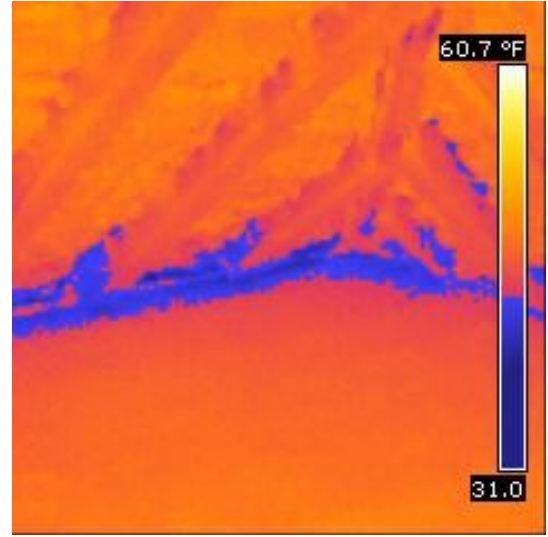
Location Floor: Attic  
 Location Direction: Right Front Corner

**Observations:**  
 Dark blue thermal patterns indicative of cold air infiltration. Correction is recommended to reduce energy loss and utility bills.

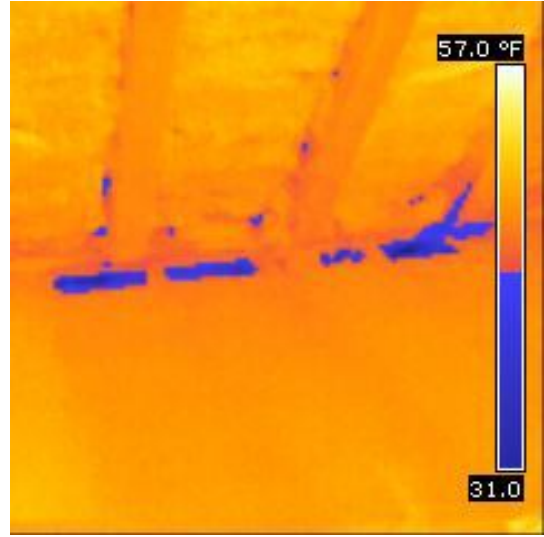
Location Floor: Attic

**Observations:**  
Dark blue thermal patterns indicative of cold air infiltration. Correction is recommended to reduce energy loss and utility bills.

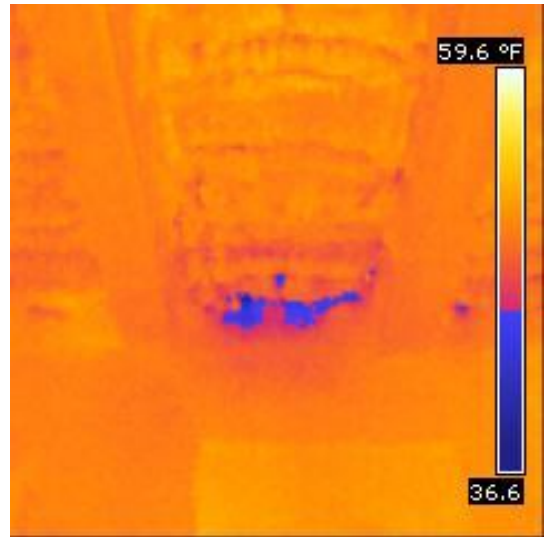
Location Floor: Attic  
Location Direction: Front

**Observations:**  
Dark blue thermal patterns indicative of cold air infiltration. Correction is recommended to reduce energy loss and utility bills.

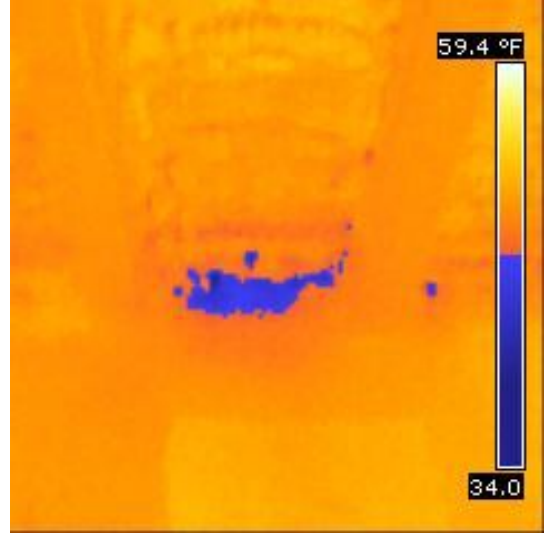
Location Floor: Attic

**Observations:**  
Dark blue thermal patterns indicative of cold air infiltration. Correction is recommended to reduce energy loss and utility bills.

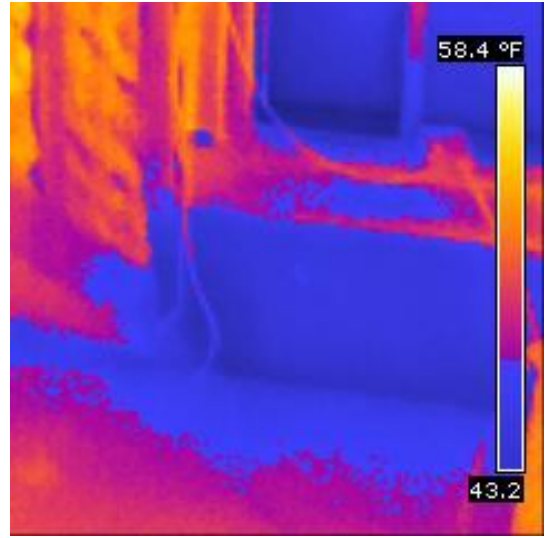
Location Floor: Attic  
Location Direction: Right Front Wall

**Observations:**  
Dark blue thermal patterns indicative of cold air infiltration. Correction is recommended to reduce energy loss and utility bills.

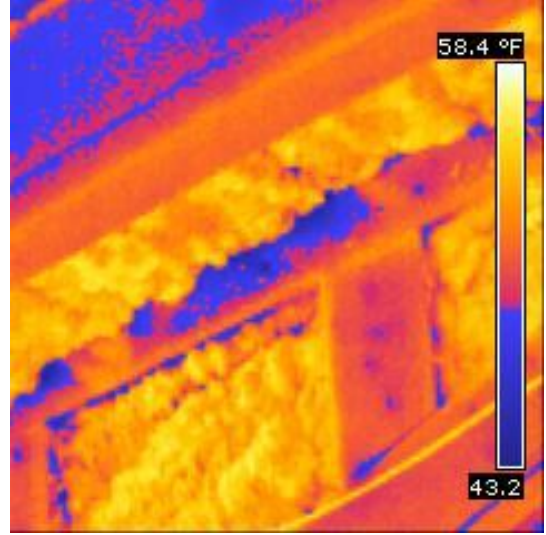
Location Floor: Attic

**Observations:**  
Dark blue thermal patterns indicative of cold air infiltration. Correction is recommended to reduce energy loss and utility bills.

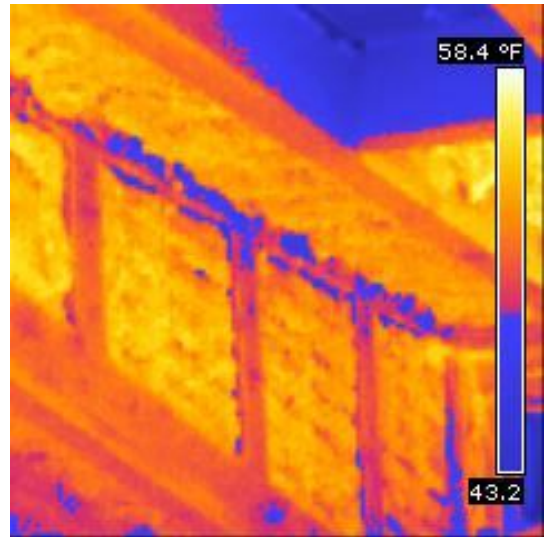
Location Floor: Attic

**Observations:**  
Dark blue thermal patterns indicative of cold air infiltration. Correction is recommended to reduce energy loss and utility bills.

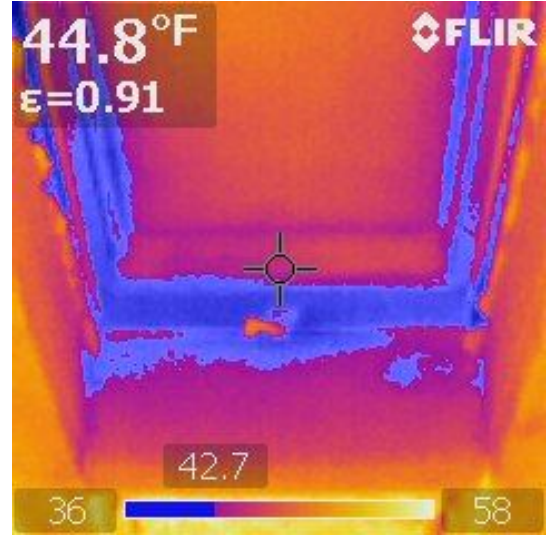
Location Floor: Attic

**Observations:**  
 Dark blue thermal patterns indicative of cold air infiltration. Correction is recommended to reduce energy loss and utility bills.

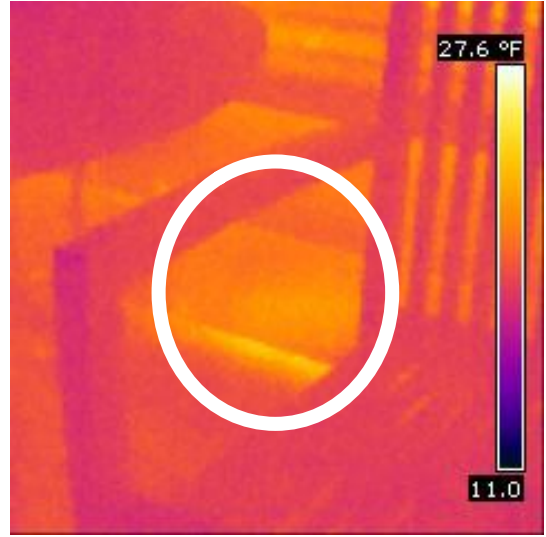
Location Direction: Front Porch

**Observations:**  
 Dark Red thermal patterns indicative of energy loss. Correction is recommended to reduce energy loss and utility bills.

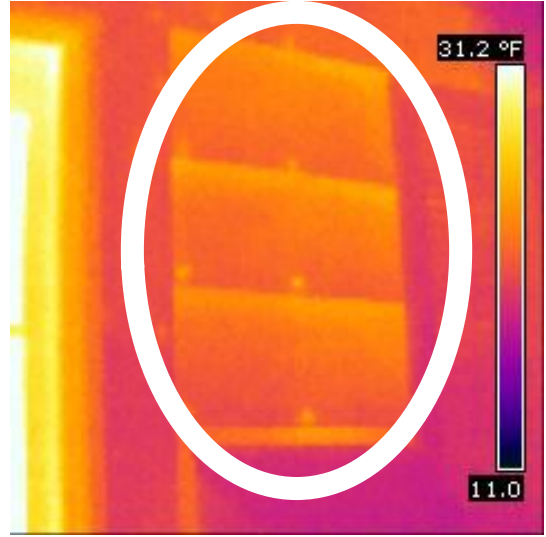
Location Direction: Front Porch

**Observations:**  
 Dark Red thermal patterns indicative of energy loss. Correction is recommended to reduce energy loss and utility bills.

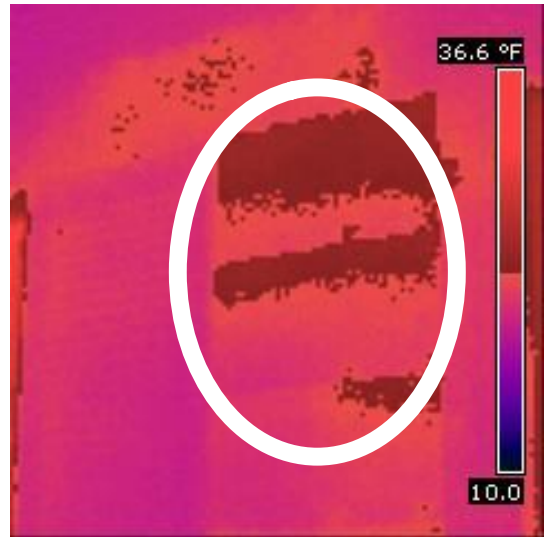
Location Direction: Front Porch

**Observations:**  
 Dark Red thermal patterns indicative of energy loss. Correction is recommended to reduce energy loss and utility bills.

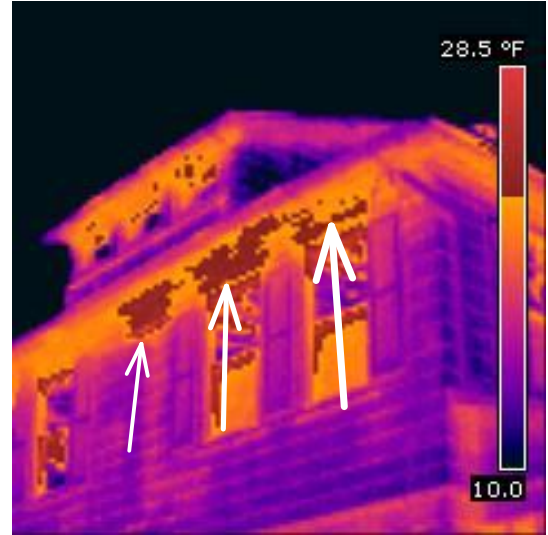
Location Direction: Left Front Corner

**Observations:**  
Red thermal patterns indicative of energy loss. Correction is recommended to reduce energy loss and utility bills.

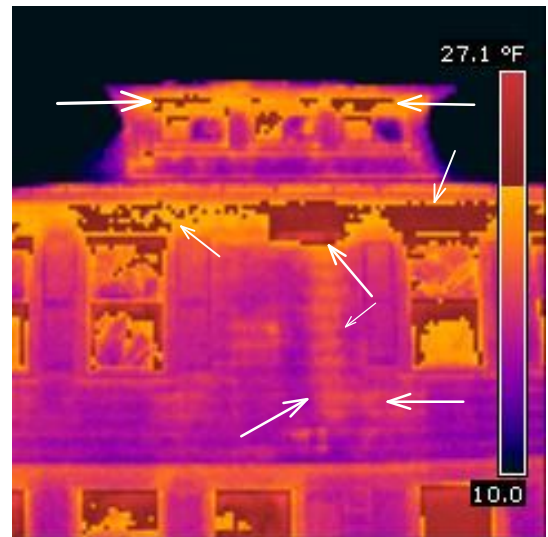
Location Direction: Left Side Wall

**Observations:**  
Dark Red thermal patterns indicative of energy loss. Correction is recommended to reduce energy loss and utility bills.

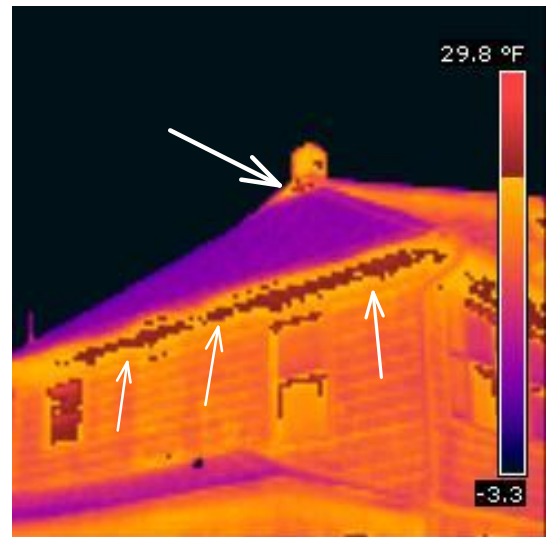
Location Direction: Rear

Dark Red thermal patterns indicative of energy loss. Correction is recommended to reduce energy loss and utility bills.

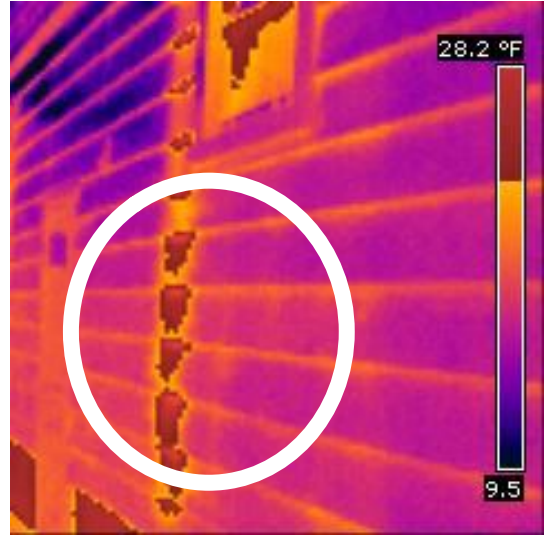
Location Direction: Right Side Wall

**Observations:**  
Dark Red thermal patterns indicative of energy loss. Correction is recommended to reduce energy loss and utility bills.

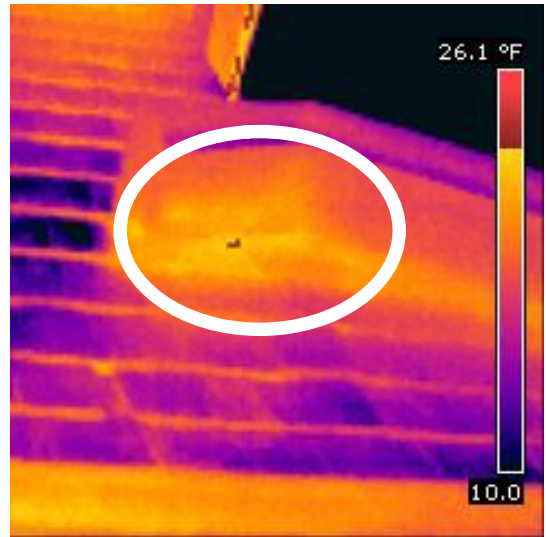
Location Direction: Right Side Wall

**Observations:**  
Dark Red thermal patterns indicative of energy loss. Correction is recommended to reduce energy loss and utility bills.

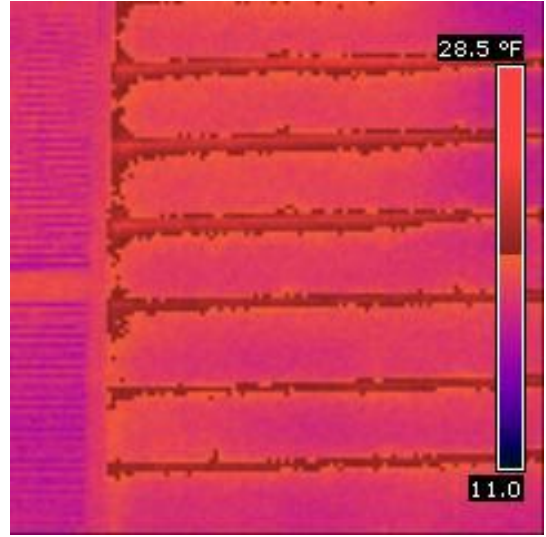
Location Direction: Right Side Wall at Stairs

Observations:  
Dark Red thermal patterns indicative of energy loss. Correction is recommended to reduce energy loss and utility bills.

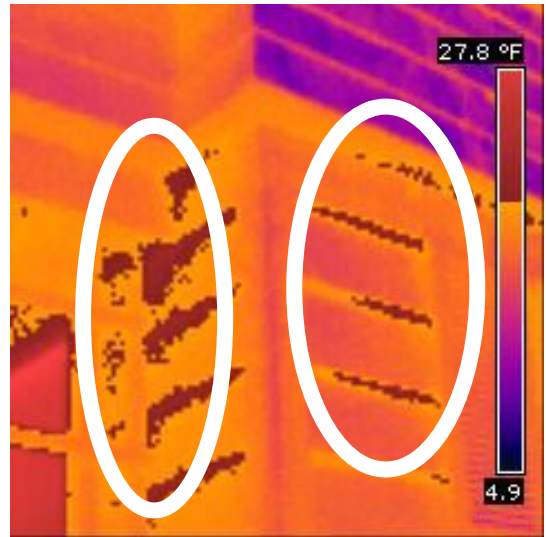
Location Direction: Right Front Corner

Observations:  
Dark Red thermal patterns indicative of energy loss. Correction is recommended to reduce energy loss and utility bills.
